SERIOUS INCIDENT

Aircraft Type and Registration:	Boeing 737-8AS, EI-ENF
No & Type of Engines:	2 CFM 56-7B26 turbofan engines
Year of Manufacture:	2010 (Serial no: 35034)
Date & Time (UTC):	17 March 2022 at 0045 hrs
Location:	Manchester Airport
Type of Flight:	Commercial Air Transport (Passenger)
Persons on Board:	Crew - 6 Passengers - 167
Injuries:	Crew - None Passengers - None
Nature of Damage:	Fractured left main gear wheel hub
Commander's Licence:	Airline Transport Pilot's Licence
Commander's Age:	35 years
Commander's Flying Experience:	9,041 hours (of which 8,834 were on type) Last 90 days - 167 hours Last 28 days - 60 hours
Information Source:	Aircraft Accident Report Form submitted by the pilot and subsequent enquiries with the operator and wheel manufacturer

Synopsis

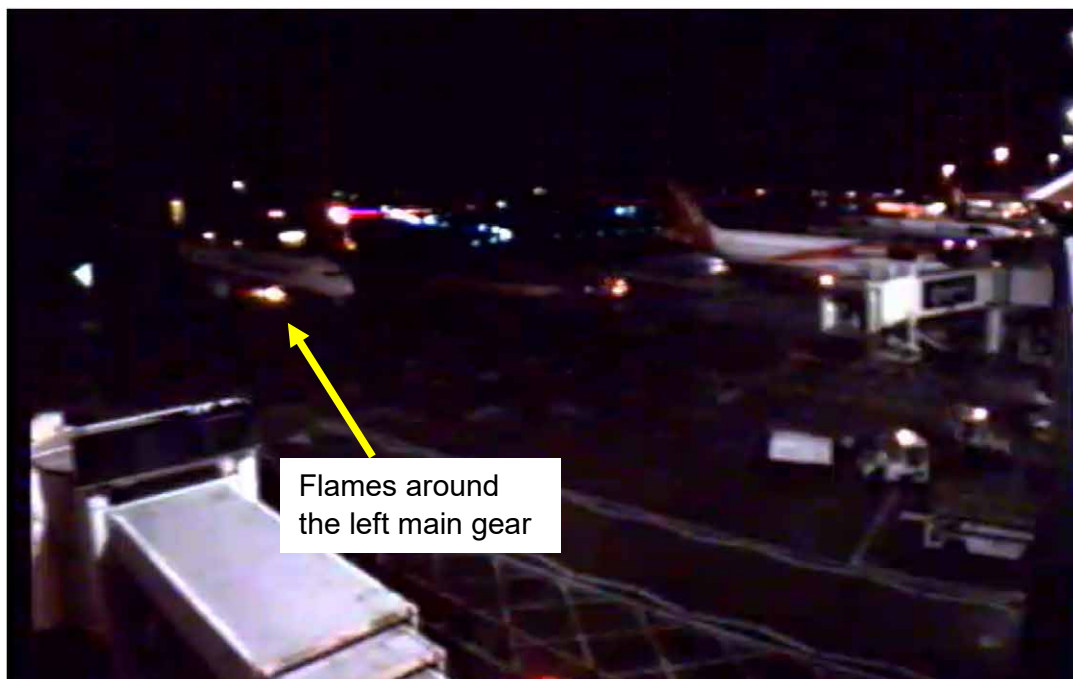
Figure 1

Whilst taxiing to the gate after landing, the outboard wheel on the left main gear failed because of a fatigue crack in the wheel hub. The wheel failure caused a hydraulic leak from the brake piston and the heat generated by the misaligned wheel, caused the hydraulic fluid to combust resulting in a fire.

CCTV images showed that the fire started as the aircraft turned left from the apron towards the gate (Figure 1).

Still from CCTV showing a fire around the left main gear as the aircraft turned onto the stand (reproduced with permission)

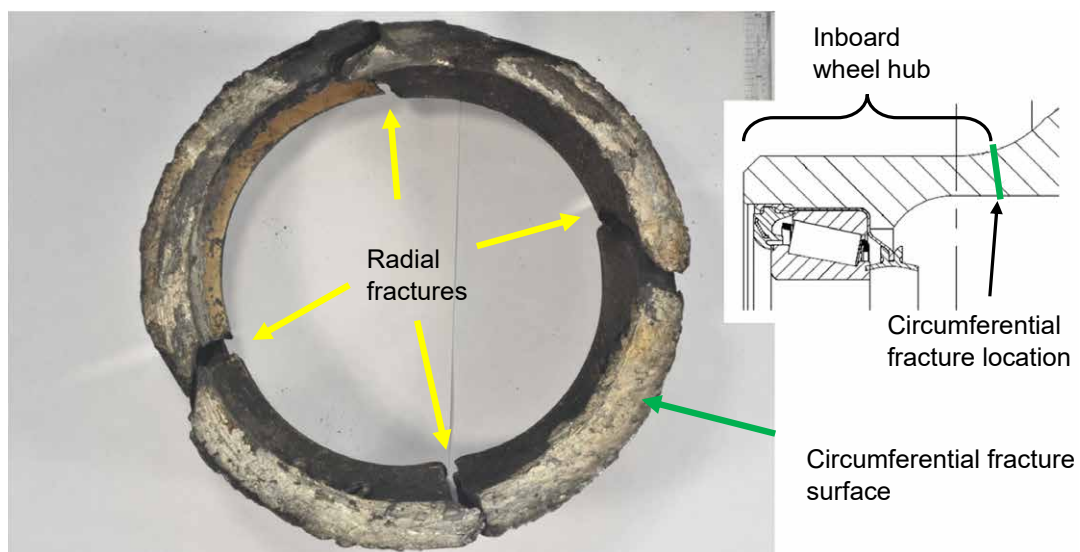
Figure 3

After the event, the aircraft was examined by the operator's engineering personnel who discovered that the left main wheel inner hub had fractured. The resulting misalignment of the wheel had damaged the brake piston, causing a hydraulic fluid leak. They assessed that the heat generated by the misaligned wheel, whilst the aircraft taxied to the stand, was sufficient to ignite the hydraulic fluid.

The wheel and brake manufacturer subsequently identified that the inboard wheel hub had fractured radially in four locations; they also identified a circumferential crack around the hub (Figure 3).

Inboard wheel half fragments showing the location of the circumferential and four radial fractures (reproduced with permission)

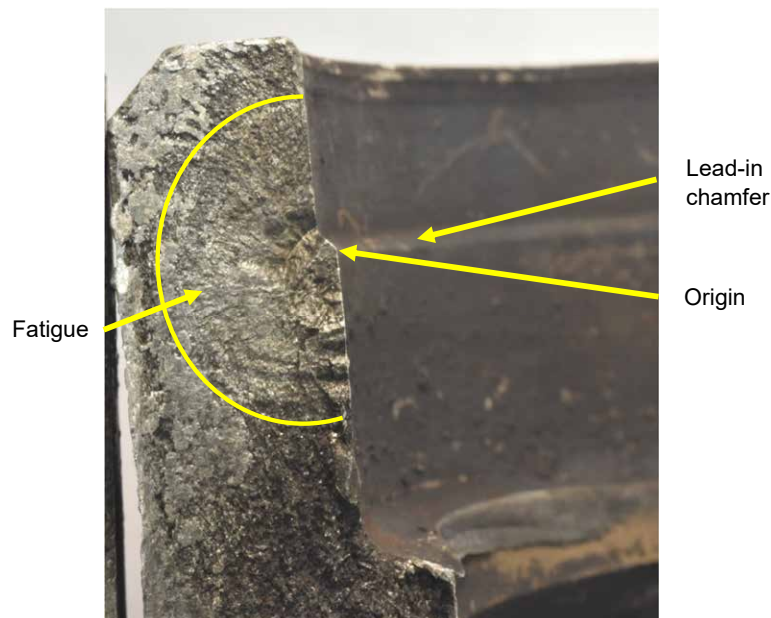
Figure 4

The fatigue crack originated from a corrosion pit in the wheel hub. Following this occurrence, the wheel manufacturer developed an ultrasonic inspection technique to identify cracks in this location on the hub and the operator has incorporated the new inspection into their maintenance programme.

Three of the four radial fractures and the circumferential fracture were all consistent with overload. A fatigue crack was identified on one of the fracture surfaces, which originated at a corrosion pit located on the lead-in chamfer of the inner wheel half bearing bore (Figure 4). A number of other fatigue cracks, all originating from corrosion pits, were also found in the bore.

Radial fracture surface with area of fatigue highlighted (reproduced with permission)

The wheel manufacturer has developed an ultrasonic inspection to assess the condition of the internal bore of the wheel hub to identify the presence of cracks originating at the lead in chamfer of the bearing bore.

The operator has introduced this optional ultrasonic inspection on their fleet of Boeing 737-8AS aircraft.

The wheel manufacturer stated that they would amend the component maintenance manual to introduce an ultrasonic inspection of the inner wheel half hub lead in chamfers.
