ACCIDENT

Aircraft Type and Registration:	Cessna 441 Conquest II, EI-DMG	
No & Type of Engines:	2 Honeywell (Garrett Airesearch) TPE 331-10-534S turboprop engines	
Year of Manufacture:	1980	
Date & Time (UTC):	25 June 2019 at 0800 hrs	
Location:	Glasgow Prestwick Airport	
Type of Flight:	Private	
Persons on Board:	Crew - 2	Passengers - 7
Injuries:	Crew - None	Passengers - None
Nature of Damage:	Engines, propellers and right-hand nose locker door damaged	
Commander's Licence:	Commercial Pilot's Licence	
Commander's Age:	50 years	
Commander's Flying Experience:	4,563 hours (of which 1,035 were on type) Last 90 days - 40 hours Last 28 days - 11 hours	
Information Source:	Aircraft Accident Report Form submitted by the pilot and subsequent AAIB enquiries

Synopsis

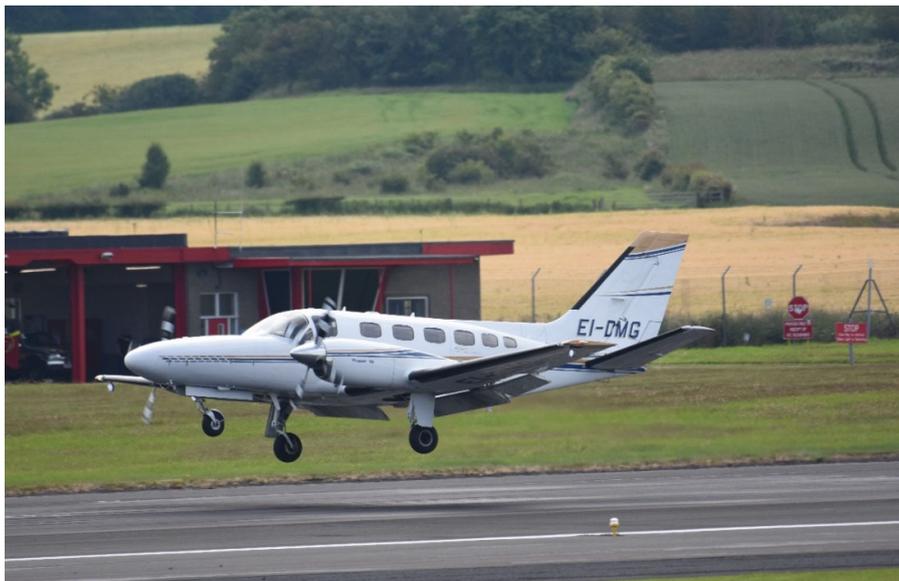
Figure 1

A photograph taken of EI-DMG prior to touchdown (Figure 1) shows that the nose landing gear was partially extended prior to landing.

EI-DMG nose landing gear partially extended prior to touchdown
(image used with permission)

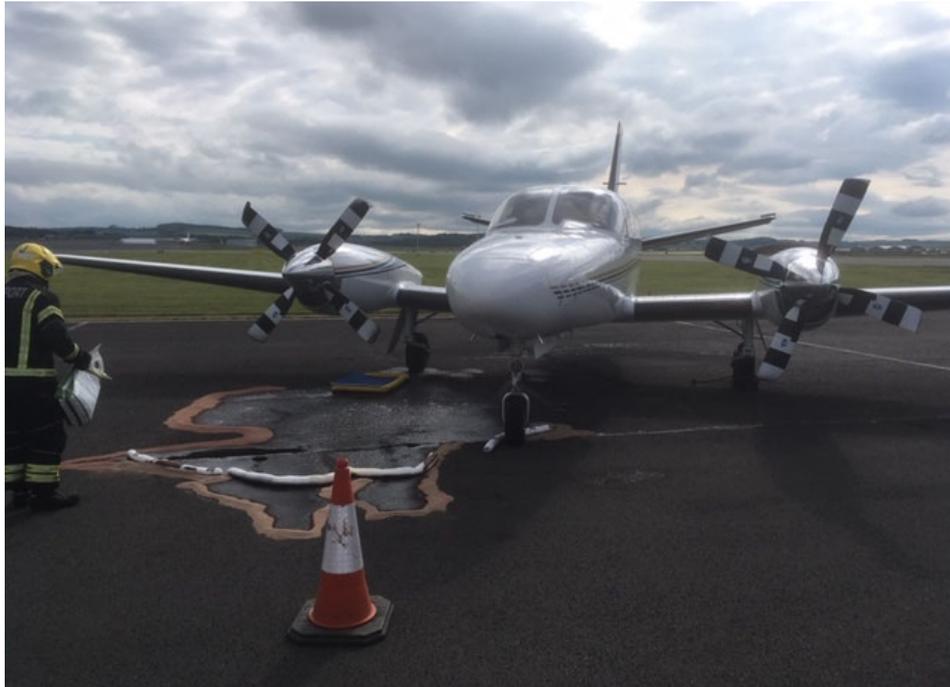
Figure 2

While taxiing to the parking area, a passenger alerted the commander to fuel leaking from the right engine. The taxi was expedited and the firewall shutoff valves were then activated. There were no injuries and the occupants disembarked normally without assistance. The aircraft sustained damage to the engines and propellers. Subsequent inspection of the runway showed propeller strike marks over a distance of several metres in the touchdown zone.

EI-DMG after landing showing fuel leak and damage to propellers
(image used with permission)

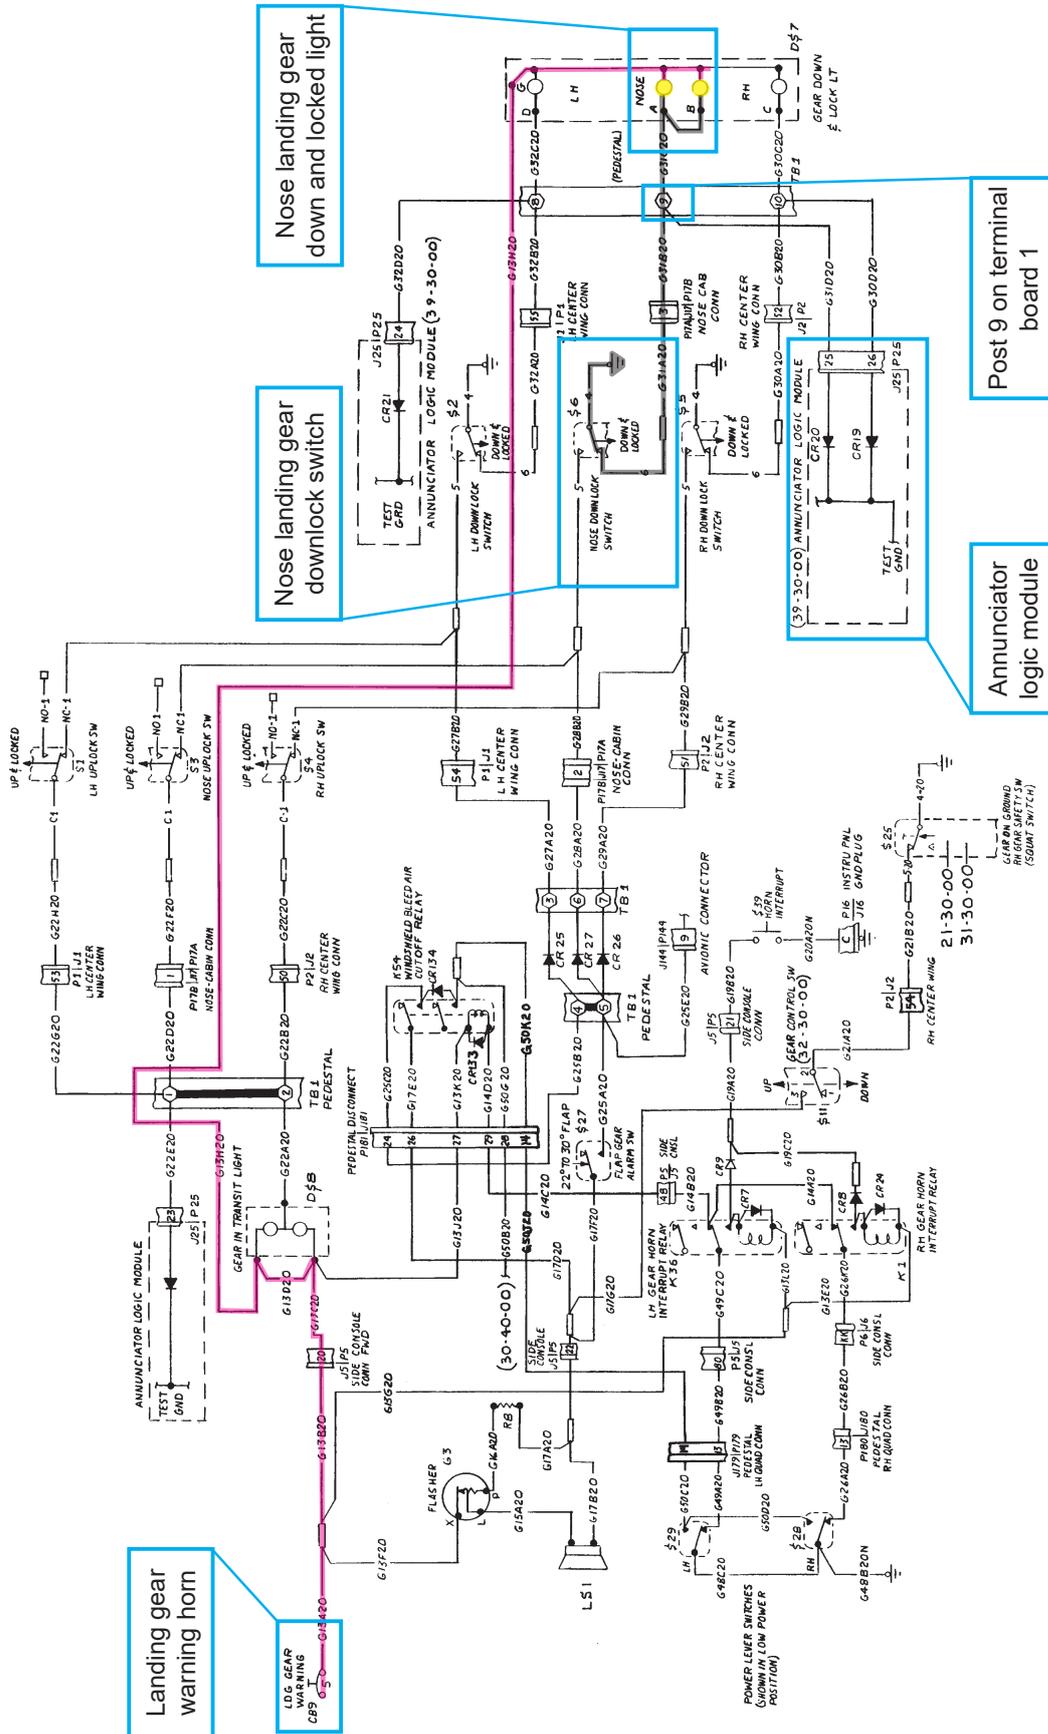
Figure 3
Landing gear and flap warning system from Cessna 441 Wiring Diagram Manual

The manufacturer confirmed that if the nose landing gear DOWN AND LOCKED light senses an electrical ground, it will illuminate regardless of the nose gear downlock switch position (Figure 3). It was therefore possible that a faulty downlock switch could provide a continual ground to the DOWN AND LOCKED light. Other potential sources of electrical ground could include an electrical short in the wire between the DOWN AND LOCKED light and the downlock switch; inadvertent grounding of post 9 on terminal board 1; incorrect wiring on terminal board 1; or a defect within, or shorted wire from, the annunciator logic module to post 9 on terminal board

The manufacturer also indicated that a faulty downlock switch could provide a possible explanation for the failure of the nose landing gear to fully extend. If the nose landing gear downlock switch had failed in the DOWN AND LOCKED position, when the landing gear selector switch was selected to DOWN, an immediate path to ground would exist for the nose landing gear DOWN AND LOCKED lights and also for the hydraulic bypass valve. This would cause the bypass valve to open and allow hydraulic fluid to be routed back to the hydraulic reservoir, returning the system to its 'at rest' position. The main landing gear of the Cessna 441 are assisted by airflow to reach the down and locked position. The nose landing gear is extended against the airflow and may take longer to extend. Therefore, it may be possible for the main landing gear to be driven by hydraulic power to the down and locked position but, upon receipt of an erroneous ground signal from the downlock switch, for hydraulic pressure to be prematurely removed before full extension of the nose landing gear is achieved. A failure of the downlock switch in this manner would also remove the path to ground for the landing gear warning horn, preventing its operation.

The aircraft manufacturer described several possibilities which could create an erroneous ground signal at the nose landing gear DOWN AND LOCKED light causing it to illuminate even though the nose landing gear was not fully extended. It was determined that one of these, a nose landing gear downlock switch failed in the down and locked position, could also account for improper extension of the nose landing gear and absence of the landing gear warning horn activation.
