INCIDENT

Aircraft Type and Registration:	Boeing 737-8AS, EI-DPK
No & Type of Engines:	2 CFM56-7B27 turbofan engines
Year of Manufacture:	2007 (Serial no: 33610)
Date & Time (UTC):	26 February 2019 at approximately 1105 hrs
Location:	London Stansted Airport
Type of Flight:	Commercial Air Transport (Passenger)
Persons on Board:	Crew - 6 Passengers - 169
Injuries:	Crew - None Passengers - 1 (Minor)
Nature of Damage:	None reported
Commander's Licence:	Airline Transport Pilot's Licence
Commander's Age:	39 years
Commander's Flying Experience:	5,000 hours (of which 1,800 were on type) Last 90 days - 236 hours Last 28 days - 85 hours
Information Source:	Aircraft Accident Report Form submitted by the operator and additional enquiries made by the AAIB

Synopsis

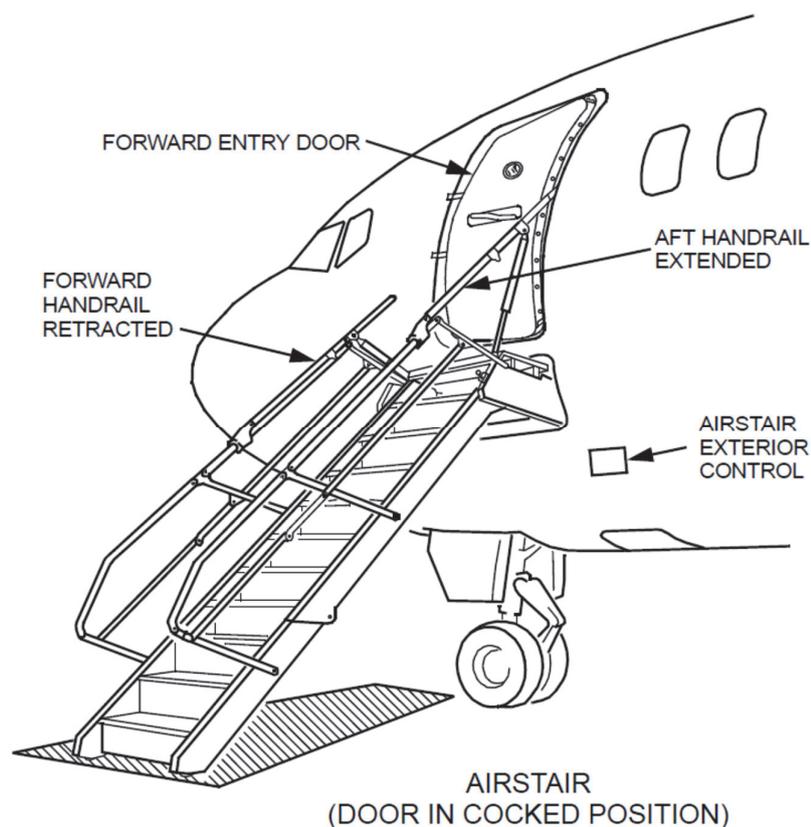
Figure 1

The airstairs include an integral two-rung handrail on either side. These rise into position during deployment of the stairs, but due to the geometric restrictions imposed by the retraction mechanism design, they do not extend to the fuselage side. In order to bridge this gap between the top of the handrails and the fuselage, a manually extendable handrail is fitted to each of the integral rails. After deployment of the airstairs, these are extended and secured to points in the entry door frame (Figure 1). Each extendable rail is supported by a strut extending from the side rail of the airstairs.

Boeing 737 forward airstairs

The flight originated in Oslo and the passengers were disembarking on arrival in Stansted. It was daytime and weather conditions were reported to be dry. As a child left the aircraft with his family, he stumbled and fell sideways to the ground from the top two or three steps of the integral airstairs. The exact sequence of events leading to the fall was unclear, but the father reported that the child was walking while holding his hand. He felt the child pull from his hand and then fall sideways from the stairs. After assessment by airport medical personnel, the child was allowed to continue their journey without treatment.

The operator of EI-DPK confirmed that warning placards and anti-slip material were in place on the aircraft when the child fell. In addition to these recommendations, after the previous AAIB investigation, the operator installed a retractable roller-tensioned tape and detachable airstair rails to further reduce the likelihood of somebody falling.
