ACCIDENT

Aircraft Type and Registration:	ATR 72-201, EI-REH	
No & Type of Engines:	2 Pratt & Whitney Canada PW 124B turboprop engines	
Year of Manufacture:	1990	
Date & Time (UTC):	21 October 2009 at 1030 hrs	
Location:	Stand 7, Manchester Airport	
Type of Flight:	Commercial Air Transport (Passenger)	
Persons on Board:	Crew - 4	Passengers - 33
Injuries:	Crew - None	Passengers - None
Nature of Damage:	Significant damage to propeller blades and stand infrastructure	
Commander's Licence:	Airline Transport Pilot's Licence	
Commander's Age:	30 years	
Commander's Flying Experience:	3,790 hours (of which 1,425 were on type) Last 90 days - 225 hours Last 28 days - 60 hours	
Information Source:	AAIB Field Investigation

Synopsis

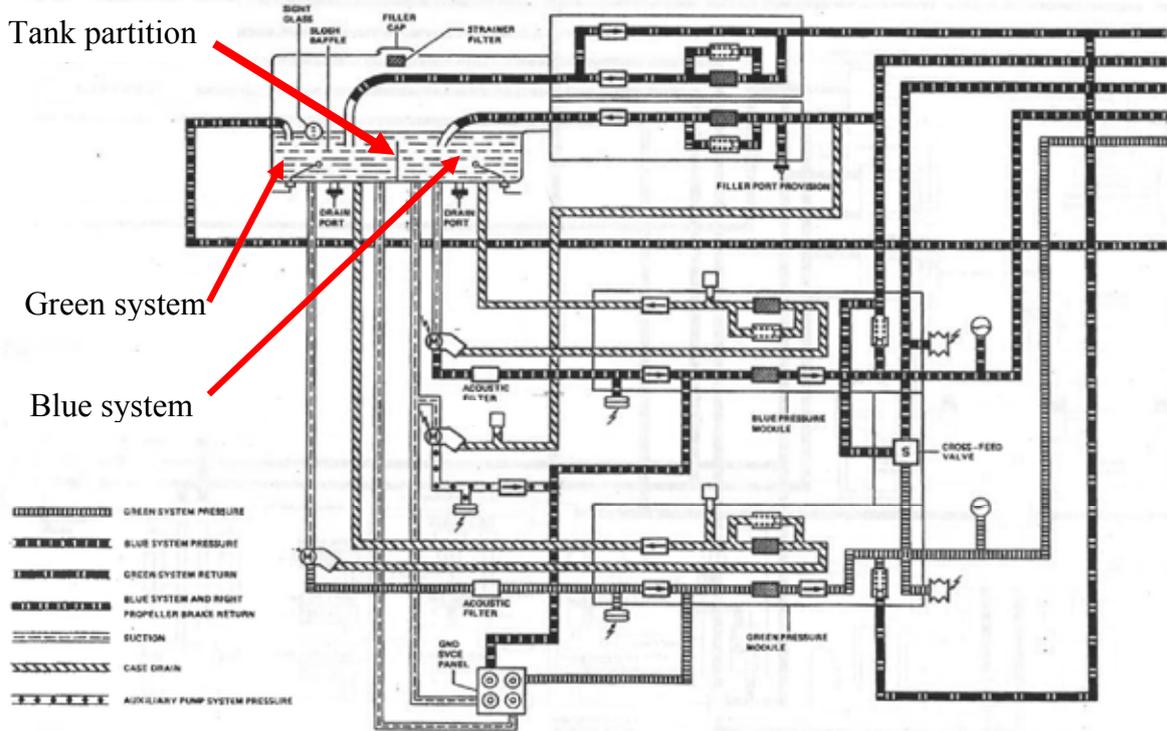
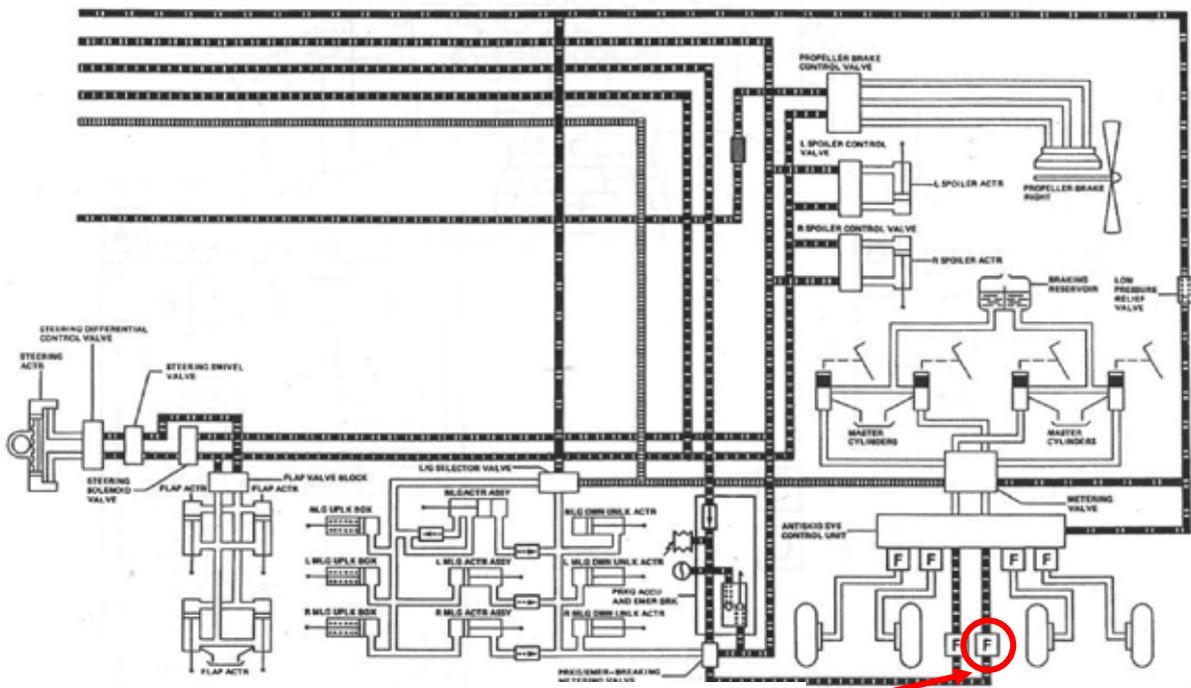
Figure 1
Hydraulic system schematic diagram

The left main landing gear aft fairing was removed in order to gain access to the hydraulic system components. It was apparent that the floor of the bay was wet with hydraulic fluid and that no fluid was visible in the reservoir sight glass. After removing the filler cap it was found that the Blue system side of the reservoir was empty. The reservoir was refilled; approximately 5 litres were required to achieve the 'Full' indication on the sight glass. The park brake lever was set to off and the DC pump was operated for a few seconds using the pedestal button; this pressurised the Blue system to approximately 3,000 psi, as indicated on the Blue and Emergency Brake accumulator gauges. However, the Blue system pressure decayed rapidly, as fluid was seen to leak from the rearmost of two hydraulic fuse assemblies attached to the anti-skid manifold; the location is shown schematically in Figure 1.

Failed hydraulic fuse

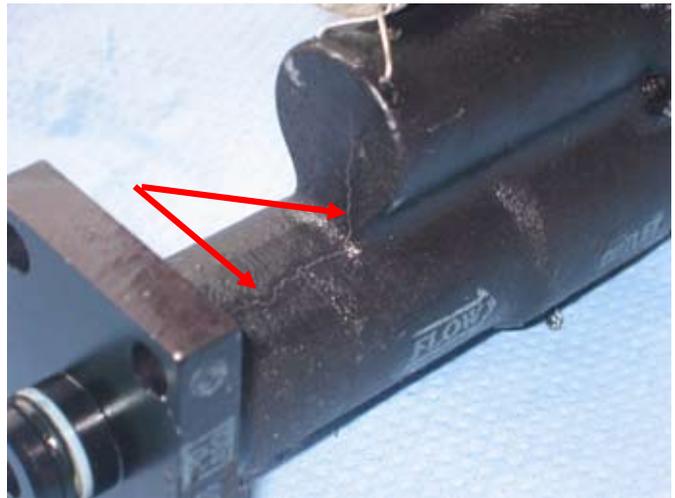
Figure 2

The defective hydraulic fuse was removed and was observed to have a crack in its valve body; this can be seen in Figure 2.

The function of a hydraulic fuse is to limit the loss of fluid in the event of a downstream leak, such as could be caused by the failure of a pipe or a union. It operates by means of a flow rate sensing valve mechanism that moves to close off the fluid flow. In the case of the failed component, the crack was effectively upstream of the valve mechanism, which was rendered ineffective as a result.

The component was subjected to a metallurgical examination. The existence of the crack in the valve body, which was manufactured from cast aluminium alloy, was confirmed by means of fluorescent dye penetrant. It was also found that the crack ran along the wall between the two internal chambers within the body. The valve body was subsequently broken open; examination of the fracture surface revealed that it was primarily brittle overload with two small areas of fatigue growth either side of a channel connecting the two chambers, as indicated in the photograph at Figure 3. It was additionally noted that the fracture surface exhibited evidence of shrinkage porosity along its entire length.

Visible crack on surface of valve body

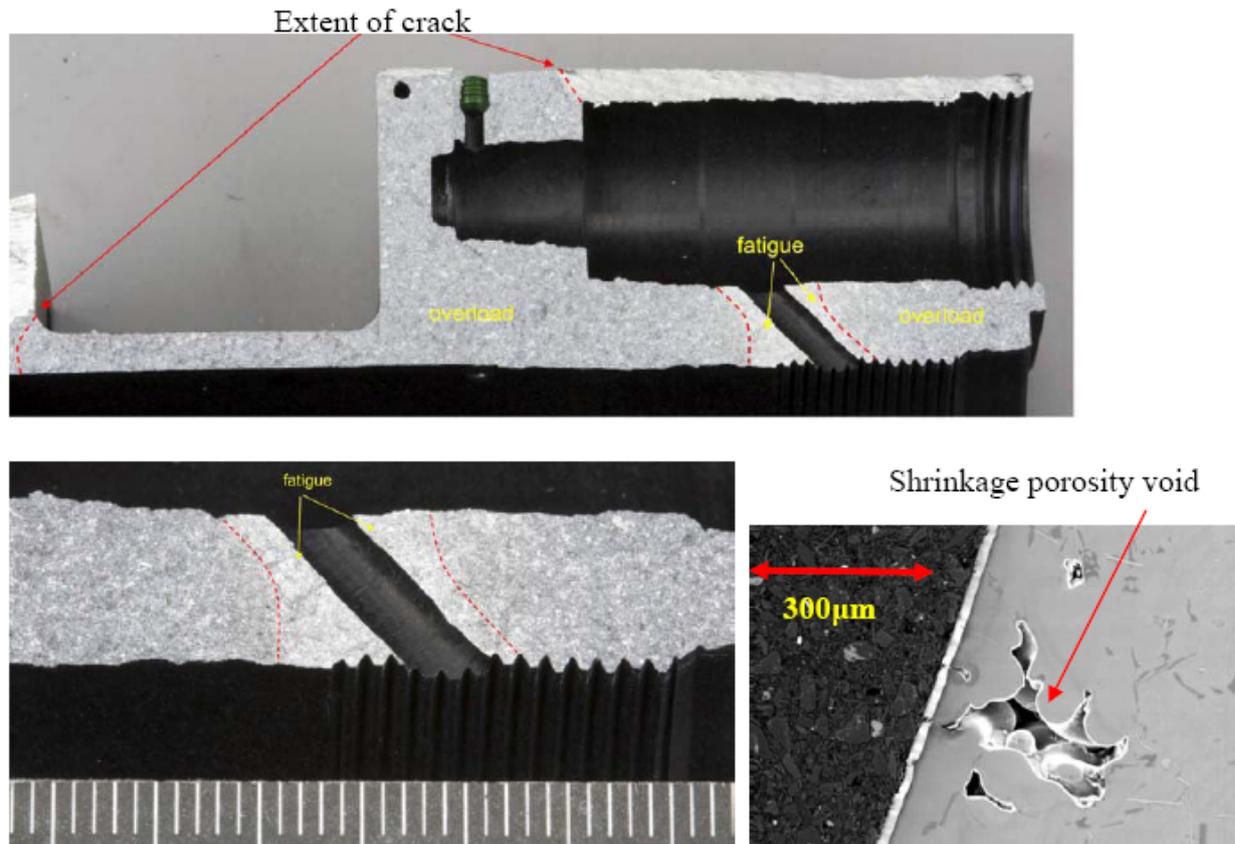
Figure 3

This is a feature that can occur as a result of non-uniform solidification during the casting process. It takes the form of voids within the material, the irregular shapes of which can result in stress concentrations from which fatigue cracks grow. An example of a void is shown in Figure 3.

The fatigue had initiated from multiple origins in the bore of the channel, with initiation appearing to be influenced by the presence of shrinkage porosity. The crack growth extended to a maximum length of around 4.5 mm before the final brittle overload failure occurred; this resulted in the observed crack, which accounted for approximately 50% of the total cross-sectional area of the component along the fracture plane. The brittle nature of the material was such that the critical crack length required before a final overload failure occurred would be relatively short. There was no evidence of any mechanical or corrosion damage that could have influenced the observed failure.

View of sectioned fuse body showing extent of the crack

The metallurgical examination revealed that the failure was caused by a fatigue crack in the hydraulic fuse body. Whilst the fatigue crack growth would have been driven by the repetitive pressure cycles, the initiation appeared to be influenced by the presence of shrinkage porosity within the casting. Whilst this might pose a question on the quality of the casting, there have been only two similar events reported across the ATR 42/72 fleet and the fact that one of them occurred to a relatively recently manufactured component suggests a random nature to the failures.
