ACCIDENT

Aircraft Type and Registration:	Boeing 737-476(SF), EI-STD	
No & Type of Engines:	2 CFMI CFM56-3C1 turbofan engines	
Year of Manufacture:	1990	
Date & Time (UTC):	29 April 2014 at 0128 hrs	
Location:	East Midlands Airport	
Type of Flight:	Commercial Air Transport (Cargo)	
Persons on Board:	Crew - 2	Passengers - None
Injuries:	Crew - None	Passengers - N/A
Nature of Damage:	Left main landing gear, left wing and engine	
Commander's Licence:	Airline Transport Pilot's Licence	
Commander's Age:	38 years	
Commander's Flying Experience:	4,279 hours (of which 377 were on type) Last 90 days - 114 hours Last 28 days - 10 hours	
Information Source:	AAIB Field Investigation

Synopsis

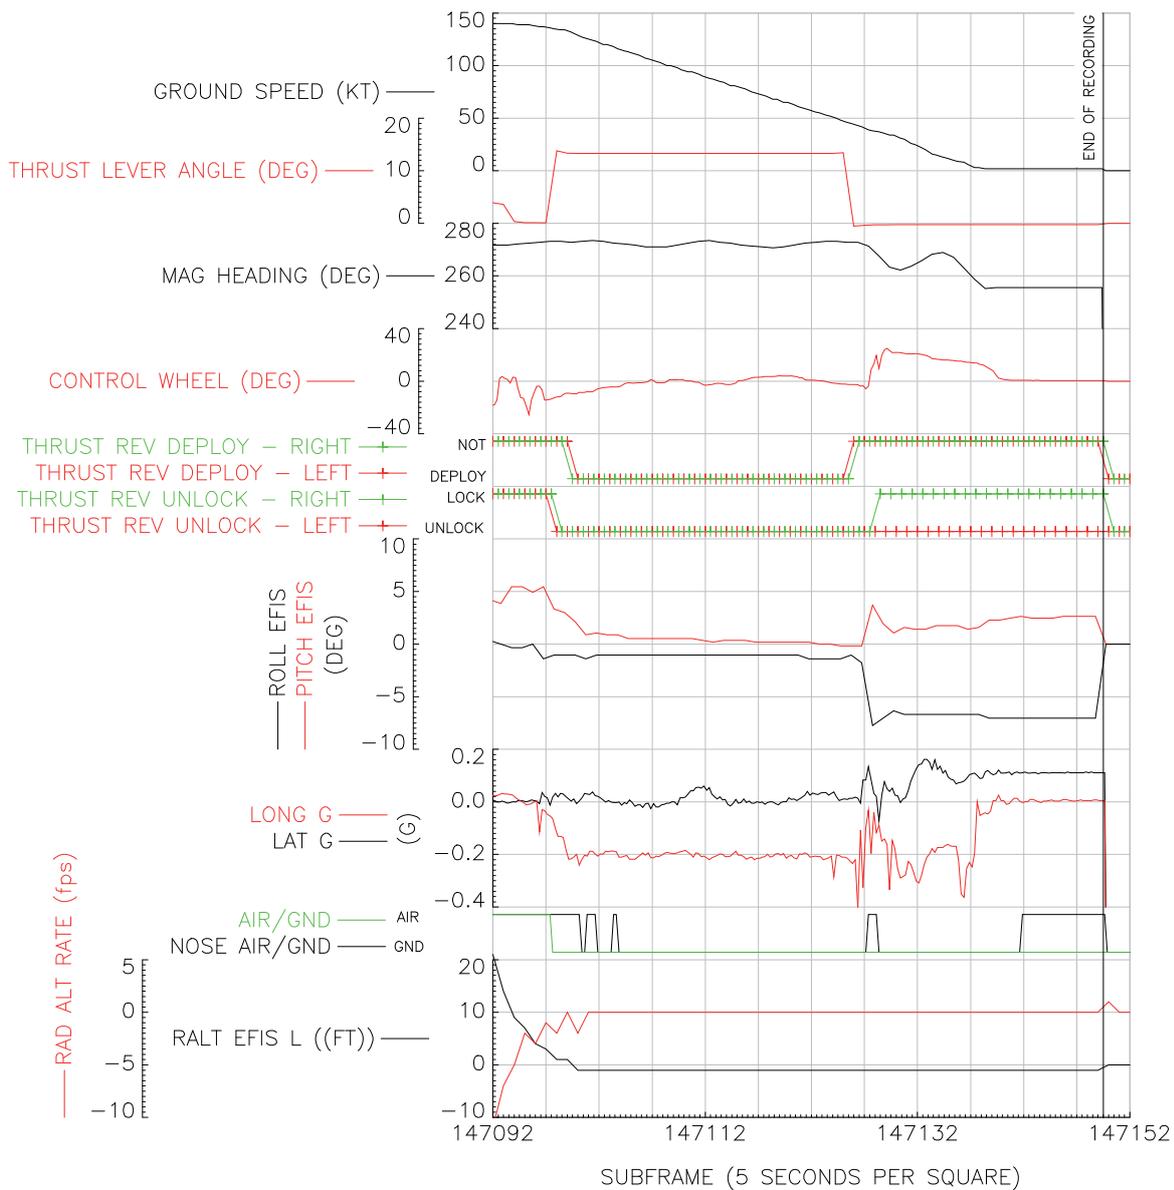
Figure 2
Pertinent FDR parameters

The aircraft took off at a recorded time of 0040:46 hrs and touched down at 0128:59 hrs. Figure 2 is a plot of the pertinent recorded parameters for the landing. There was no valid normal-acceleration parameter, but the derived closure rate with the runway does not indicate a heavy landing. The thrust reversers were deployed. There were no valid recorded brake-parameters but the longitudinal acceleration during the landing roll was very uniform. A brief spike in longitudinal acceleration was recorded as the aircraft groundspeed reduced through 52 kt. This was followed 2.25 seconds later by a larger spike in longitudinal acceleration and then oscillations with a frequency too high for the parameter to follow accurately. After approximately one second of these oscillations in longitudinal acceleration, a clockwise control wheel input was recorded, associated with a change in attitude which peaked at 7.7° left-wing-down and 3.7° nose-up pitch.

The aircraft slowed to a stop over the next 10 seconds with the longitudinal acceleration varying around the -0.2 g figure associated with the original period of steady braking. Shortly after the aircraft came to a stop, the master caution was triggered. Both the FDR and CVR recordings stopped approximately 11 seconds after the aircraft stopped. The last recorded attitude shows the aircraft stabilised at 7.0° left-wing-down and 2.6° nose-up pitch, with the nose gear weight on wheels sensor indicating AIR instead of GROUND.

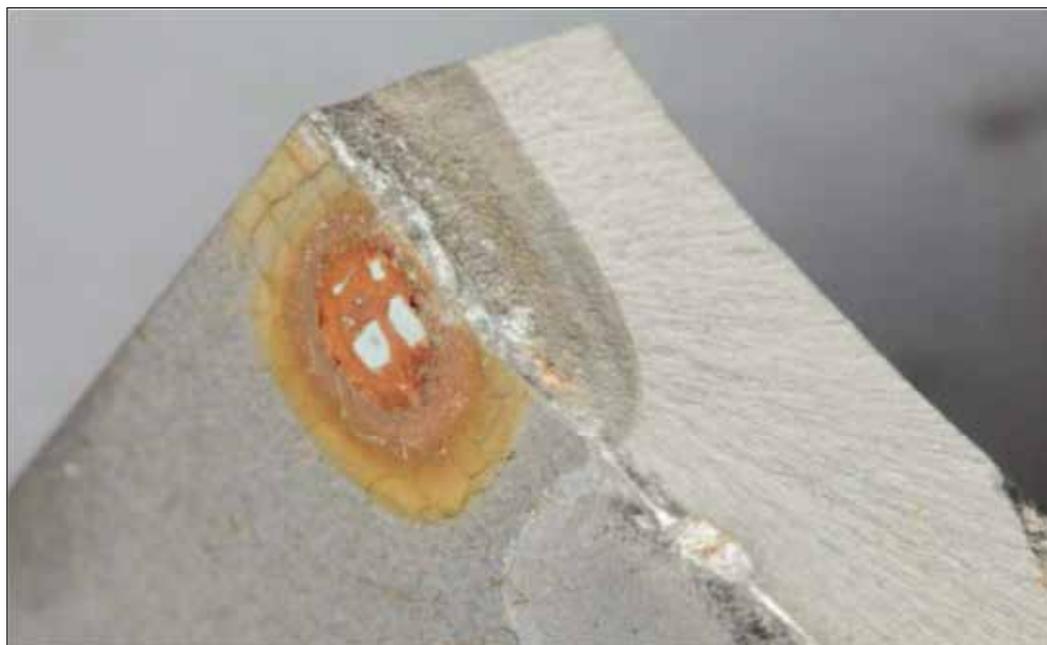
Figure 5

With the chrome plating removed, a very distinctive area of ferrous oxidation became apparent on the surface of the steel, just beneath the area of fatigue cracking (Figure 5). In addition, in the same area, there was also evidence of chrome combining with the steel.

Ferrous oxidation on the substrate beneath the chrome plating
(after longitudinal microsection)

The origin of the failure was an area of intense, but very localised heating, which damaged the chrome protection and changed the metallurgy; ie the formation of martensite within the steel substrate. This resulted in a surface corrosion pit, which, along with the metallurgical change, led to stress corrosion cracking, fatigue propagation and the eventual failure of the inner cylinder under normal loading.

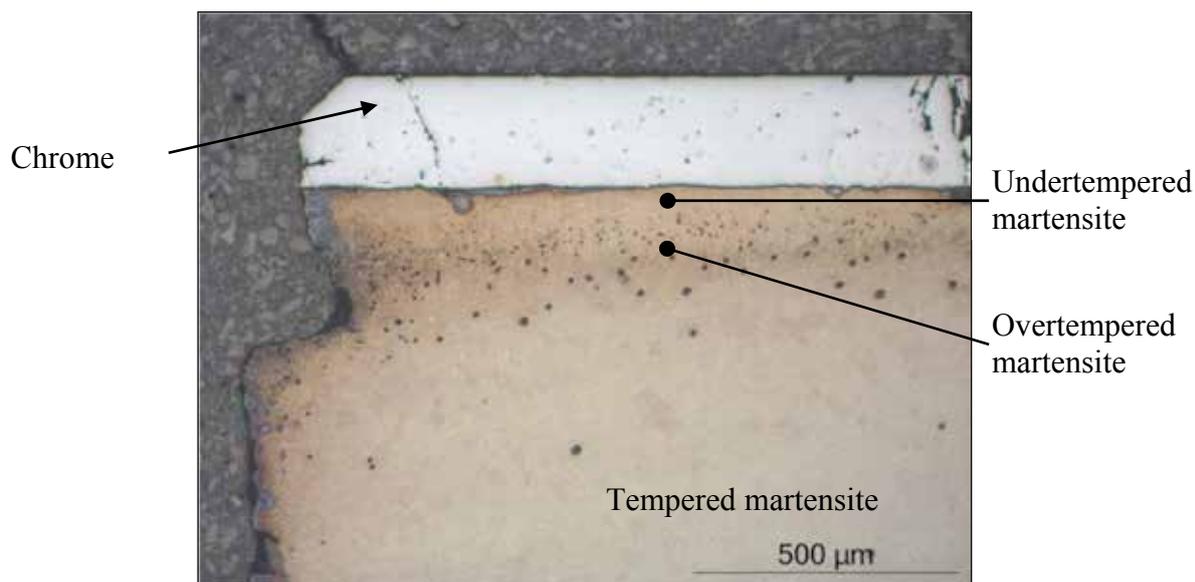
Metallurgical examination of the microsection through the fracture face showed an area in the substrate steel of over and undertempered martensite, consistent with localised heating. The hardness profile through this section also confirmed this finding. Prior to removal of the chrome, hardness checks were carried out; these showed that the chrome decreased in hardness in the vicinity of the fracture face. Figure 6 shows the disposition of the martensite.

Fracture surface metallurgy
