**ACCIDENT INVESTIGATION REPORT  
INVOLVING B737-800 AIRCRAFT  
WITH REGISTRATION EI-FRO  
AT THE INTERNATIONAL AIRPORT OF CHANIA, CRETE  
ON 23<sup>rd</sup> DECEMBER 2016**

**E03 / 2018**

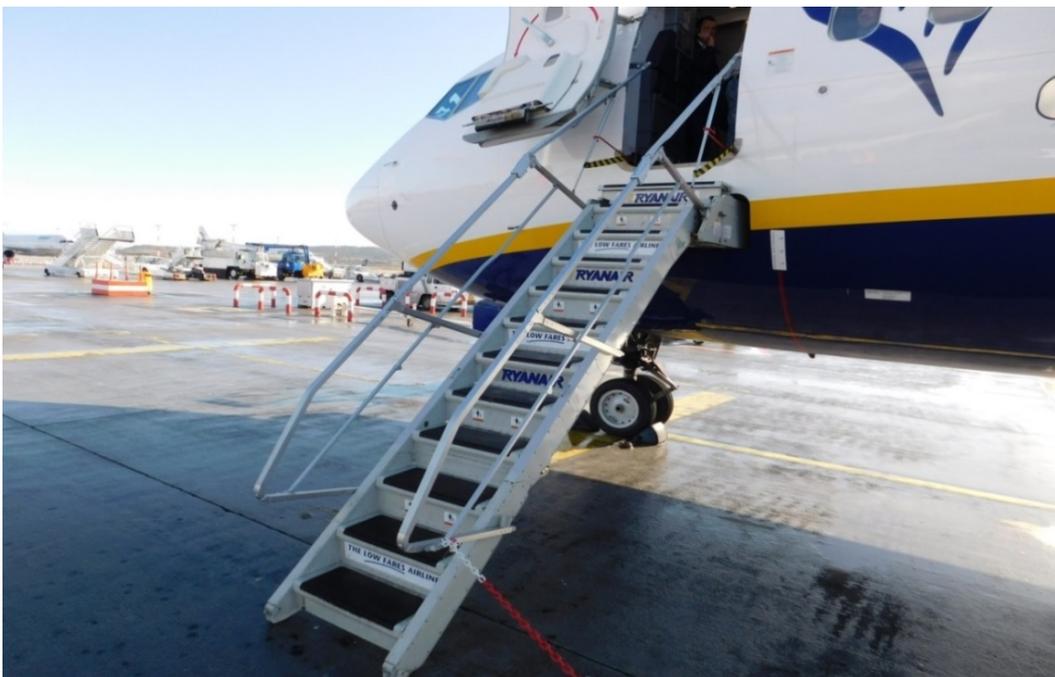
According to the testimony of the fuel company employee, prior to the commencement of the refueling operation, he (the employee) walked up the forward left stair in order to consult with the captain on the quantity of fuel to be delivered. The stair is of the folding type it is a constituent part of the aircraft and opens mechanically both from the outside and from the inside of the aircraft. Part of the handrails is automatically deployed simultaneously with the deployment of the stair, whereas the last section of the handrails, extending over the three last steps, can only be deployed when the door of the aircraft is fully open, since it is supported on the inside of the fuselage, at the point of contact of the door. (Photos 1 & 2).

**Photo 1:** The forward folding stair of the aircraft fully extended.

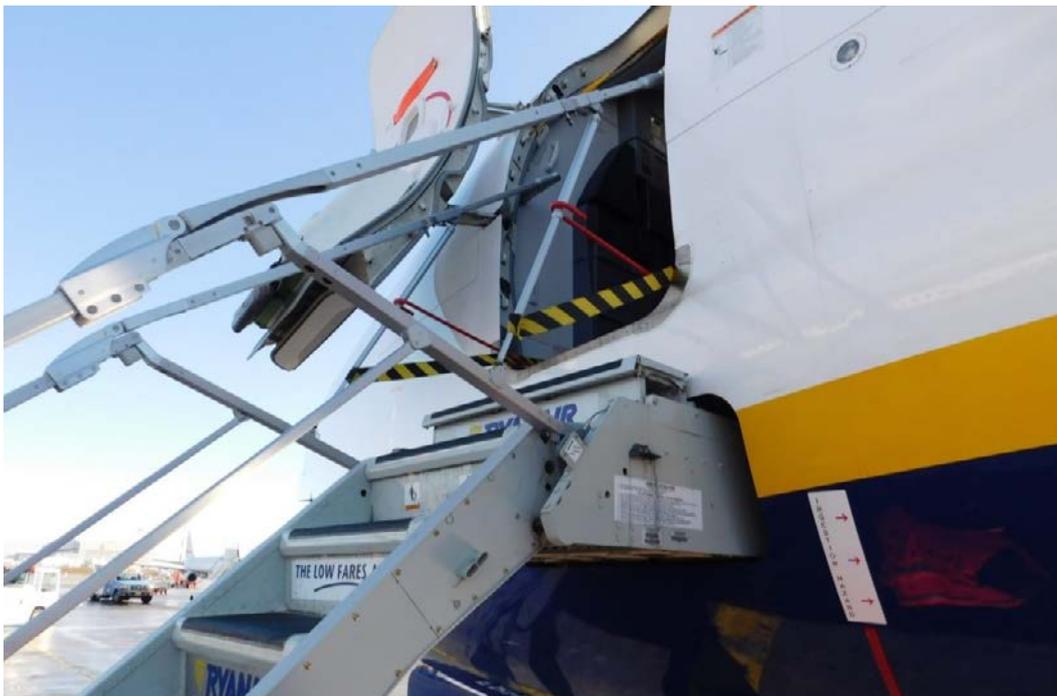
According to his testimony, on the said day and because it was raining none of the above persons was outside the aircraft. Given that there was no one to sign the form and take a copy thereof and due to the fact that there was no way to communicate with the crew of the aircraft, the employee, as per his own testimony, went up to the aircraft himself in order to handle the relevant procedure for the fuel form. It is noted that when the employee walked up the stair the first time, the left forward door was open and the handrails were deployed in position; however, when he went up a second time in order to complete the procedure relevant to the fuel form, the said door was closed at its greater part due to the rain and there was only a small opening at its side, whereas the handrails at the uppermost part of the stair were not deployed.

**Photo 2:** Uppermost part of the forward folding stair of the aircraft.

moved in the direction opposite to the direction of opening of the door and even though he tried to hold on to the handrail of the folding stair this was not possible given that the handrails at the uppermost part of the stair were stowed. As a result, the employee lost his balance, fell on the ground from a height of about three meters and sustained serious injuries.

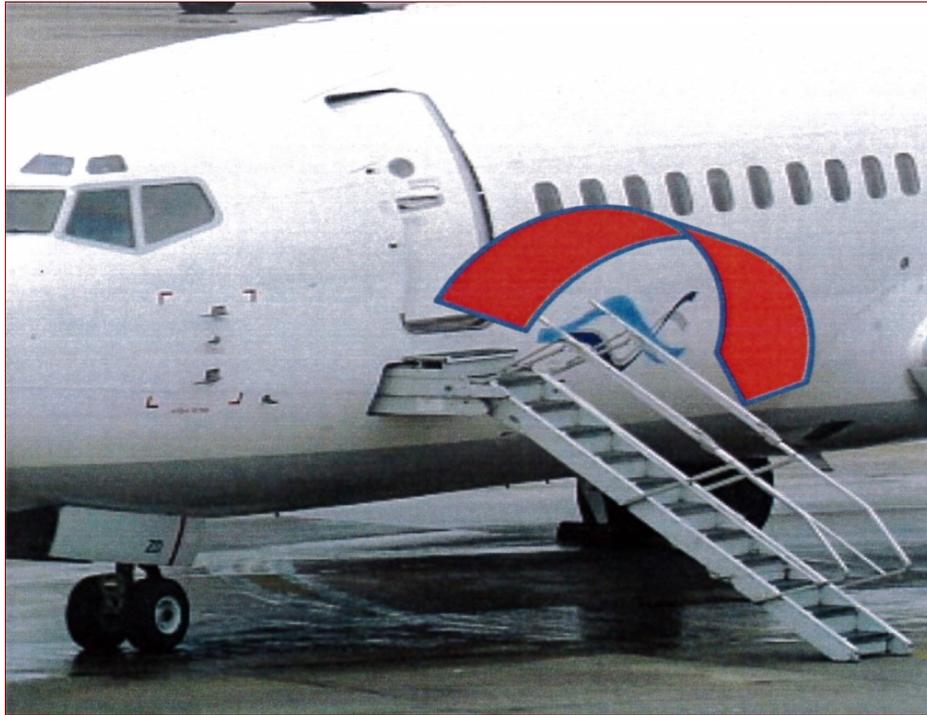
According to the testimony given by the chief flight attendant (No. 1) who opened the door and the testimony of her colleague, a cabin crew member (No. 4), the employee, having knocked on the door of the aircraft and after the crew established that he was outside by looking through the door window, but also through the small opening at the side of the door, given that visibility was poor as a result of the rain, was asked whether he wanted to enter the aircraft. When he replied in the affirmative, he was requested to move back so as not to be hit by the door when opening. The employee was hit by the door and, losing his balance, fell to the ground from a height of about three meters resulting in him sustaining serious injuries (Photo 3).

**Photo 3:** The direction of fall of the fuel personnel from the folding stair.

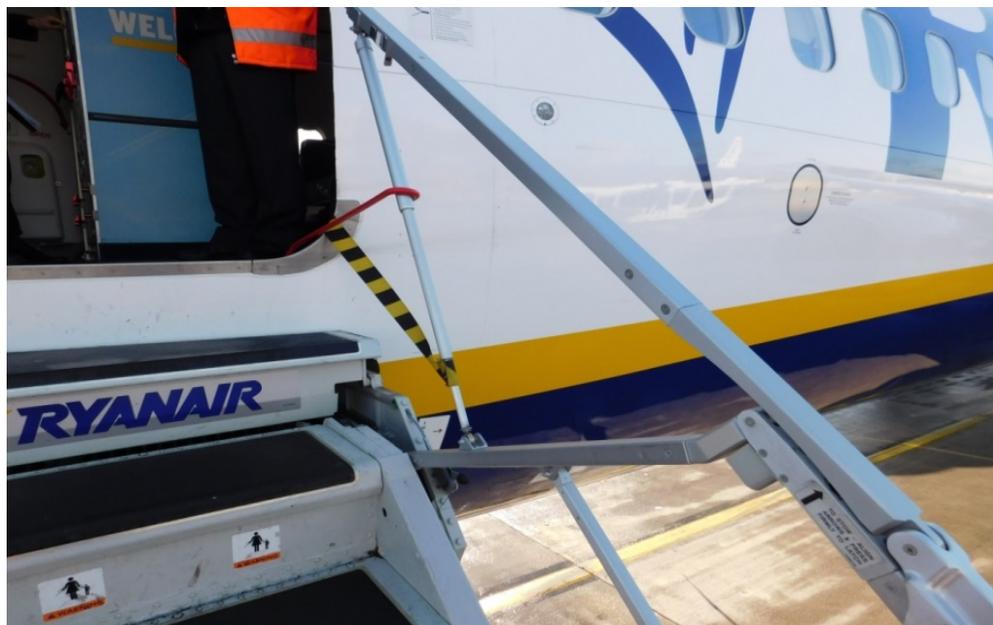
According to the testimony of the fuel company employee, when he reached the last step of the stair and before he had a chance to knock on the door of the aircraft to let the cabin crew know that he was there in order for them to open the door, the door suddenly opened (moving outward) and hit him. He then lost his balance and fell from the stair to the ground, which caused him to sustain serious injuries, even though he wore the requisite equipment for his personal protection. It is noted that in the said folding stair, the last step is narrow (Photo 4) so the person standing on such step for the purpose of knocking on the door to be let in is found in a very short distance from the door of entry to the aircraft.

**Photo 4:** Uppermost part of the folding stair.

Moreover, when someone is on the last step of the folding stair, they must exercise particular care so as not to lose their balance when moving backwards to steer clear of the door, in order to avoid being hit by it when it opens, as they have to go down one step.

The fact that the handrails at the top part of the stair were not extended was consequent to the fact that the door remained almost closed, as prescribed in the airline instructions in order to avoid the ingress of rainwater inside the aircraft.
