**AVIATION AND MARITIME INVESTIGATION AUTHORITY**  
Námestie slobody 6, P.O.BOX 100  
810 05 Bratislava 15

# FINAL REPORT

incorrect action of the ATS Authority, reduction of separation minimum

Reg. No: SKS2019001

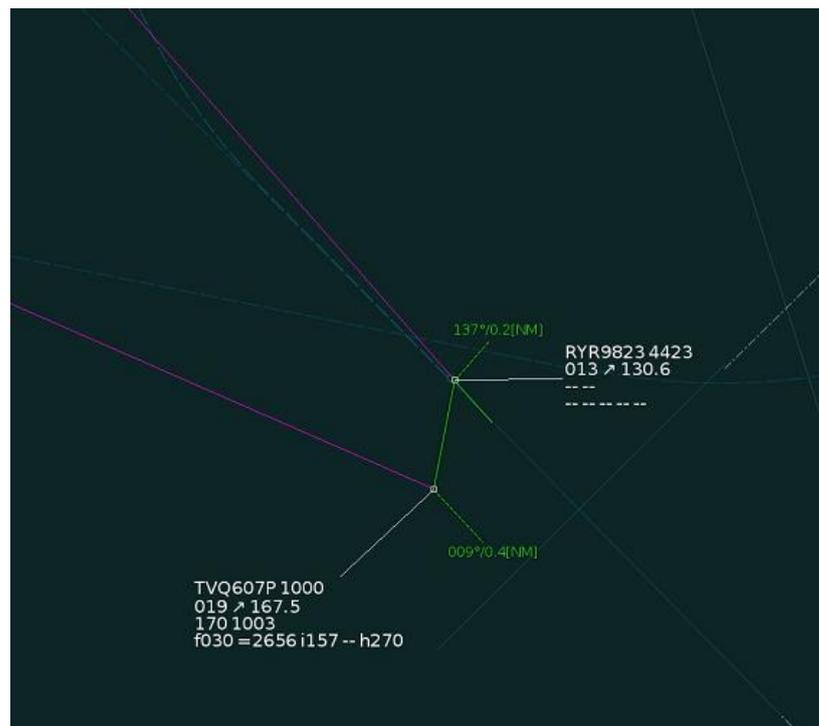
EI-FOO took off according to plan. The first radar record of the flight in E2000 was displayed at 07:24:10 as a non-correlated target after take-off.

At 07:24:13, the EI-FOO flight was displayed in E2000 as a correlated target with A013.
