Accident to the BOEING 737-800 registered EI-DAC

on 25 February 2015

en route at FL 380 in Bordeaux FLIR

Severe clear air turbulence, en route, injury to two cabin crew personnel, diversion

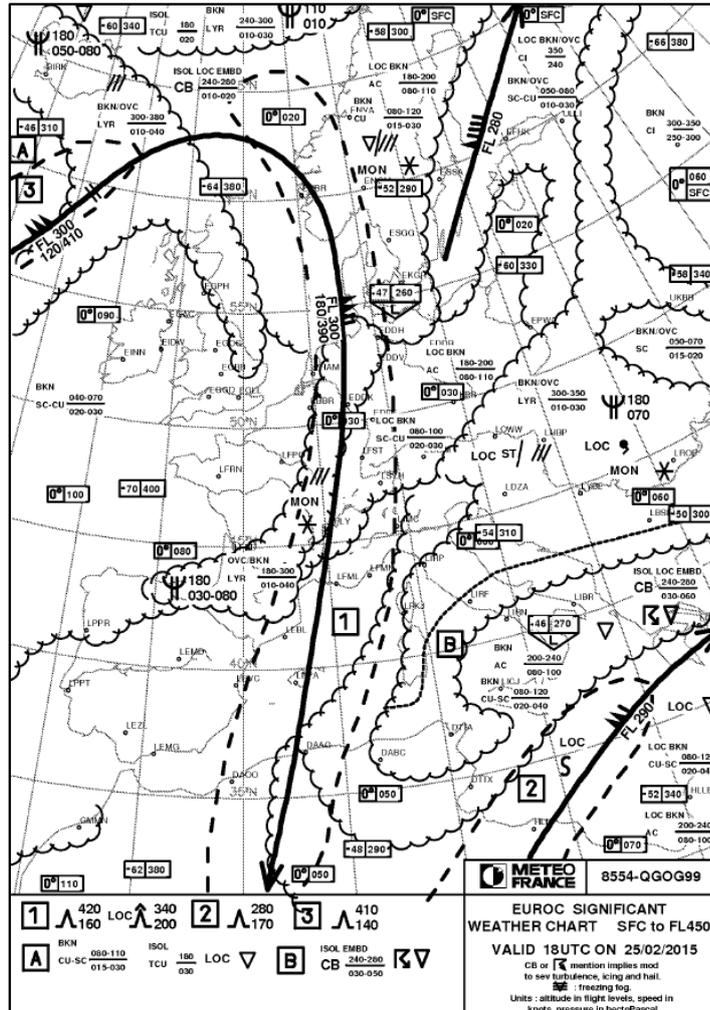
18:00 Europe SIGWX chart

A strong high-pressure system off the coast of Portugal and a low-pressure system over Sicily were channelling a strong north jet stream⁽²⁾ over France, the strongest jet core being east of the aeroplane's flight path, between FL 300 and FL 360.

The meteorological conditions estimated by Météo-France in the sector of the accident were: wind from 360° at 100 kt at FL 340 and from 360° at 90 kt at FL 380, clear sky above FL 300, temperature -58°C at FL 340 and -64°C at FL 380, severe turbulence.
