Investigation Report

AX001-1-2/02
May 2004

Kind of occurrence: Accident
Date: 1 July 2002
Location: (near) Ueberlingen/Lake of
Constance/Germany
Type of aircraft: Transport Aircraft
Manufacturer/Model: 1. Boeing B757-200
2. Tupolev TU154M
Injuries to persons: 71 fatalities
Damage to aircraft: Both aircraft destroyed
Other damage: Damage to open field and forest
Source of Information: BFU Investigation

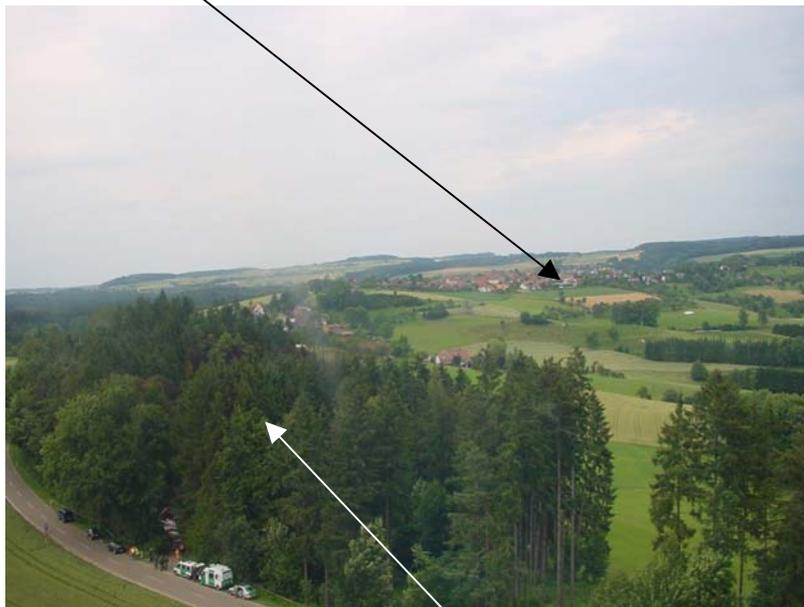
Main wreckage

The main wreckage of the B757-200 was found approximately 1 km west-south-west of the village of Taisersdorf, eastward of the street K 7788 in a mixed forest. The accident site covered an area of 110 m x 30 m.

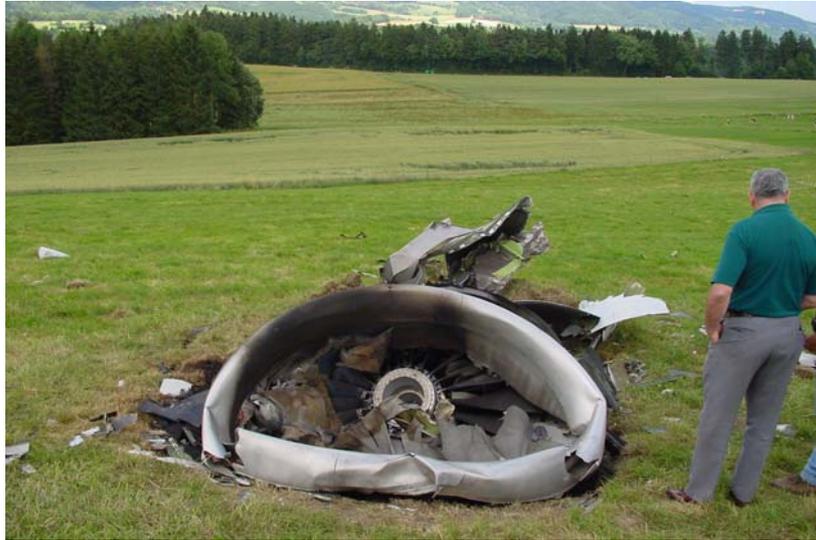
The right engine had crashed on a meadow 250 m west and the left powerplant in a corn field 300 m southwest of the main wreckage. Both engines showed traces of fire caused by the burning of the remaining fuel in the fuel systems. Both engines had penetrated the ground to such an extent that they were almost level with the surface. They exhibited significant mechanical damage.

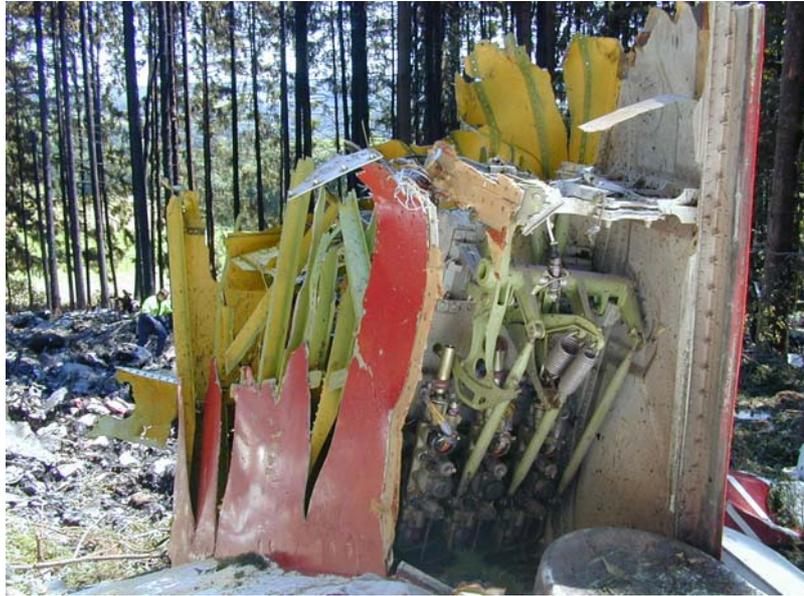
The left side of the skin was torn off in several pieces to the rear left.

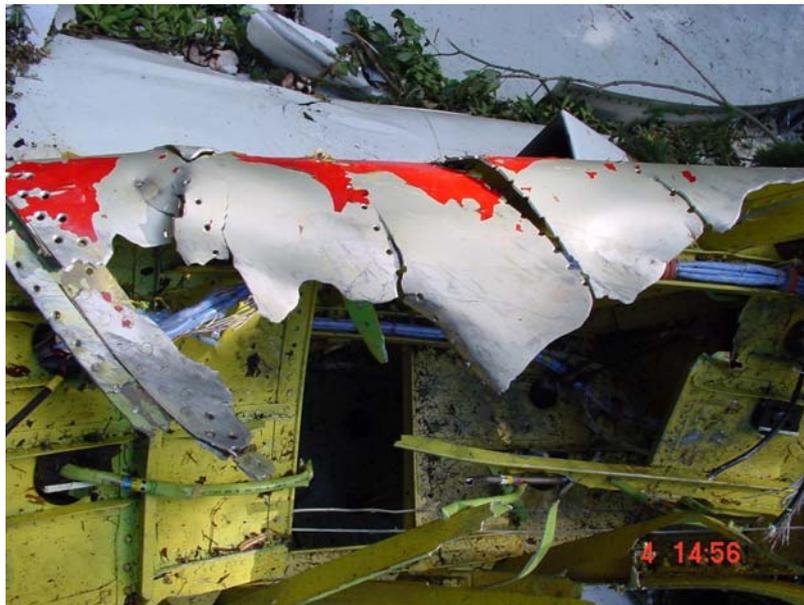
The top of the right side was bent to the rear left.

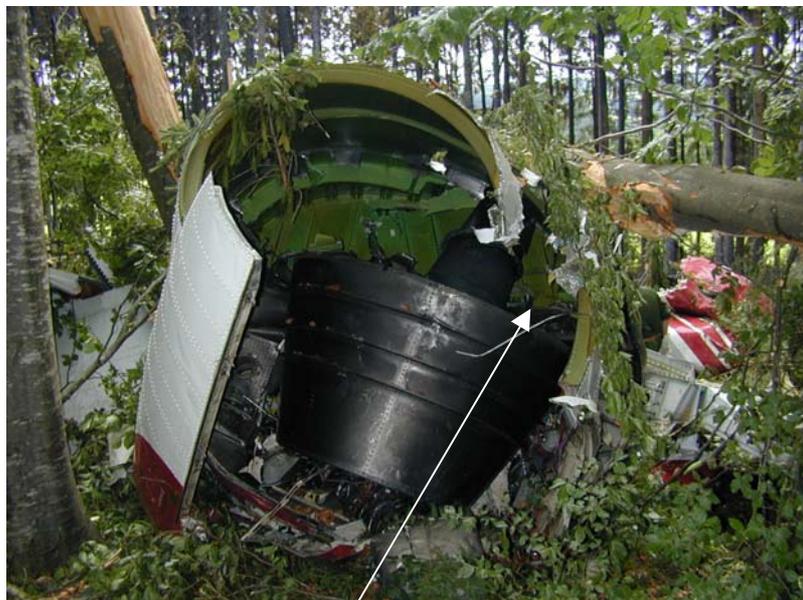
exhaust of APU

The APU access doors were present. The APU was torn off its bracings.

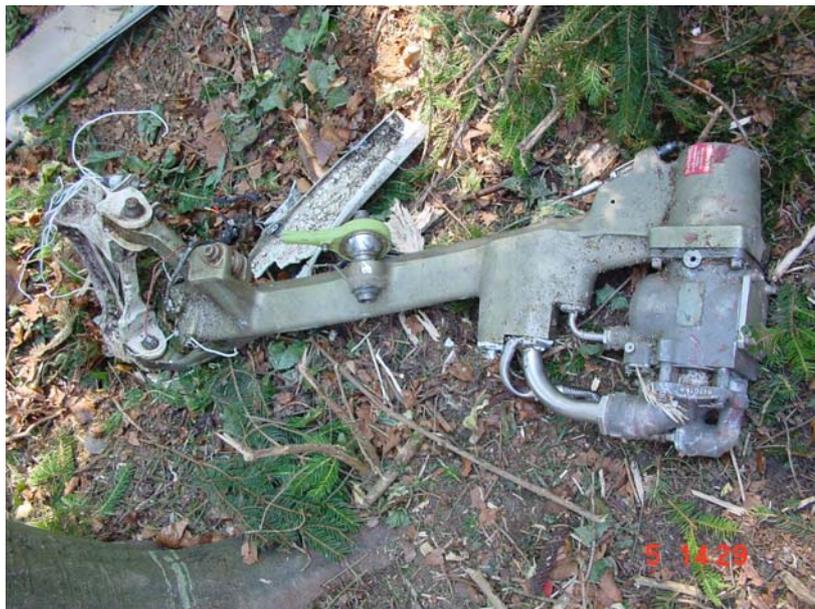
ram air turbine without propeller

The ram air turbine (RAT) was found almost undamaged and without any traces of fire.

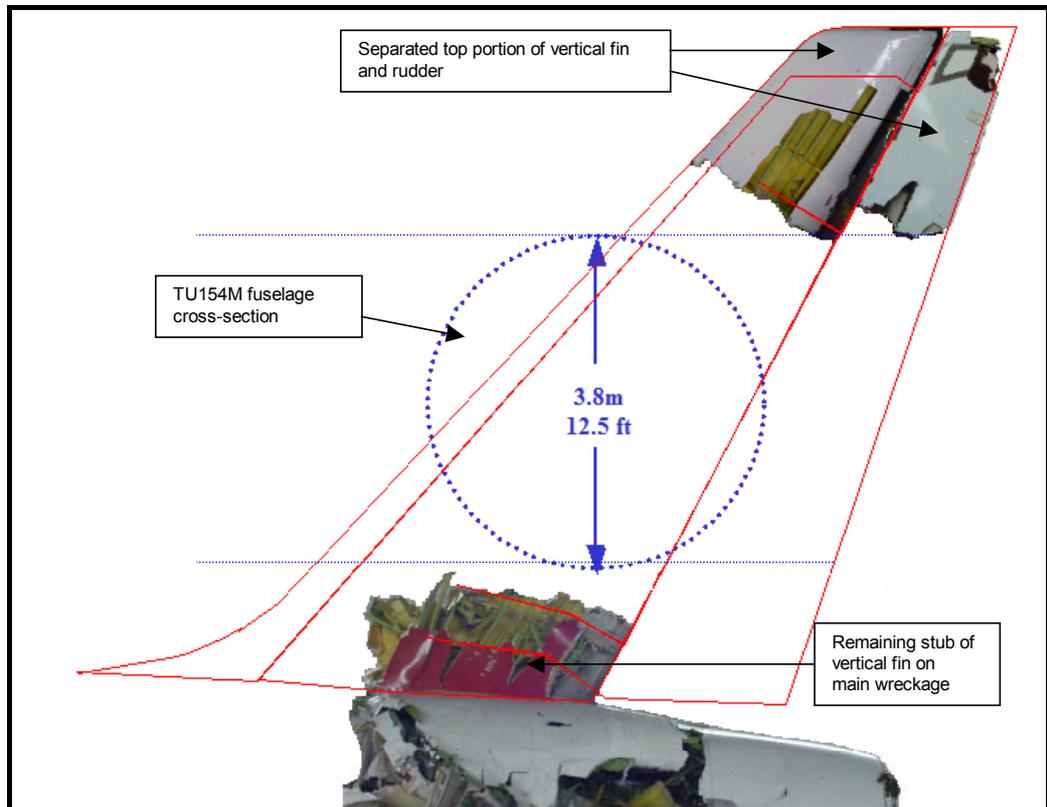
- On collision, the airplane lost about 80% of the vertical tail. The manufacturer stated that the loss caused the airplane to become aerodynamically unstable in the yaw axis.

B757-200 damage on vertical tail in relation to cross-section of TU154M

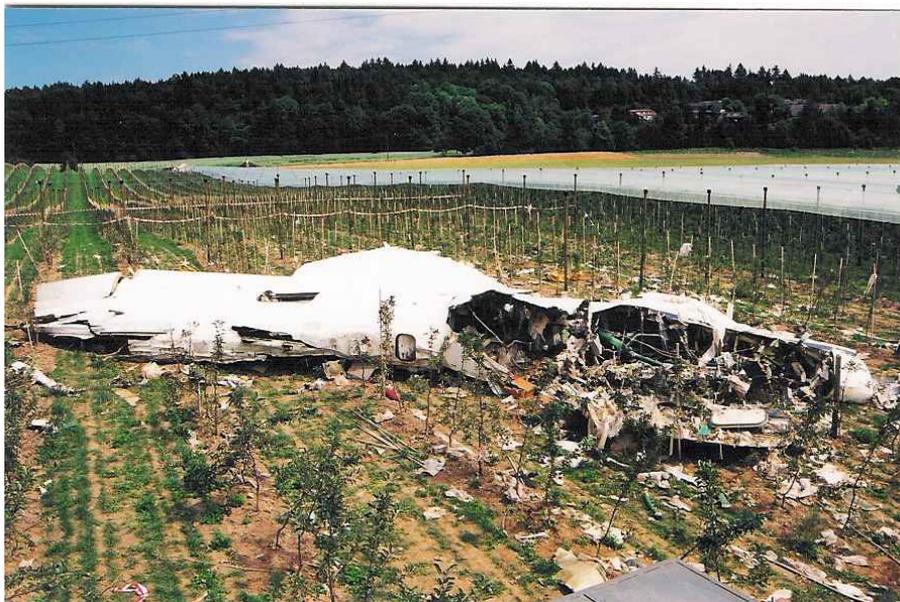
overall view – forward section of the aircraft fuselage

The forward fuselage section had crashed in the area of Brachenreuthe in level terrain (apple plantation) immediately south of a power line running in a direction of 290° and 20 m north of a paved field path. The wreckage part with a total length of about 19 m was lying on its left side. It had been separated in the area of the 41st frame of a total of 83 frames and pointed in the direction of 127°. The fuselage frames were broken. The skin on the bottom was torn open over a length of 9 m. The skin on top of the fuselage had burst open in two areas in longitudinal direction. The fuselage had been flattened to about half of its original diameter of 3.80 m.

Evidence of fire or collision evidence was not found.

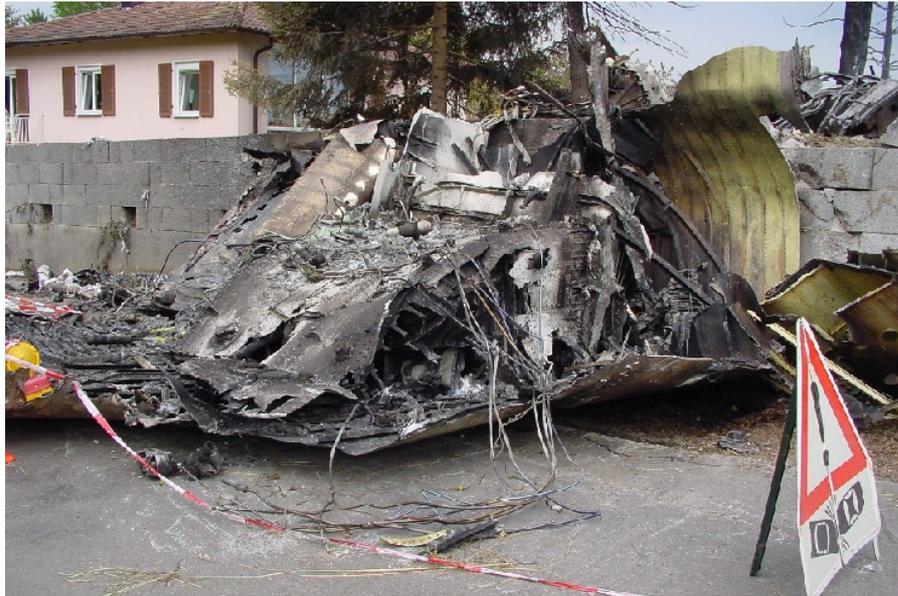
The centre wing section was found on the paved access road in front of a wall. The wreckage part itself had burnt. The fire had affected the road very little. The right wing had separated from the centre wing section at the area of the wing root.

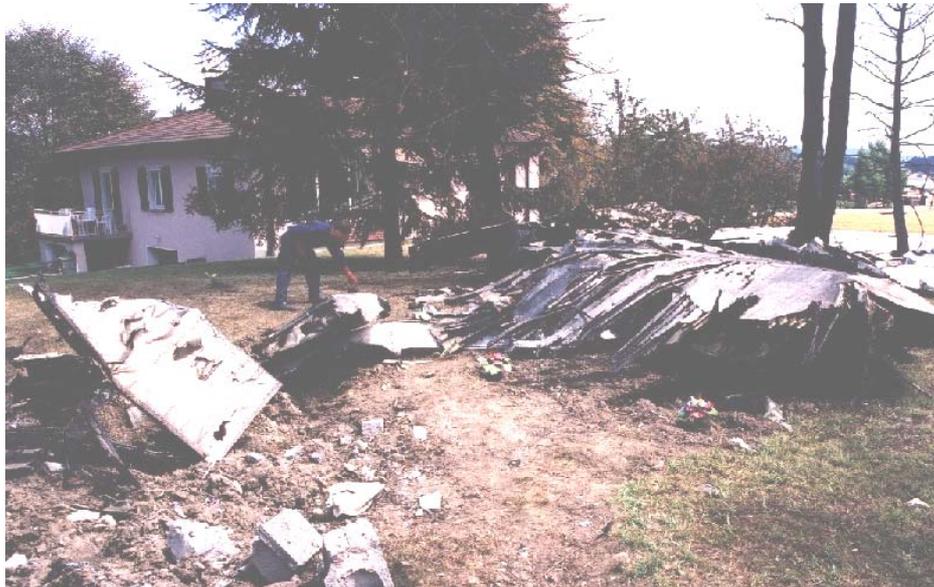
Left wing

The connection of left wing and centre wing section consisted of the trailing edge in the area of the inboard flap and hydraulic lines. The wing was found at a residential garden at a level higher than and at a distance of about 10 m from the house. The wing had been separated from the leading edge in a transversal line in the direction of the fuselage. The point of rupture is located between wing root and inboard slat. Some parts of this wing area were not present.

The fire melted the outer third of the wing. The completeness of the wing, however, could be told by its outlines which included the wing tip.

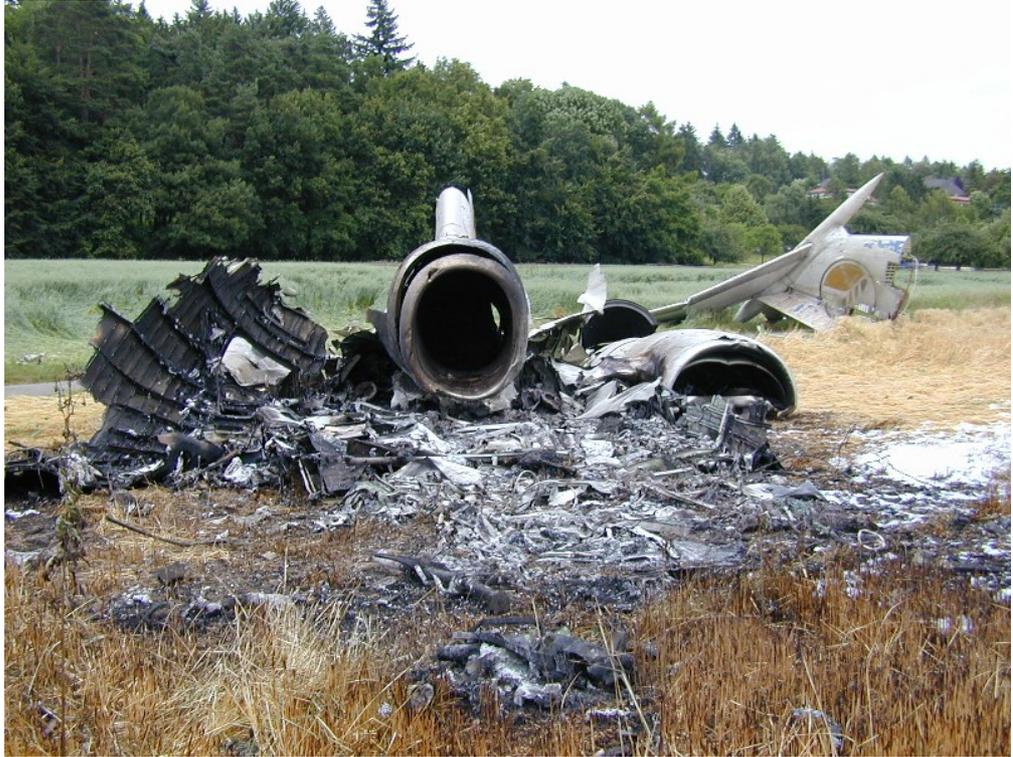
overall view – rear fuselage section/tail unit

The rear fuselage had on the left side broken off at frame 56 and on the right side at frame 52. It was destroyed by fire and impact forces and pointed into the direction of 235°.

No collision evidence was found on the leading edges of the vertical fin and horizontal stabilizer and at the air intakes of the three engines.

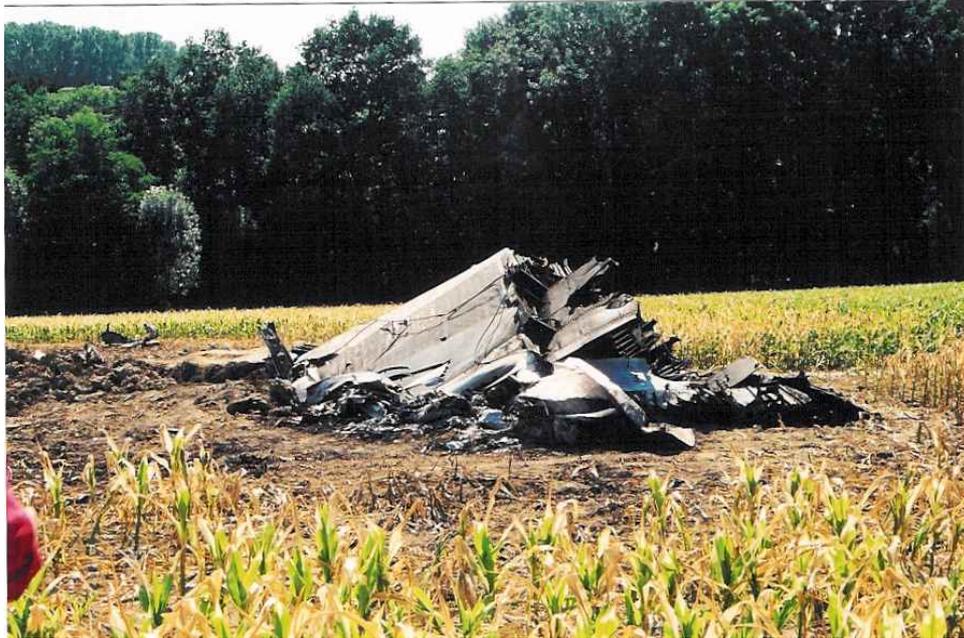
overall view – right wing

The wreckage part was found in a corn field some 800 m south of the accident site of the fuselage and some 30 m west of the district road 7786 north of the village Aufkirch. Leaking and burning fuel affected the plants in a radius of 15-20 m around the crash site. The plants showed a brownish colour.

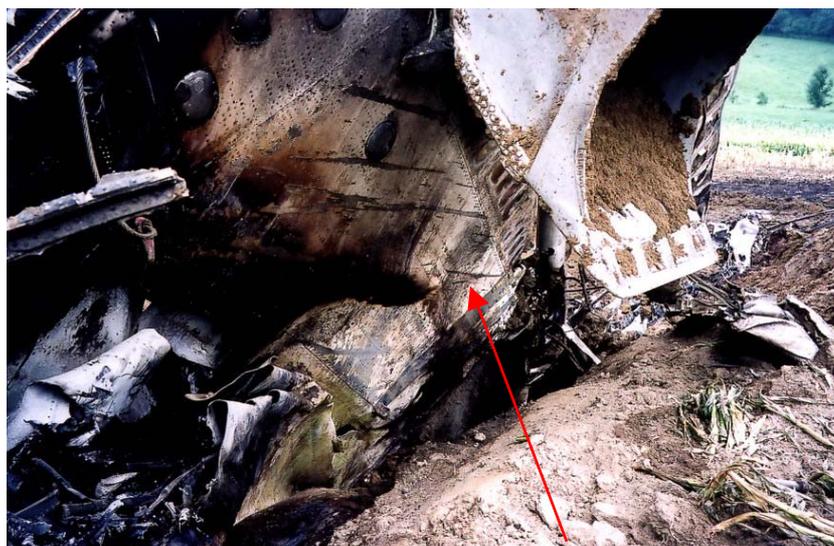
The ditch caused by the impact had a length of about 18 m and pointed into the direction of 228°. The inner section of the wing from the wing root to the main landing gear stuck 3.5 m deep in the earth. Most of the outer section of the right wing from the main landing gear to the wing tip had been destroyed by the fire except for the leading edge and the slats. A 6 m long wreckage part of the right wing's upper surface including the remains of the registration marks was found some 20 m from the wing's crash site. On the wing's lower surface between the wing root and the main landing gear scratch marks of about 3.6 m length and 0.9 m width and red paint transfer were found. The flap track and carriage of the inner flap, one landing gear door and the rear part of the main landing gear fairing were missing.

lower surface of the right wing with scratch marks

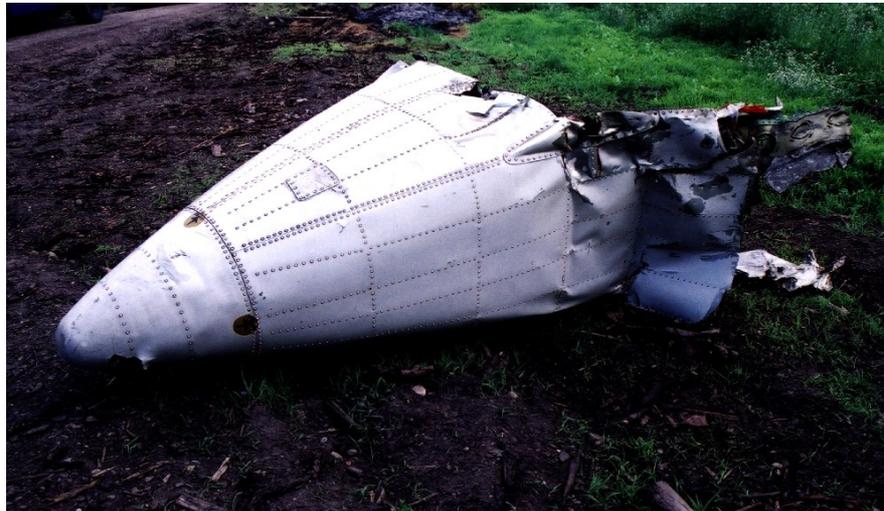
Fairing of right main landing gear

A 2.80 m long part of the TU154M's fairing of the right main landing gear was found 1 kilometre west of Steinhöfe. It showed traces of red paint and remains of the honeycomb structure of the B757-200.

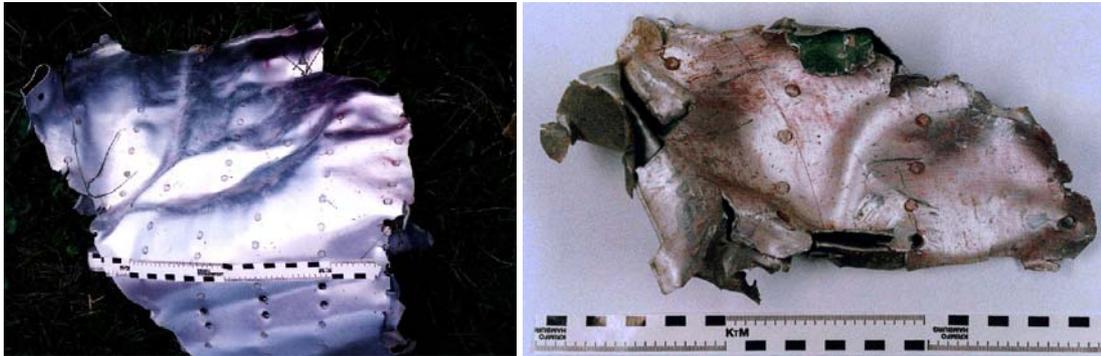
On the left wing collision traces between the wing root and the inboard slat were found. The fragments of the wing leading edge showed traces of red paint.

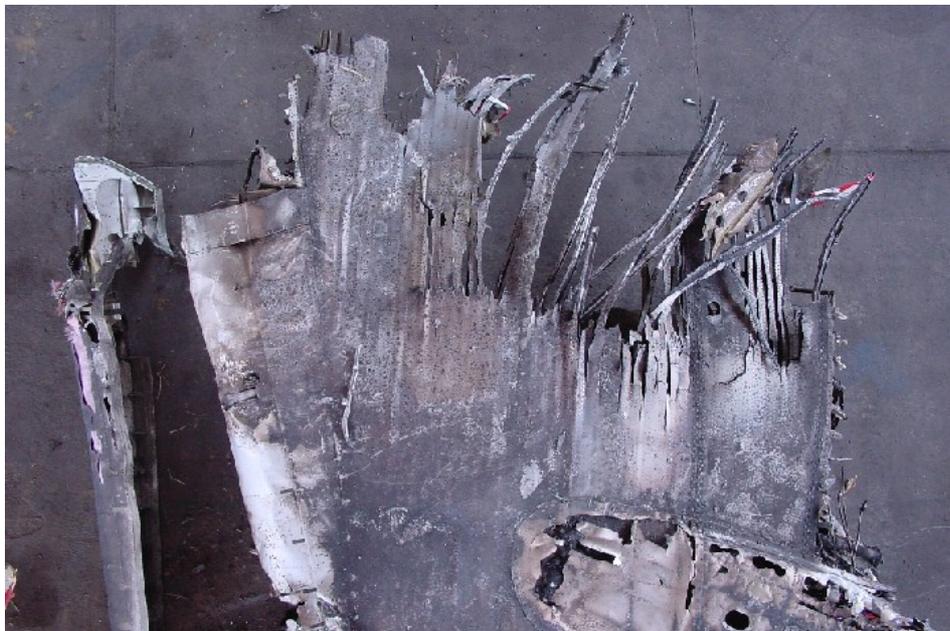
The wing including the wing spars had been severed by the collision. At the point of rupture the stringers of the wing were bent rearwards.

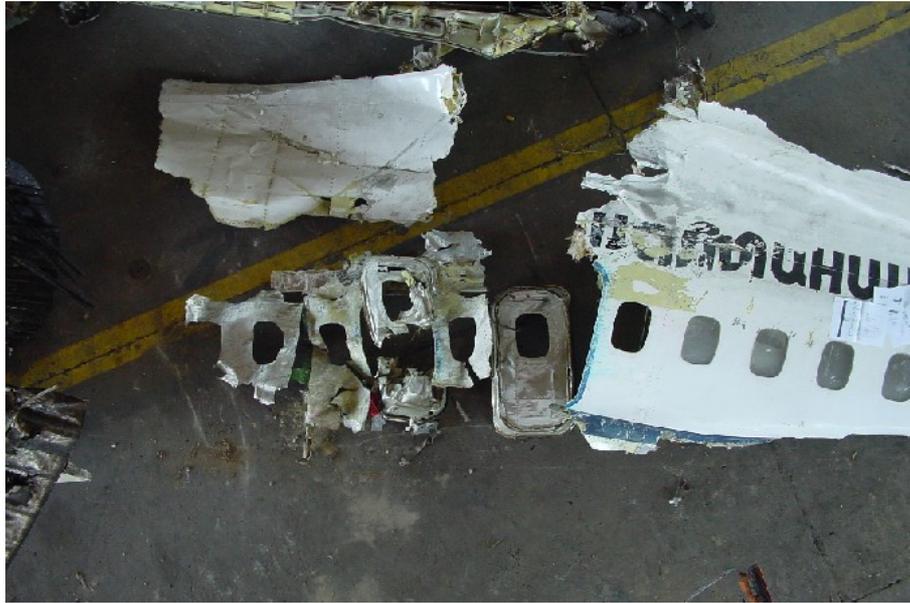
The area of both overwing emergency exits on the left side of the fuselage was smashed. Scratch marks, an extensive paint scrape-off and traces of red paint were found.

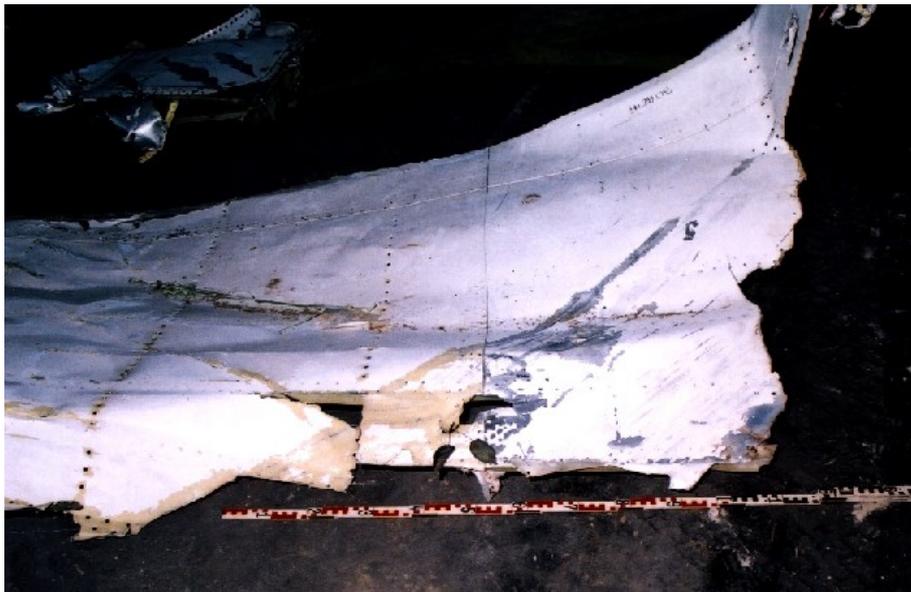
The angle between the scratch marks found on parts of the fuselage roof and the TU154M's longitudinal axis was 46°.

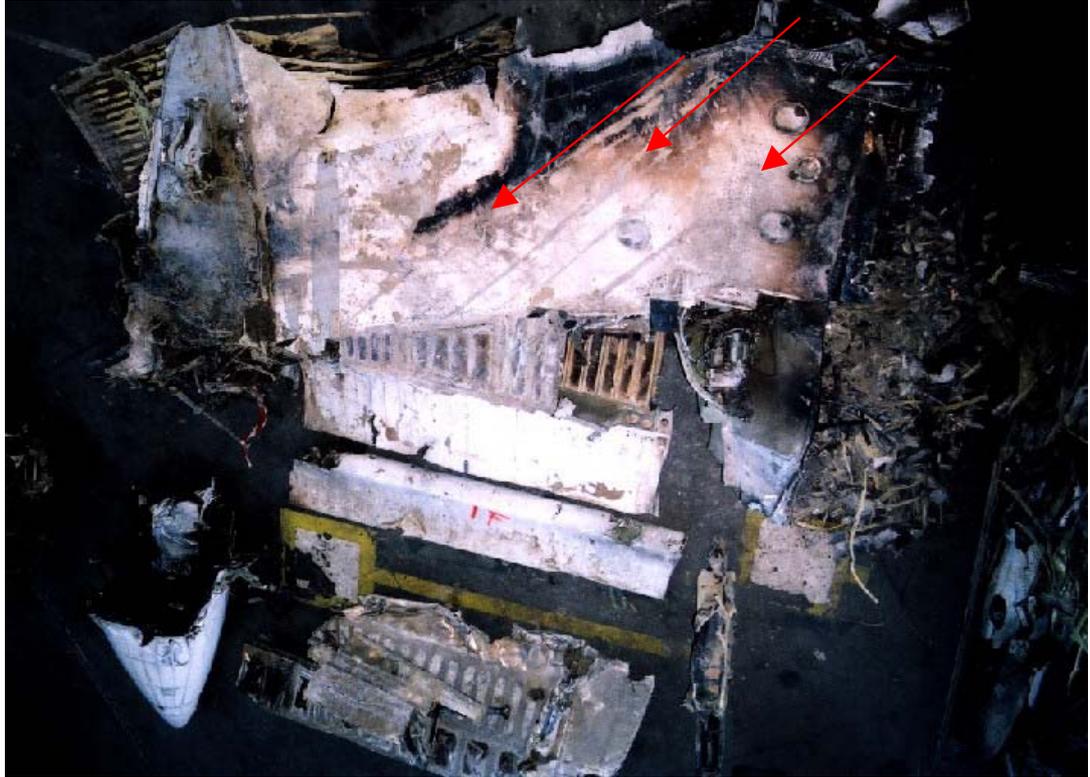
On the right wing's lower surface several parallel scratch marks of 3.60 m maximum length and 0,90 m width were found. They ran at an angle of 46° to the airplane's longitudinal axis into the direction of the right main landing gear. Traces of red paint were also found in this area.

right wing lower surface with traces of the collision

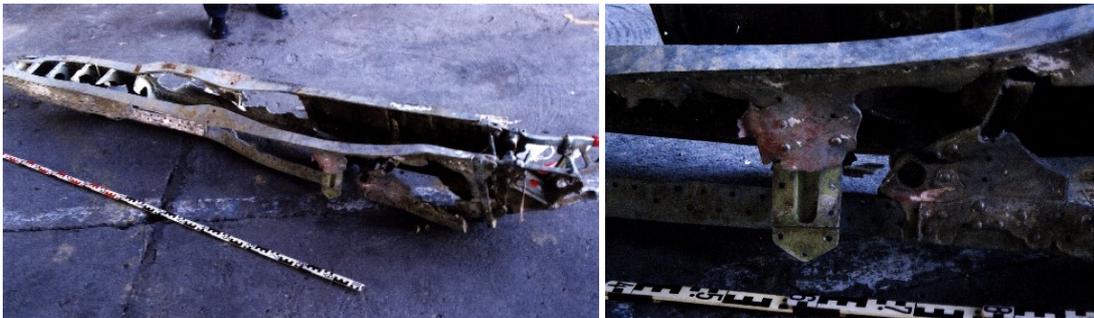
On the inboard side of the flap trap and carriage originating from the right wing, mechanical deformations and traces of red paint were found.

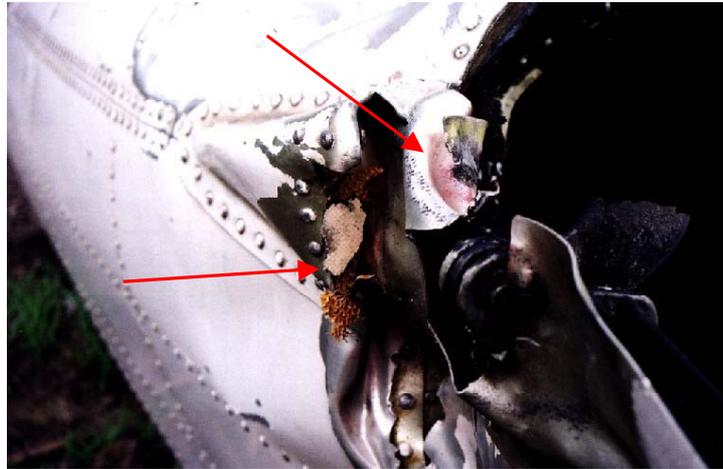
On the rear part of the fairing of the right main landing gear which had also been separated from the wing, traces of red paint and remains of the honeycomb structure of the B757-200 rudder were found.

Red paint and debris of the B757-200

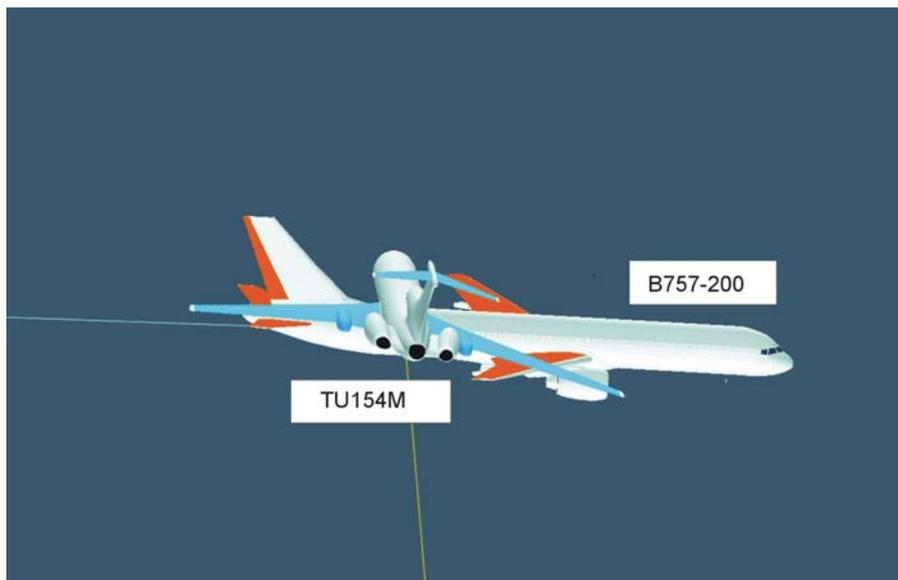
Reconstruction of the collision according to FDR data and collision evidence

FDR data shows that the TU154M had a MH of 274°, a pitch angle of 0° and a bank angle of 10° right at the time of the collision. The B757-200 flew a MH of 004°, with a pitch of approximately -2° and a bank angle of 0°.
