Interim Report

| Location: | Near Lugano (Switzerland) |
| Manufacturer / Model: | Boeing / B737-800 |
| State File Number: | BFU FX003-12 |

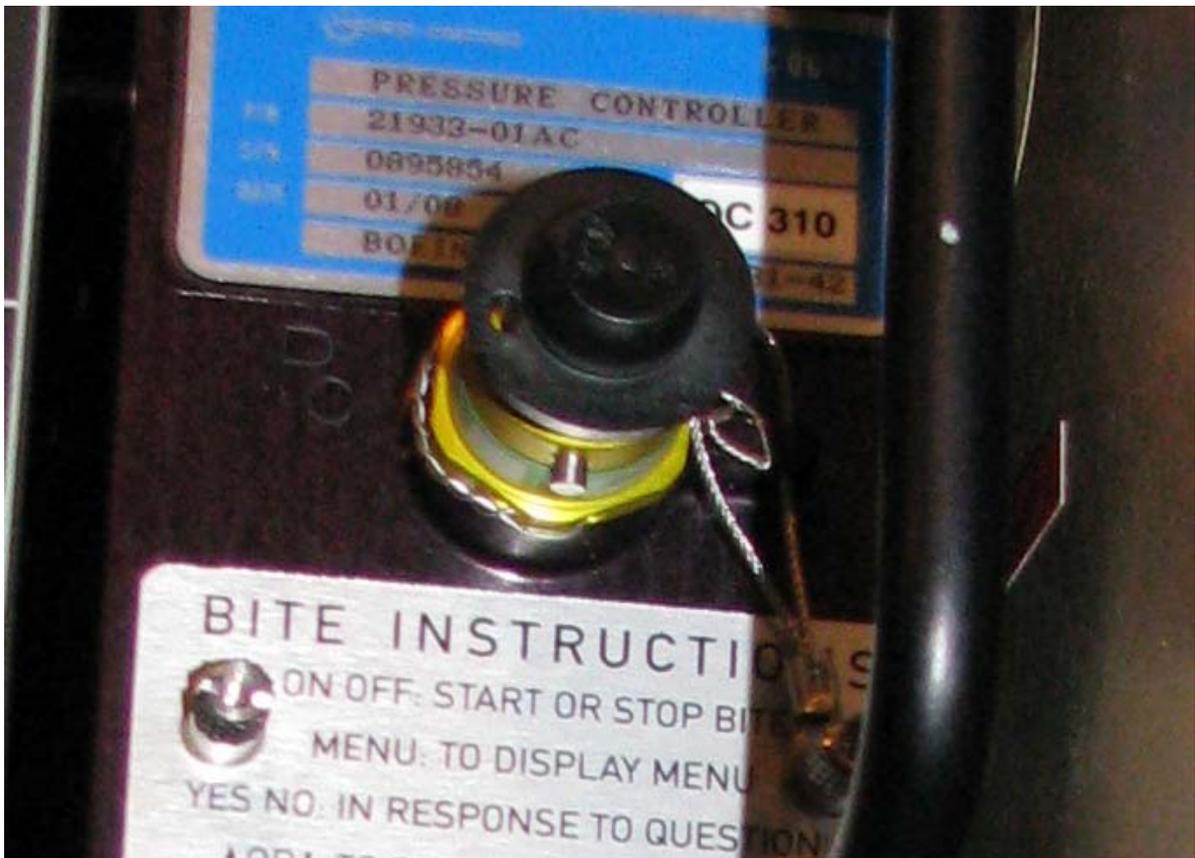
Cabin Pressure Controller #1 Static Port

The two cabin pressure controllers were installed in the electronic equipment compartment behind the nose landing gear. The static port on the CPC#1 was covered with a black shipping plug.

During the climb phase transmission errors occurred (fault code 39 RS422_XMIT_FAIL and fault code 40 RS422_WA_FAIL). Subsequently CPC#2 changed to standby and CPC#1 took over. At that time CPC#2 had measured an ambient pressure of 4.28 PSI and 4.27 PSI (about 295 hPa), respectively. This was about flight level 305. The cabin pressure was measured with 12.10 PSI and 12.09 PSI (about 833 hPa), respectively. Twelve seconds later CPC#2 recorded fault code 17 (CABIN_10000FT_MESSAGE). The measured ambient pressure was 4.22 PSI and the cabin pressure 10.10 PSI. The cabin rate of climb was measured with 6776.25 ft/min at that time. Six seconds later fault code 18 (CABIN_13500FT_MESSAGE) was recorded. The measured ambient pressure was 4.20 PSI (289 hPa) and the cabin pressure 8.80 PSI (607hPa). At that time the cabin rate of climb was at 7656.5 ft/min.

The BFU is in the possession of a written statement of one of the maintenance employees which describes the content and process of the maintenance work carried out the night before the serious incident. The operator stated the employee held the license for certified category B2 personnel (Avionic). He stated that during the night he had downloaded the CPC data from the non-volatile memory (NVM). Afterwards he had assisted in finding out which of the two CPCs had been "in control" during the previous flights. The NVM had not recorded any fault codes. Subsequently carried out pressurization system ground tests on both CPCs did not reveal any faults. Since they had to wait for a spare part to arrive the work on the airplane had been interrupted and continued in the morning. Among other things, the CPC#1 was changed. During installation of the CPC he had forgotten to remove the shipping plug.

The Federal Aviation Administration (FAA) should require Boeing to re-design the shipping plugs in a way which makes them more recognisable. The shipping plugs should also be coupled with an eye-catching tag.

Maintenance and Repair Organisations should only cover the static ports of a cabin pressure controller with a shipping plug which is clearly visibly coupled with a tag.

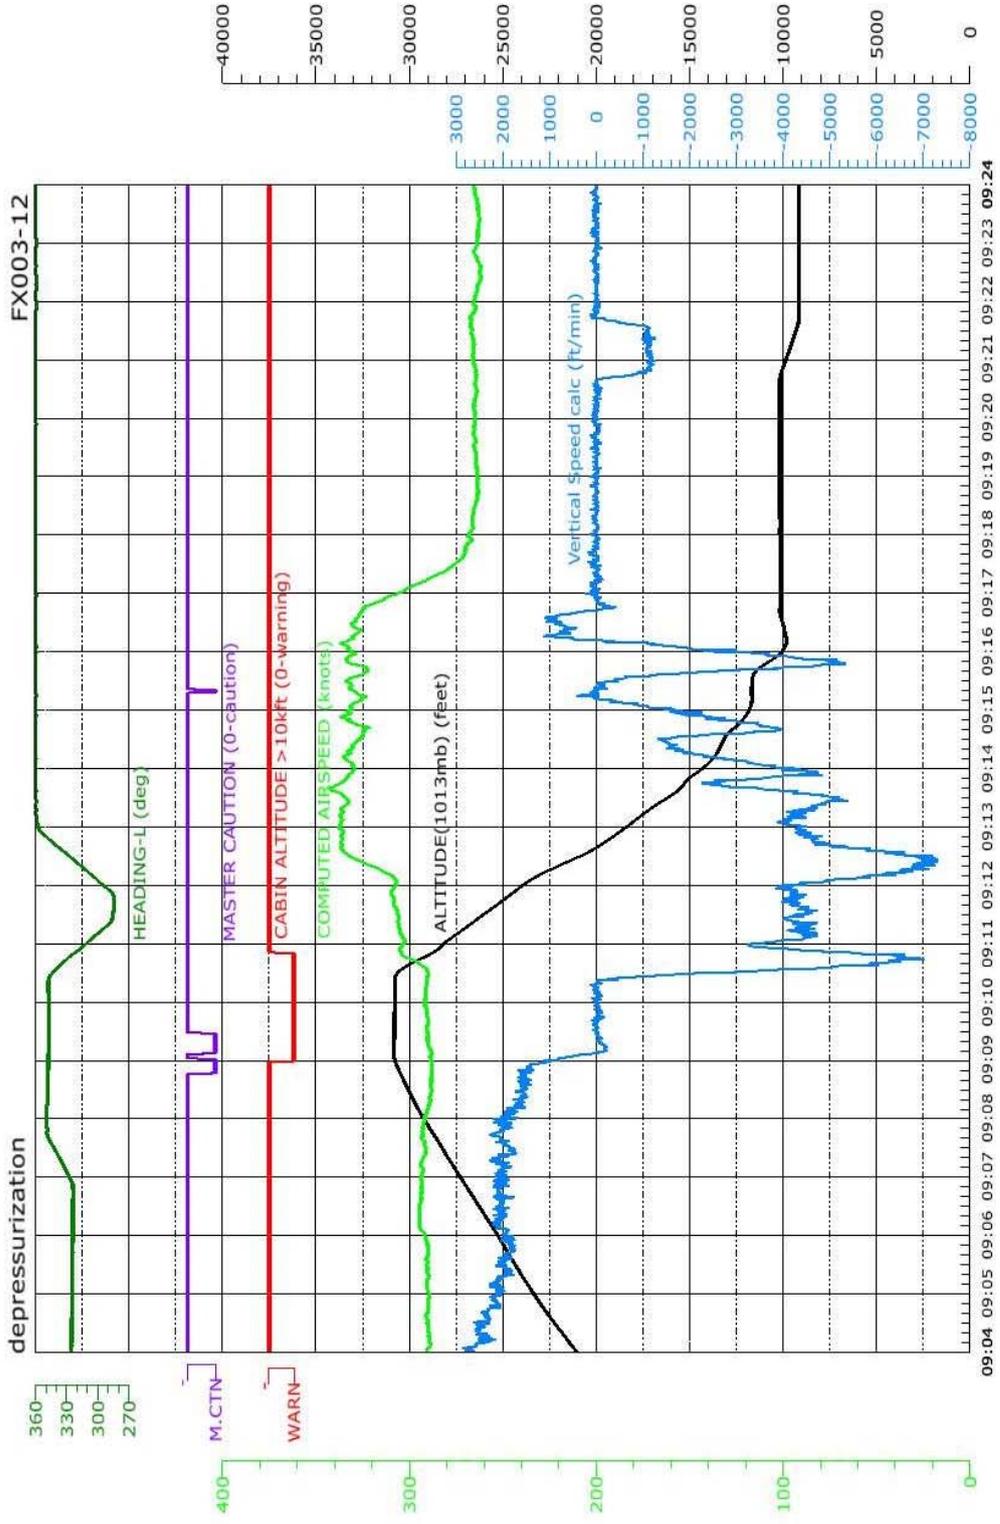
Excerpt FDR data

The data of the Flight Data Recorder (FDR) showed that at 1108:40 hrs the master caution and about 20 seconds later the cabin altitude warning (cabin altitude > 10,000 ft) was triggered. The warning ceased about two minutes later.
