**DATA SUMMARY**

Date and time	<b>Monday, 7 June 2010; 12:00 local time<sup>1</sup>, approximately</b>
Site	<b>Girona Airport</b>

Registration	<b>EI-DAX</b>
Type and model	<b>BOEING 737-800</b>
Operator	<b>Ryanair</b>

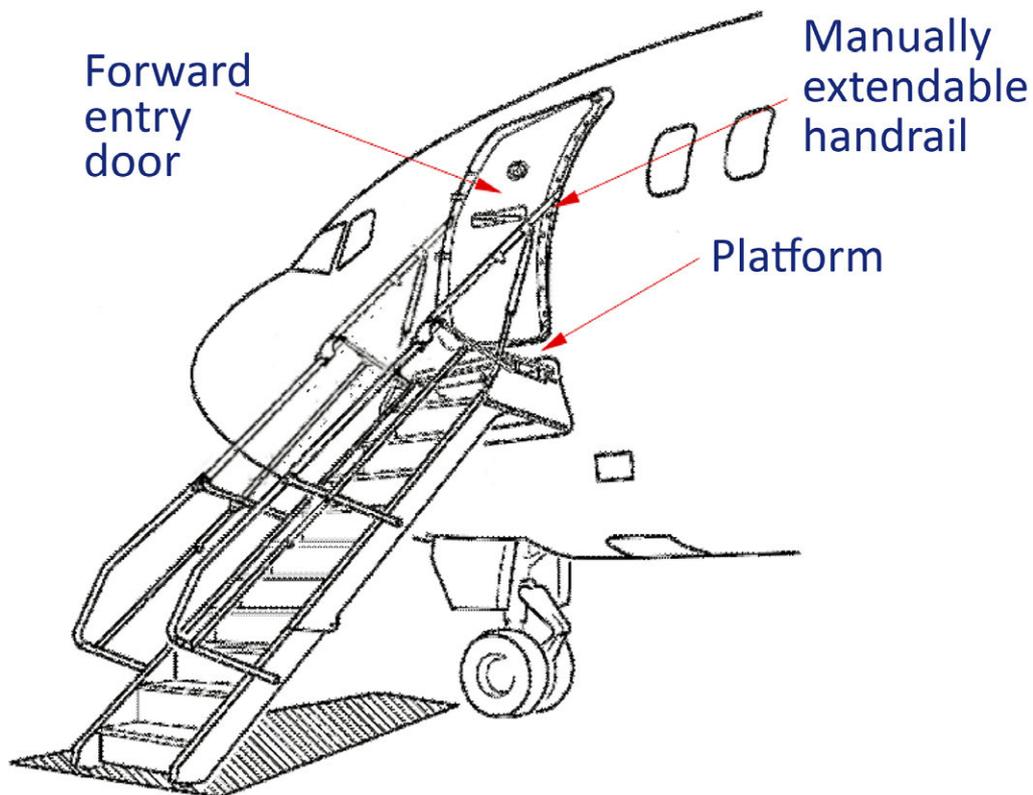
Figure 1. Forward stairs on B-737

Some Boeing 737 airplanes are equipped with retractable stairs at the forward left cabin door. These stairs allow passengers to board and disembark without the need for additional ground equipment. These stairs include a handrail on either side. To span the distance between the upper end of the handrail and the fuselage, extendable sections are manually attached to the fixed rails such that once the stairs are deployed, these sections are affixed to the door frame. Each extendable handrail is attached with an extendable strut that joins the handrail to a rail at the lower part of the platform (see Fig. 1).

The Boeing 737 is one of the airplanes that uses integrated airstairs to facilitate boarding and disembarking without the need for ground-based stairs or a telescoping jet bridge. When the stairs are deployed, the extendable beams on either side are intended to prevent falls to the side, and the extendable rails against falls from the top platform. Although these extendable handrails do provide protection to adults against falling, the gap between the handrail and the platform poses a danger to small children who are boarding or disembarking from the airplane since it is large enough for a small child to fit through, and therefore to fall.

As for the bulletins, though they increase the level of slip protection for the top platform and add visual indications of a potential injury risk, they do not provide physical protection to prevent children from falling through the gap.

The safety recommendations issued by the AAIB in August 2011 addressed these issues by insisting on the need to establish controls to ensure that any modification to the Flight Attendant Manual is reported to operators, to review the boarding and disembarking procedures such that assistance is provided to passengers traveling with small children or who need special attention, and to review the design of the stairs such that a barrier be added to prevent or decrease the possibility of falling between the handrail and the platform on the stairs.
