Report A-004/2018

Accident involving a Boeing 737-8AS aircraft, registration EI-EKI, operated by Ryanair, in the Canaries airspace (Spain) on 10 February 2018

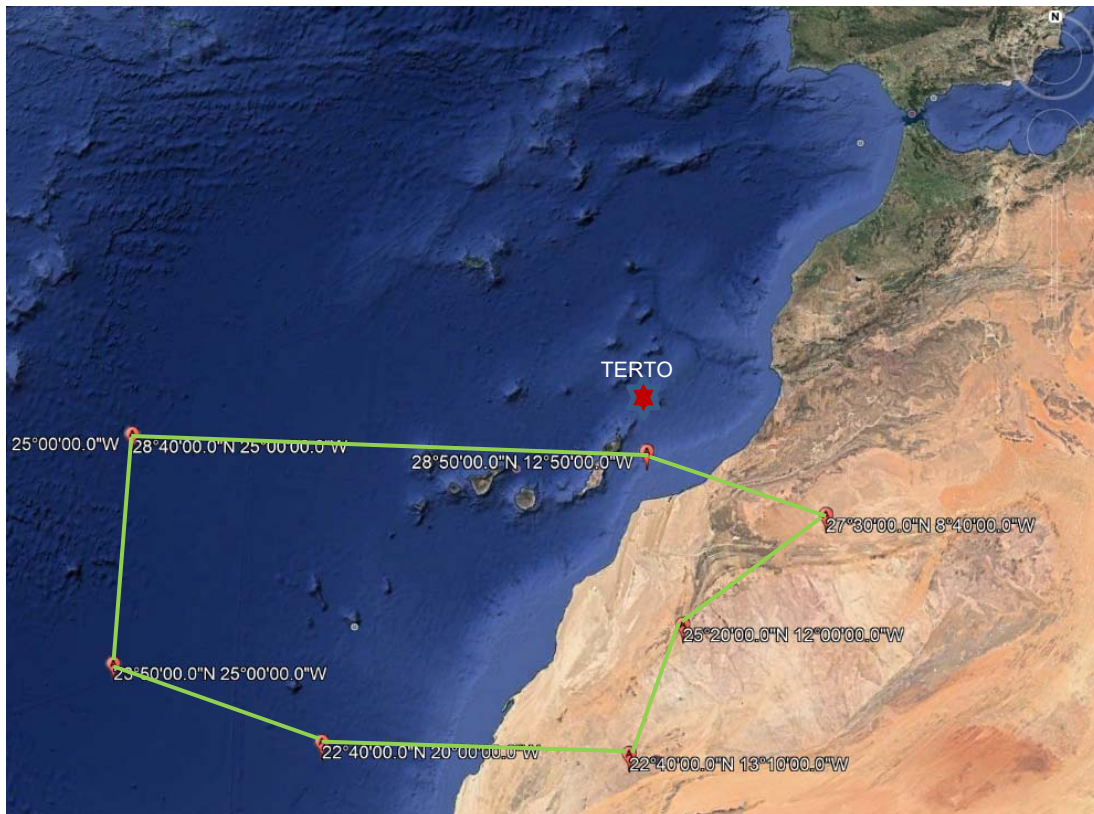
The first of these called for severe turbulence moving south between the 23 and 29 north parallels from 13:00 until 17:00 UTC between FL180 and FL360 for the entire Canarias FIR. This SIGMET, issued at 11:37 UTC, was canceled at 11:45 so that another could be issued with more accurate information and indicating the presence of severe turbulence inside the polygon shown in the image below between FL180 and FL360, also from 13:00 to 17:00 UTC.

Illustration 1: Location of waypoint TERTO and of the polygon inside which severe turbulence was forecast

Therefore, the presence of severe turbulence in the vicinity of the accident, even if not exactly at waypoint TERTO, was probable,

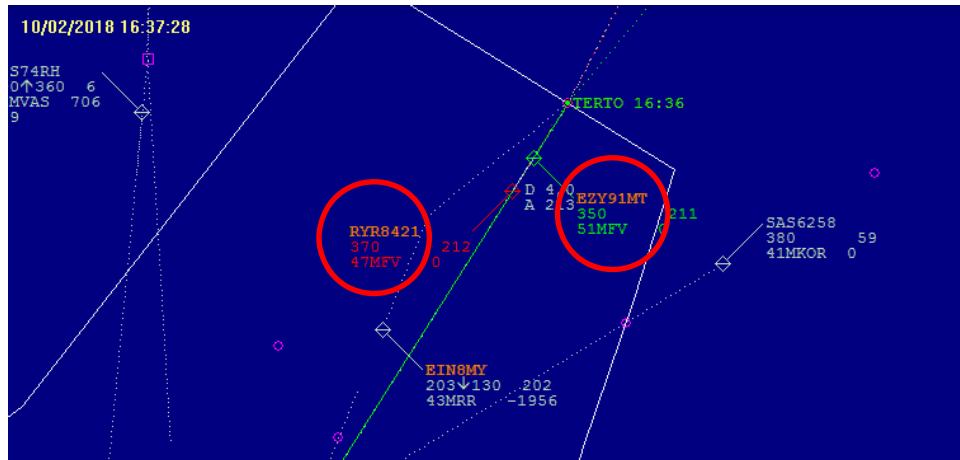
The following image shows the position of the Boeing 737-8AS aircraft, with callsign RYR8421, and of the aircraft with callsign EZY91MT, at 16:37:28. The controller identified

a potential conflict with the latter and interrupted the descent maneuver of the Boeing 737-8AS.

Illustration 2: Position of the aircraft at 16:37:28

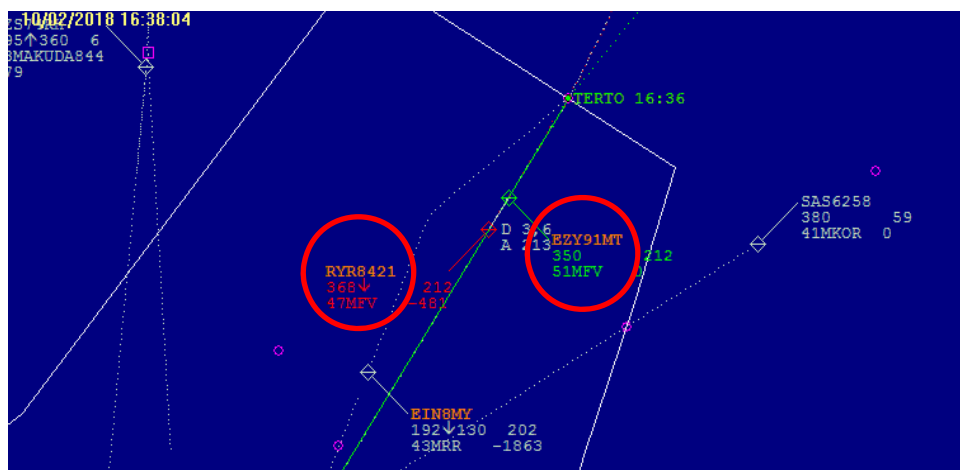
Later, at 16:38:04, the Boeing 737-8AS aircraft with callsign RYR8421 was descending from FL370 and crossing through FL368:

Illustration 3: Position of the aircraft at 16:38:04

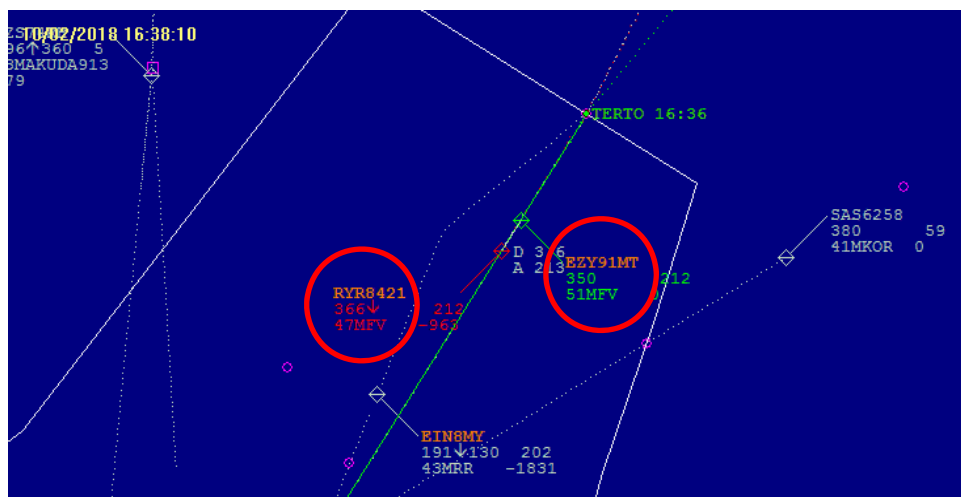
A few seconds later, at 16:38:10, the Boeing 737-8AS with callsign RYR8421 was still descending and crossing through FL366.

Illustration 4: Position of the aircraft at 16:38:10

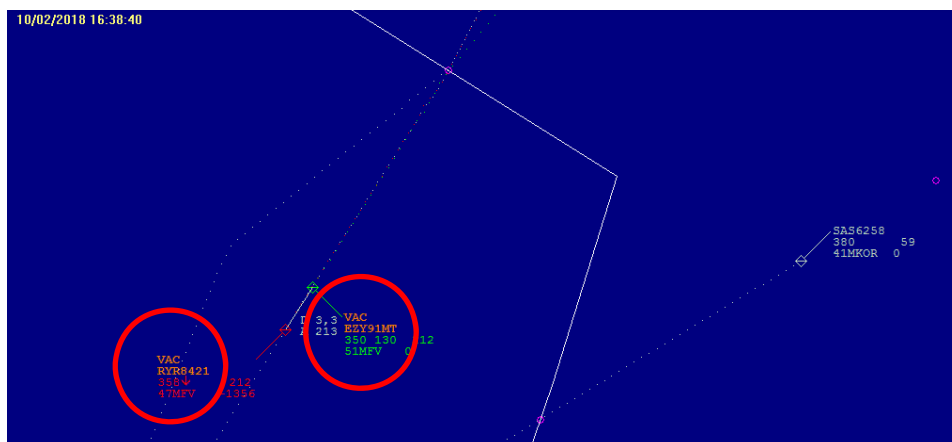
At 16:38:40, the Boeing 737-8AS with callsign RYR8421 was crossing through FL358. Although the aircraft is shown on the radar display as descending, an analysis of the radar data reveals that in reality the aircraft had been climbing since 16:38:33, when the aircraft reached its lowest altitude, which was FL357.

Illustration 5: Position of the aircraft at 16:38:40

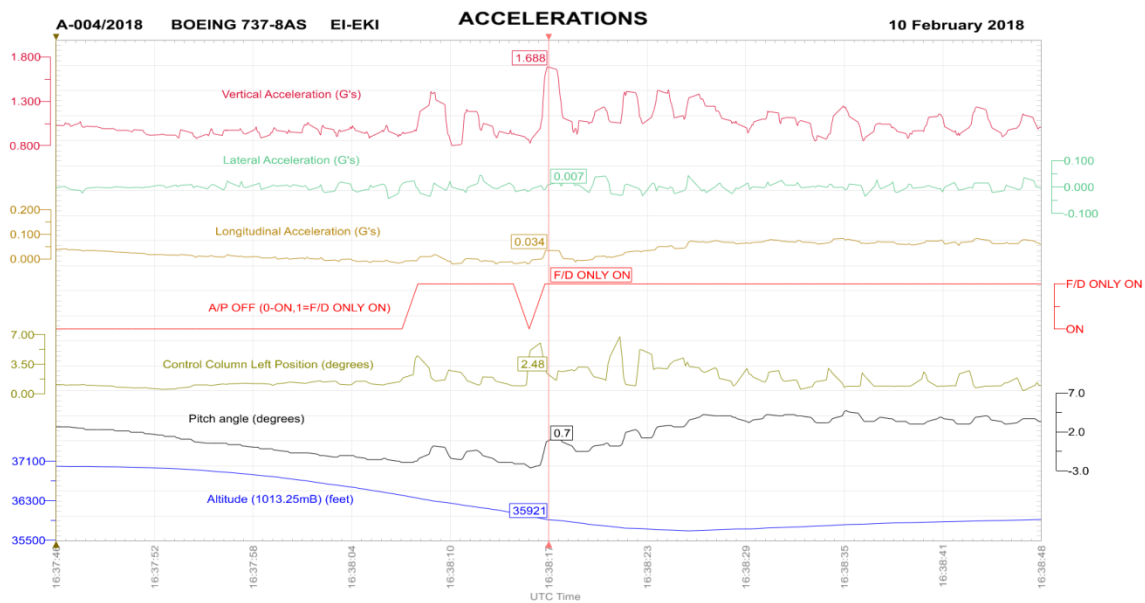
At 16:38:07, the autopilot was placed in ALT HOLD mode and disengaged one second later. At the time, the aircraft was crossing through FL364 at a vertical rate of -3600 ft/min².

At 16:38:08, an input to the pitch control column was recorded, with the pitch changing from 1.38° in the previous second to 4.51° at that instant. This resulted in the pitch attitude increasing in one second from -2° to 0°, and generated a peak vertical acceleration value of 1.409 g. The descent rate fell instantly to -2340 ft/min.

At 16:38:15, the autopilot was engaged in ALT HOLD mode. This action resulted in an increase in the position of the control column to 6.02°, which translated into an increase in pitch angle from -2.3° to 1.6° over the course of one second, causing the vertical acceleration to spike once more, this time to 1.69 g.

Subsequently, at 16:38:21, the crew again increased the position of the control column to 6.77°, producing a third peak in vertical acceleration, to 1.41 g.

The control column was eased back for a fourth time to 0.94°, followed by an increase to 4.68°, yielding a fourth peak in the vertical acceleration, to 1.43 g, at 16:38:24.
