Report IN-031/2020

Incident involving a BOEING B737-800 aircraft operated by RYANAIR, registration EI-EFJ, and lighting vehicle 'Balizamiento 3' operated by AENA, on runway 24R at Palma de Mallorca Airport, on 19 July 2020

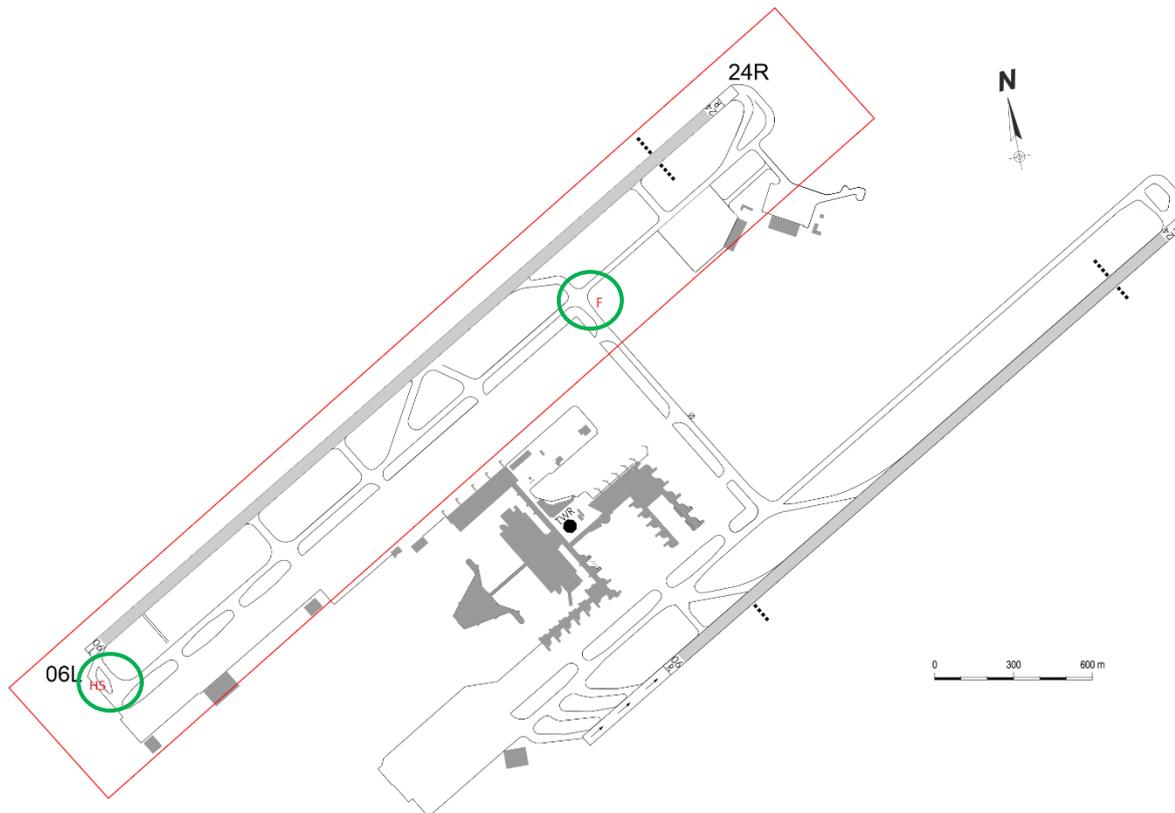
Fig. 1. Layout of Palma de Mallorca Airport.
The manoeuvring area where the incident took place is highlighted in red and holding point H5 and gate F are highlighted in green

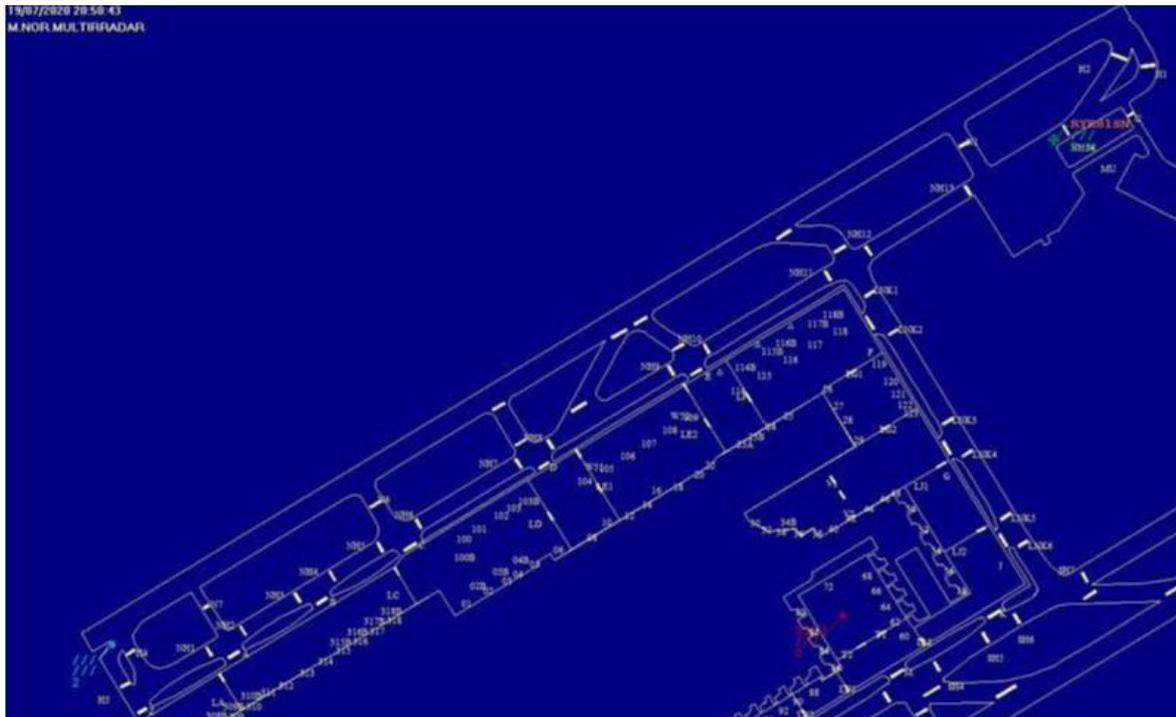
Fig. 2: Palestra image corresponding to 20:50:43

At 20:50:43, the RYR81SN aircraft established initial contact on the local controller frequency (TWR) of the Palma de Mallorca control tower and indicated that it was ready to depart. The Palma de Mallorca control tower local controller (TWR) replied: *"RYR81SN good evening, wind 210°, 5 knots, runway 24R, cleared for take-off, traffic on final 8 miles out"*. The crew of the aircraft read-back the instruction correctly. At this point, the radar shows the RYR81SN aircraft taxiing to the holding point on runway 24R and an uncorrelated label on the threshold of runway 06L, which corresponds to the Balizamiento 3 vehicle.

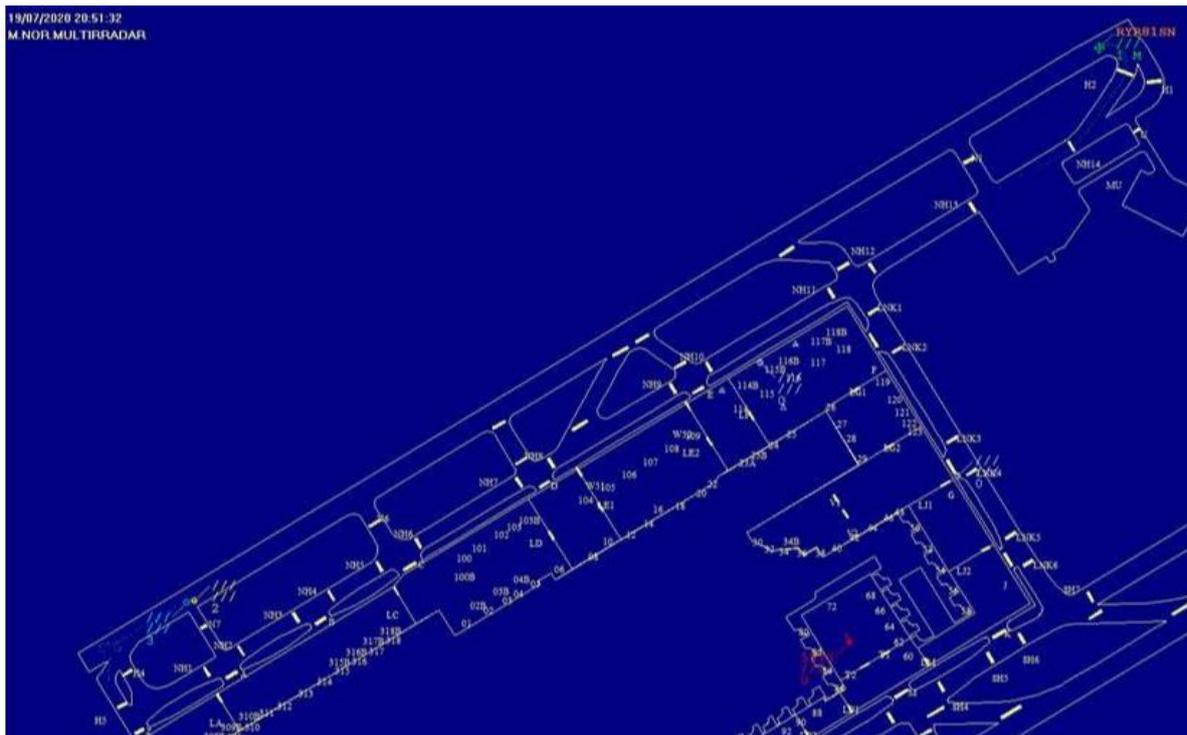
Fig. 3: Palestra image corresponding to 20:51:32

At 20:51:32, the driver of the Balizamiento 3 vehicle contacted the Palma de Mallorca control tower and reported the following: *“tower from Balizamiento 3, I’m on the north runway, you cleared me to enter, exiting immediately”*. The radar trace at that point in time shows aircraft RYR81SN aligned on runway 24R and travelling at a ground speed (GS) of 10 kt, while an uncorrelated label corresponding to the Balizamiento 3 vehicle (a duplication of the radar echo is visible) can also be seen at the opposite end of the runway, abeam on taxiway N7.

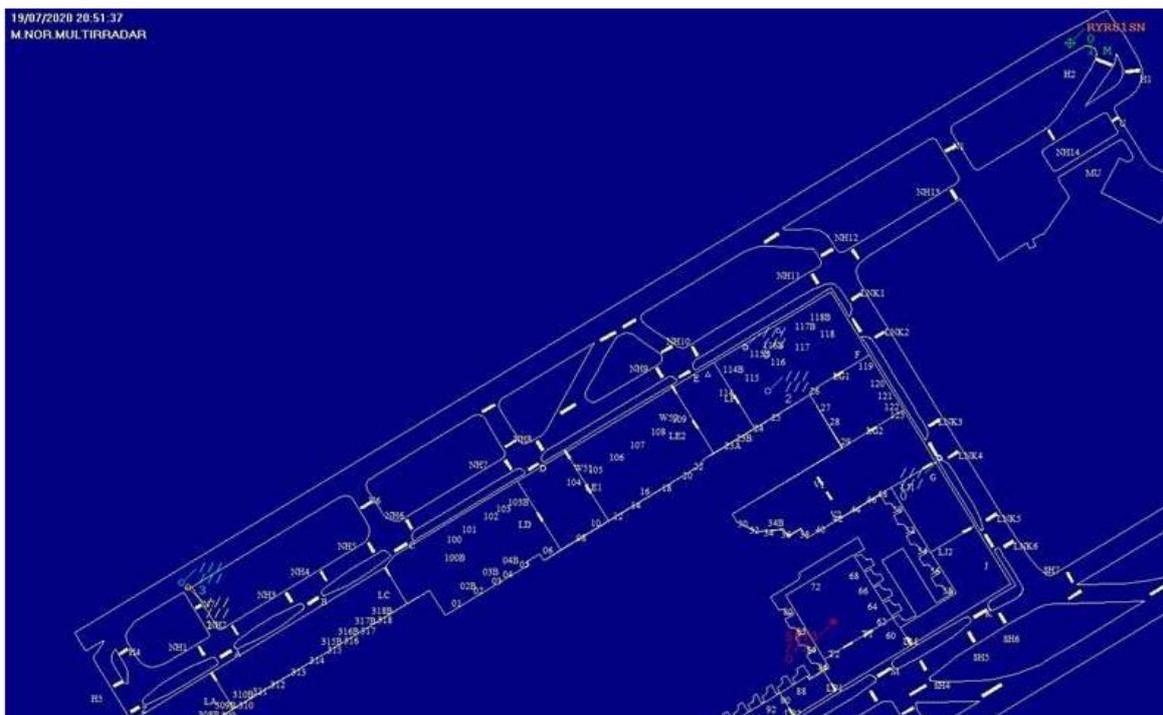
Fig. 4: Palestra image corresponding to 20:51:37

At 20:51:37, the local controller (TWR) replied: “Balizamiento 3, you told me you were on the south runway; vacate the runway immediately. Break, break. (20:51:39) RYR81SN hold position; I say again hold position”. The crew of the aircraft read-back “stopping RYR81SN”. At this point, the radar shows the RYR81SN aircraft aligned on runway 24R and travelling at a ground speed (GS) of 10 kt, while an uncorrelated label corresponding to the Balizamiento 3 vehicle (a duplication of the radar echo is visible) can be seen at the opposite end of the runway, abeam on taxiway N7.

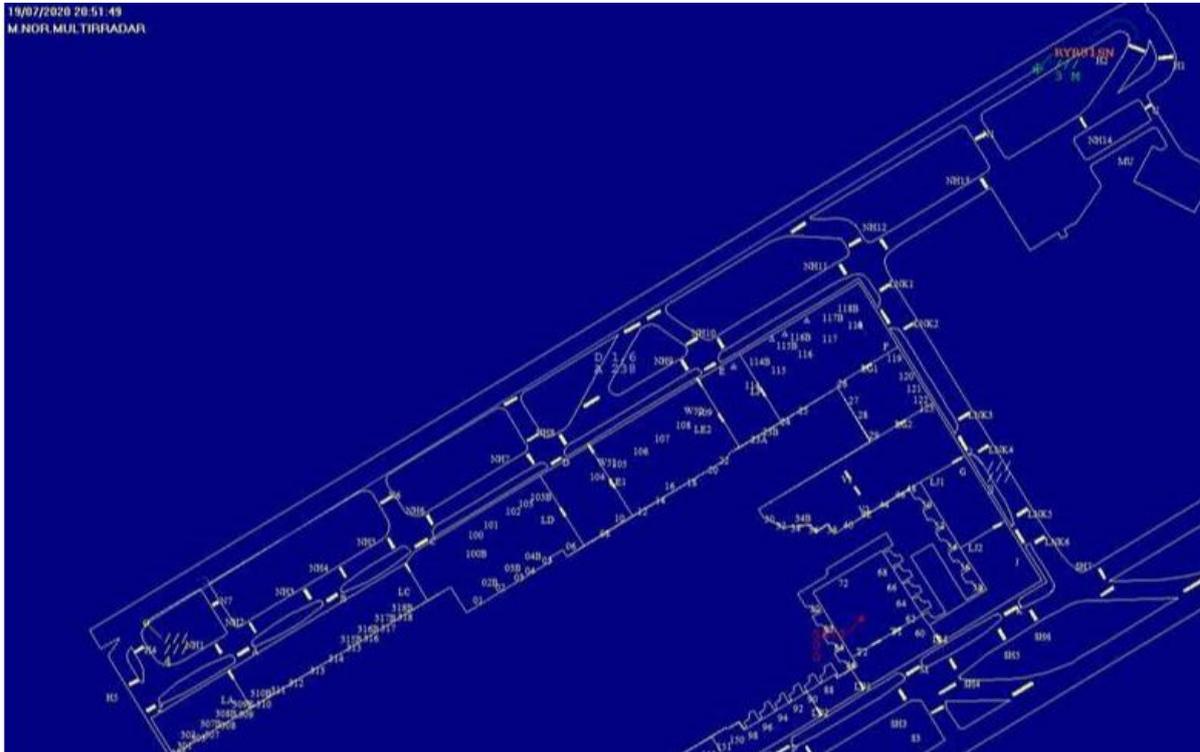
Fig. 5: Palestra image corresponding to 20:51:49

At 20:51:49, the radar shows the RYR81SN aircraft beginning its take-off roll on 24R at a ground speed (GS) of 30 kt, while an uncorrelated label corresponding to the Balizamiento 3 vehicle can be seen at the opposite end of the runway, close to exiting via H4. This was the point at which the distance between the aircraft and the vehicle was the shortest: 1.6 NM.

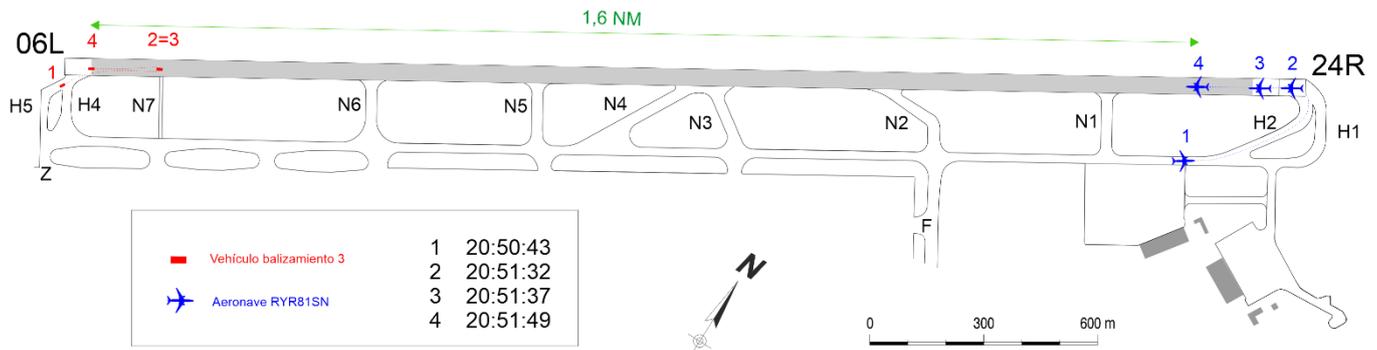
The following image shows the positions of the Balizamiento 3 vehicle (in red) and aircraft RYR81SN (in blue) at 20:50:43, 20:51:32, 20:51:37 and 20:51:49.

Fig. 6: Combined portrayal of the 4 previous images
