## Report IN-010/2010

Incident occurred on 14 May  
2010, to aircraft Boeing 737-800,  
registration EI-DYX, operated  
by Ryanair during approach  
to Valencia Airport (LEVC), Spain

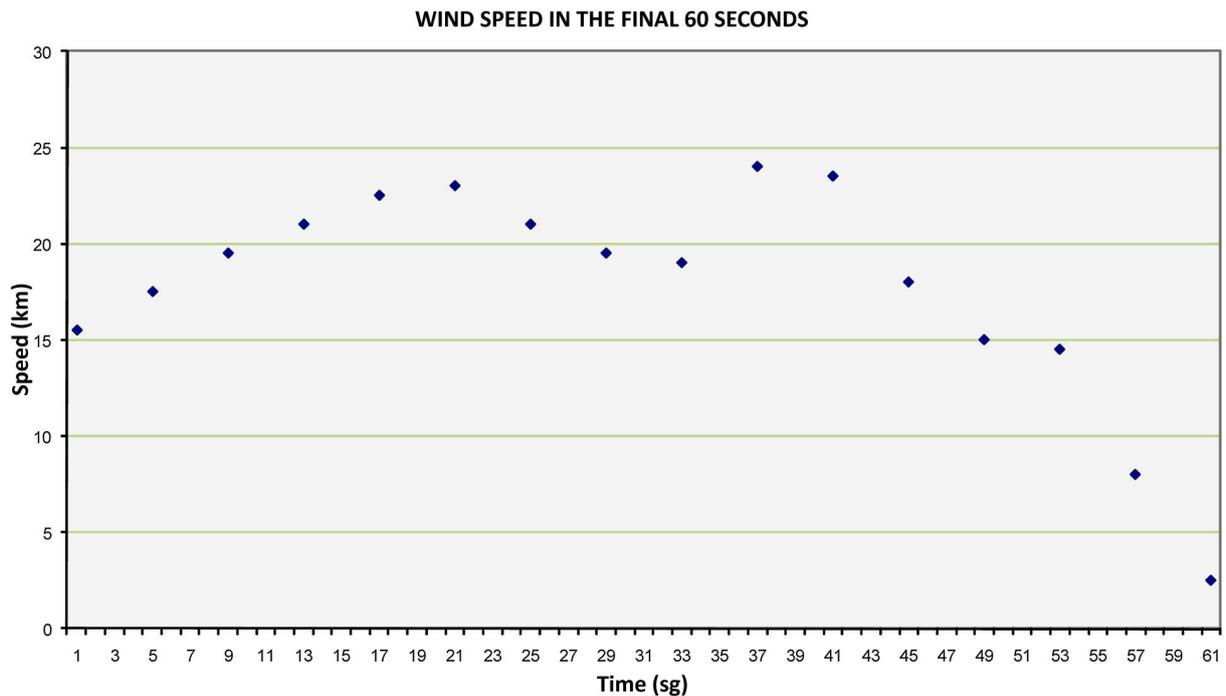
According to DFDR data, there was a tailwind during the approach (the controller had reported these conditions, as stated by other aircraft crews), but at about 200 ft the wind speed decreased rapidly almost to zero as its direction shifted to the south.

Although the wind data recorded on the DFDR during the landing are not completely reliable due to the aerodynamic influence of the ground effect and to changes in the airplane's attitude, they do offer an approximate idea of the prevailing wind conditions, which on this occasion warrant consideration, as they are consistent with the wind data reported by the control tower and other aircraft and by their agreement with the effect on the airplane's CAS (computer airspeed).

Figure 3. Change in wind speed in the final 60 seconds

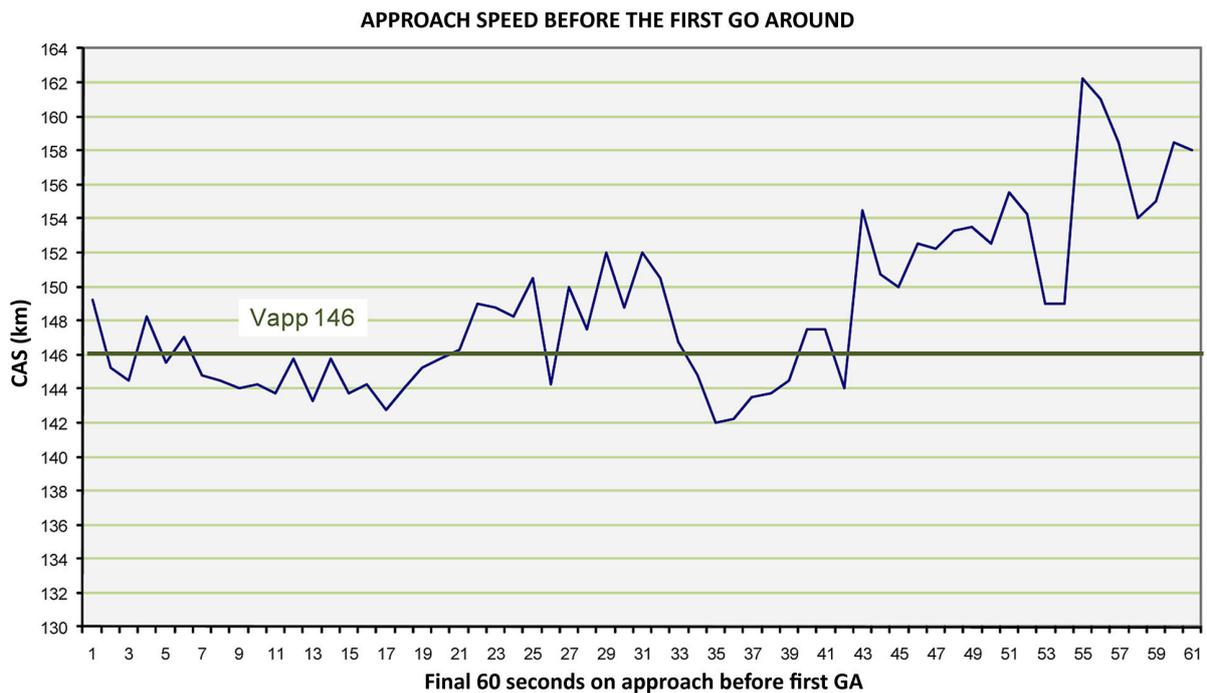
Note how the CAS increased gradually over these last 20 seconds to a momentary maximum of 162 kt. The speed the pilot was trying to maintain, or Vapp, was 146.

Figure 4. Approach speed before the first go around

- The first approach was made in tailwind conditions, just as the crew had anticipated.
- The indicated airspeed increased gradually in the last 180 ft, temporarily reaching a maximum of 162 kt ( $V_{ref} + 21$ ).
