**DATA SUMMARY**

Date and time	<b>Wednesday, 27 October 2010; 16:35 local time<sup>1</sup></b>
Site	<b>Seville Airport (Spain)</b>

Registration	<b>EI-EBR</b>
Type and model	<b>BOEING 737-800</b>
Operator	<b>Ryanair</b>

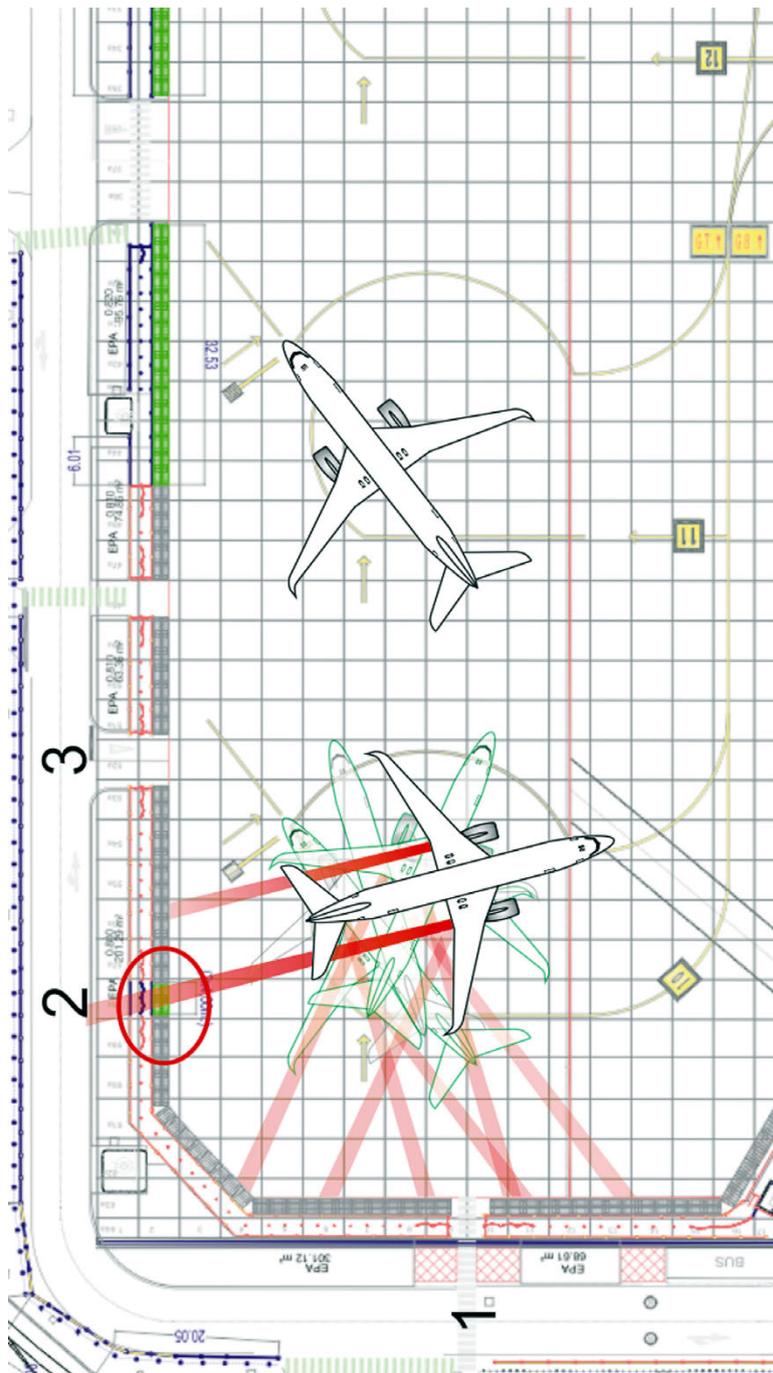
Figure 1. Position of aircraft and area affected by the jet blast

Meanwhile, a group of passengers was being led by two operators to board another aircraft of the same airline located at stand 11. The access to the aircraft was through a walkway on the apron protected by jet blast barriers. This walkway had areas that lacked barriers so as to allow the passengers to access the parked aircraft (points 1 and 2 in Figure 1).

When the aircraft started its engines and taxied, the boarding to the second aircraft was interrupted. The passengers remained behind the jet blast barriers at point 2, but the jet blast from the aircraft impacted some passengers, throwing them to the ground, as a result of which one passenger fractured an arm.

After the event, the Seville Airport closed the access to the affected apron by using jet blast barriers (point 2, Figure 1). This was not done initially because it was expected that

passengers would access stand 10 through point 2, but since it was noted that the preferred access point was 1 (see Figure 1), it was decided to close off point 2.

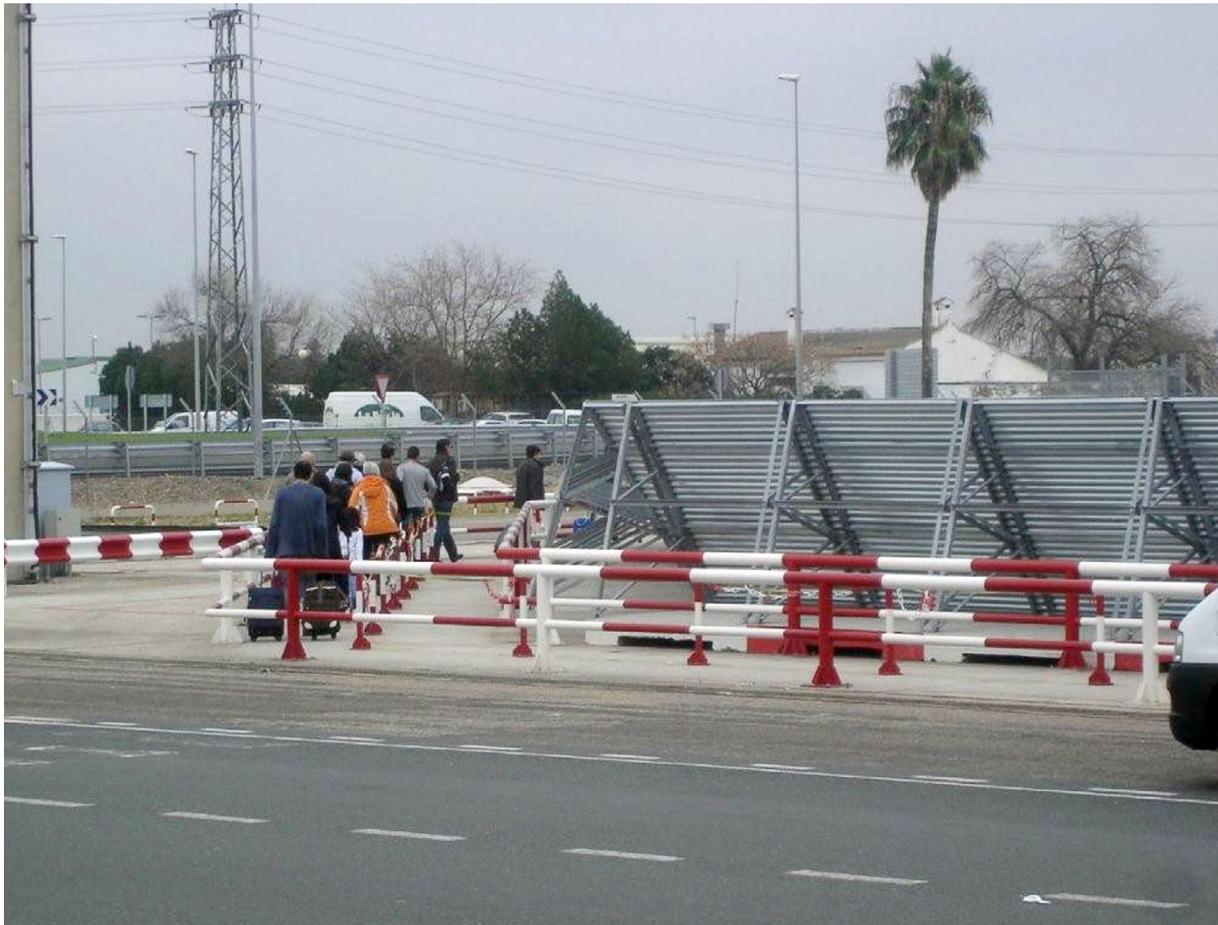
Figure 2. Path used by passengers to access stands 10, 11 and 12

In order for passengers to go from the terminal to parking stands 10, 11 and 12, they must access the apron on foot and walk along a designated path flanked by fences on either side. This path has jet blast barriers in place which are designed to protect passengers from the jet blast of stationary and maneuvering aircraft on adjacent stands. There are gaps in the barriers to allow access to the aircraft.

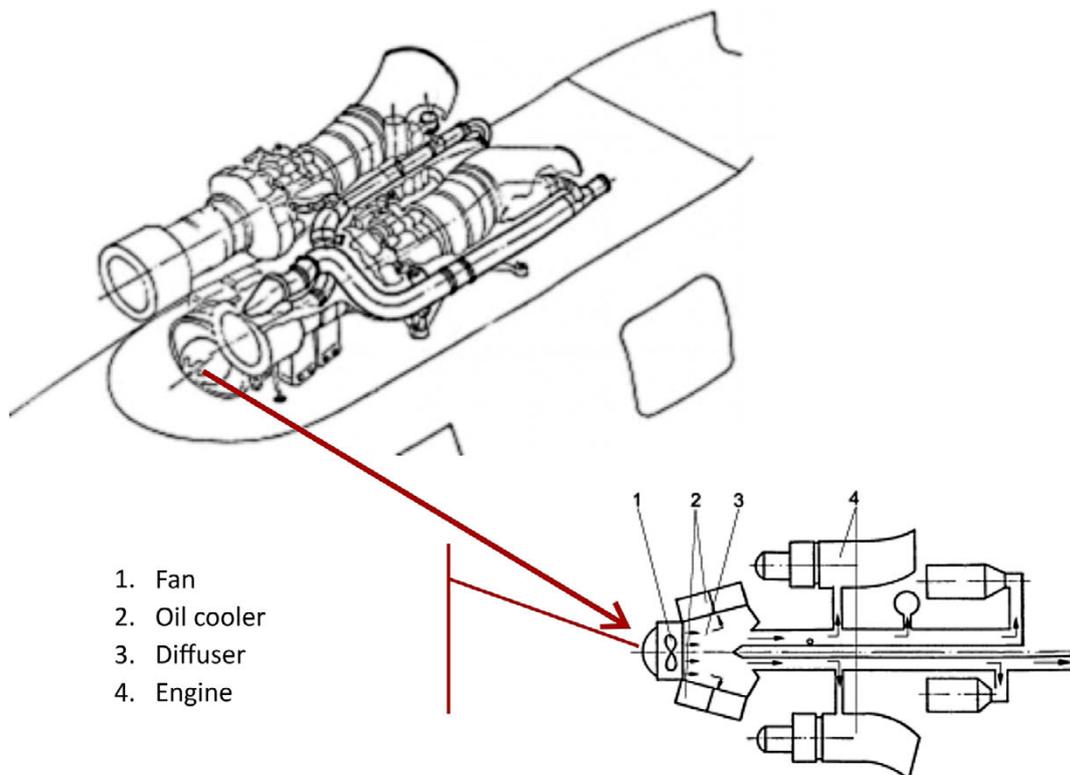
Figure 1. Accessory cooling system

An initial inspection of the aircraft revealed that the accessory cooling system (Figure 1), specifically the fan, was damaged and exhibited the effects of the fire. A more detailed inspection was conducted later by a working group consisting of, among others, technicians for the aircraft and fan manufacturers, the findings of which are summarized in Section 1.4 of this report.
