Report EXT A-006/2014

Accident involving a BOEING B-737-800,
registration EI-ENB, operated
by RYANAIR, in the vicinity
of Toulouse (France) on 23 June 2014

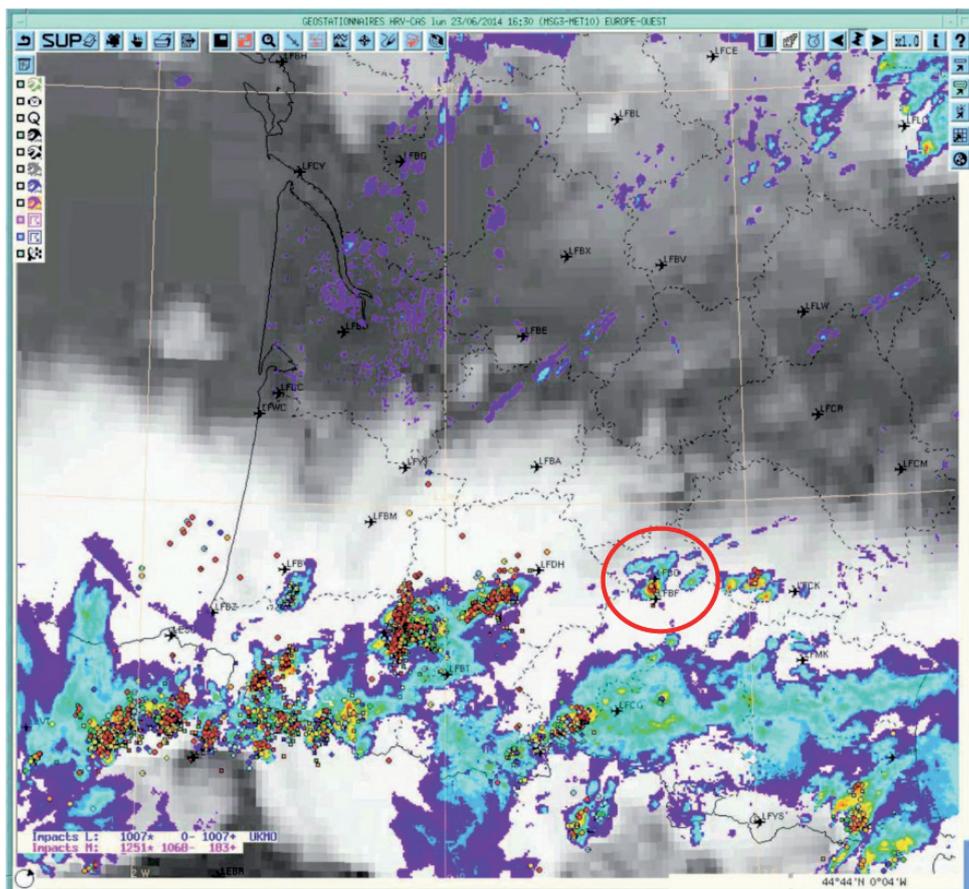
Figure 1. Satellite (IR) and radar images, and lightning map for 16:30 UTC.
The area of the event is circled in red

Figure 1 shows the satellite (IR) and radar images for 16:30 UTC. As we can see, the Pyrenean mountains were affected by developing storms, especially along their Western half. The figure also shows several isolated storm cells north of the Pyrenees, which include the one that affected the accident flight.

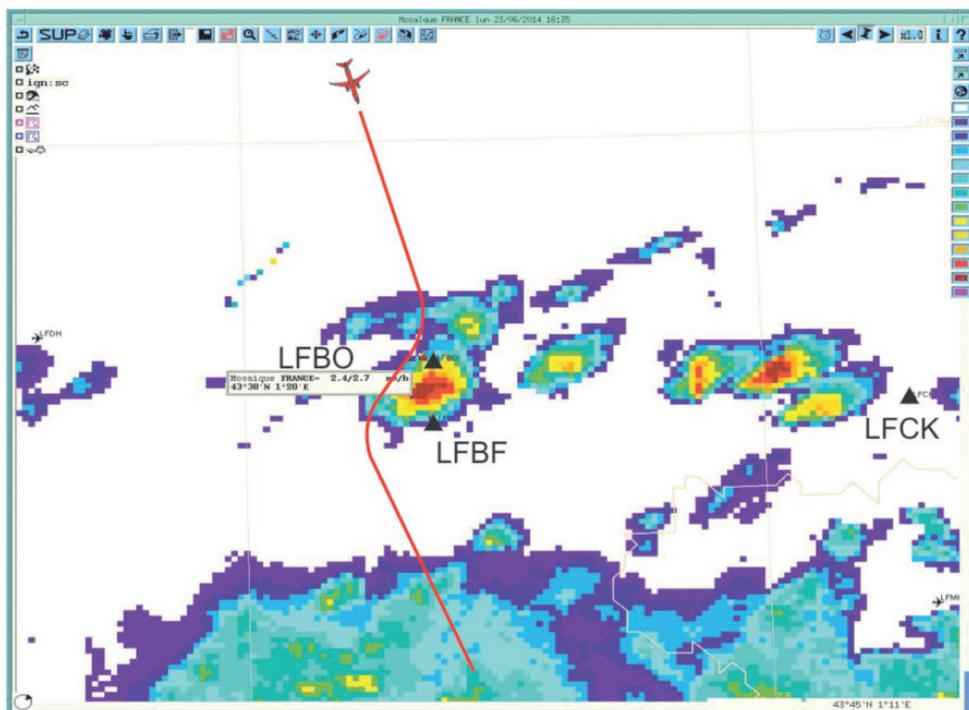
The image from 16:35 UTC (figure 2) shows an increase in the surface area colored in yellow, orange and red.

Figure 2. Weather radar image from 16:35 UTC, with the aircraft's trajectory superimposed on it

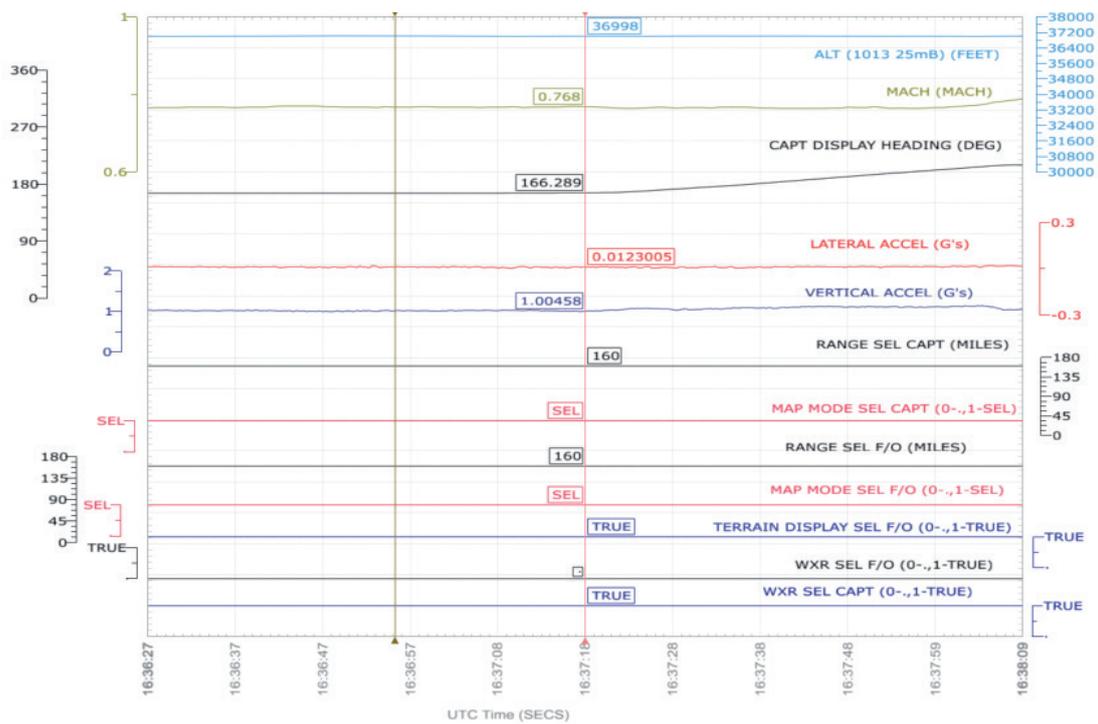
The graph reveals that at 16:37:16 UTC, the aircraft, which was on heading 165°, started a turn to the right to change course to 202°. This turn was made with the autopilot in HDG (heading) mode.

Figure 3. Graph of certain flight data in the two minutes preceding the turbulence

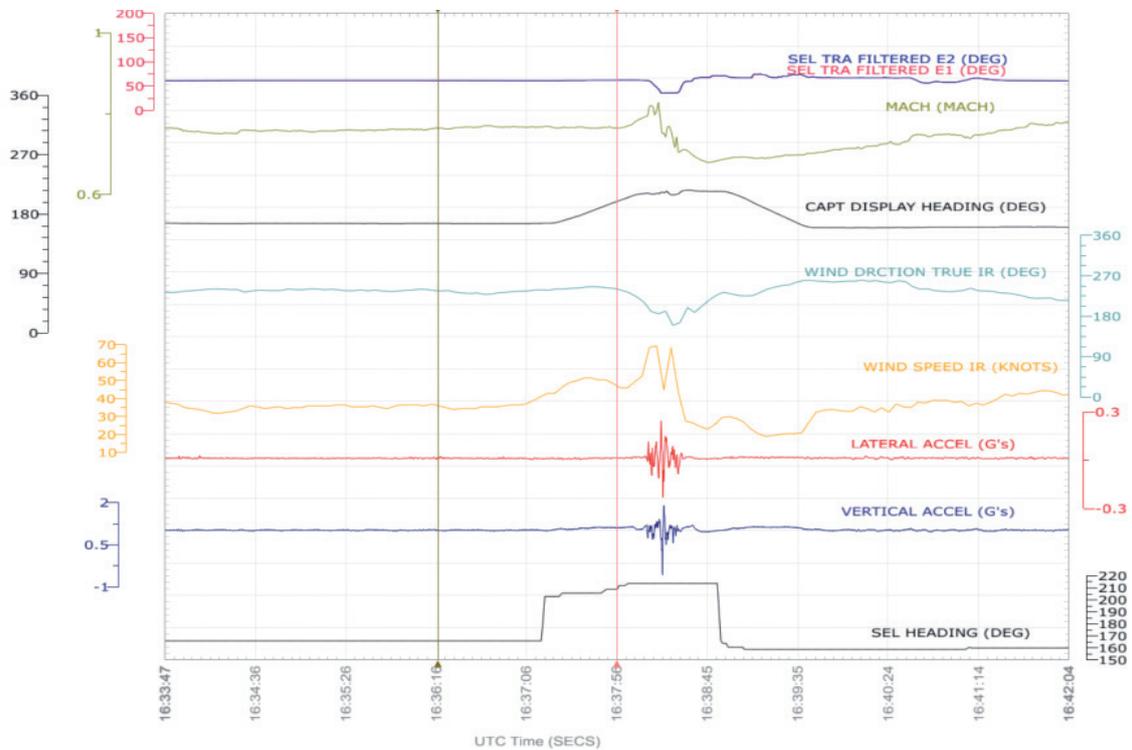
This graph, like the one in Figure 3, shows the heading change made by the crew at 16:37:16 UTC using the HDG mode selector.

Figure 4. Graph of flight parameters recorded between 16:33:47 UTC and 16:42:04 UTC

Also evident is the fact that the action to change the aircraft's heading was taken about 10 s after the wind speed recorded by the aircraft started to increase. Until that moment, the values of the remaining parameters recorded by the FDR were within normal ranges.

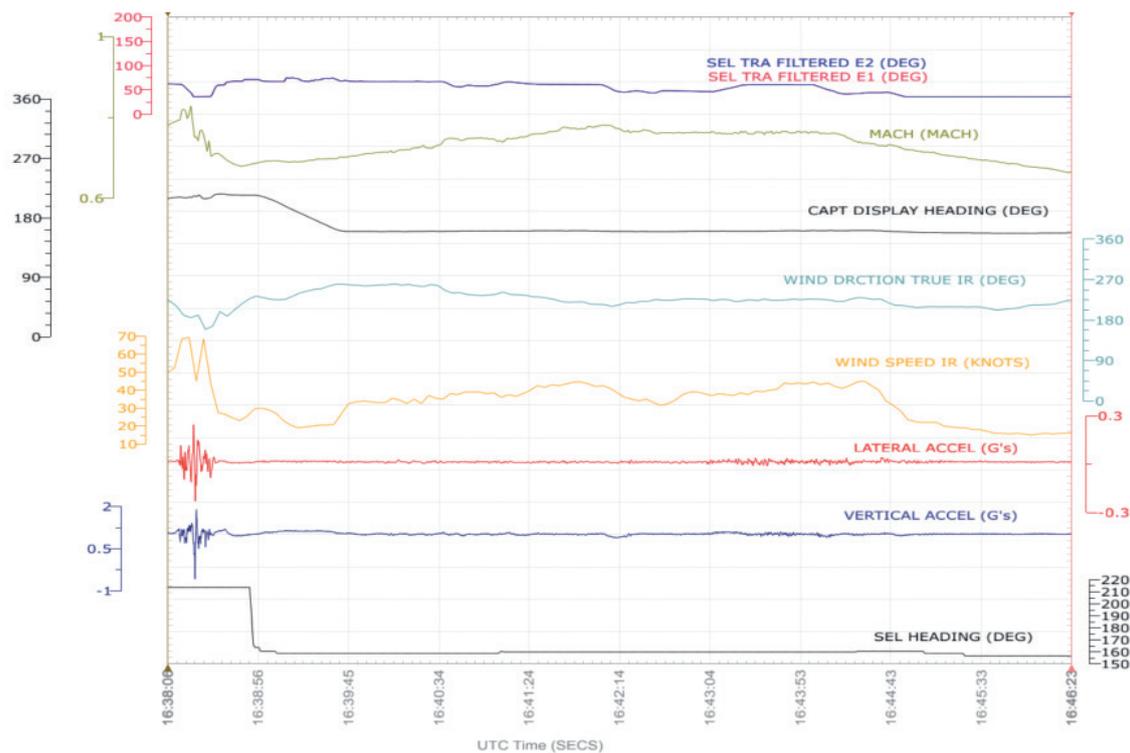
Figure 5. Graph of flight parameters recorded between 16:38:00 UTC and 16:46:23 UTC

As the graph clearly shows, the period of severe turbulence occurred during the aircraft's right turn. In fact, the turn continued after the period of intense acceleration, which took place at 16:38:40, ceased.

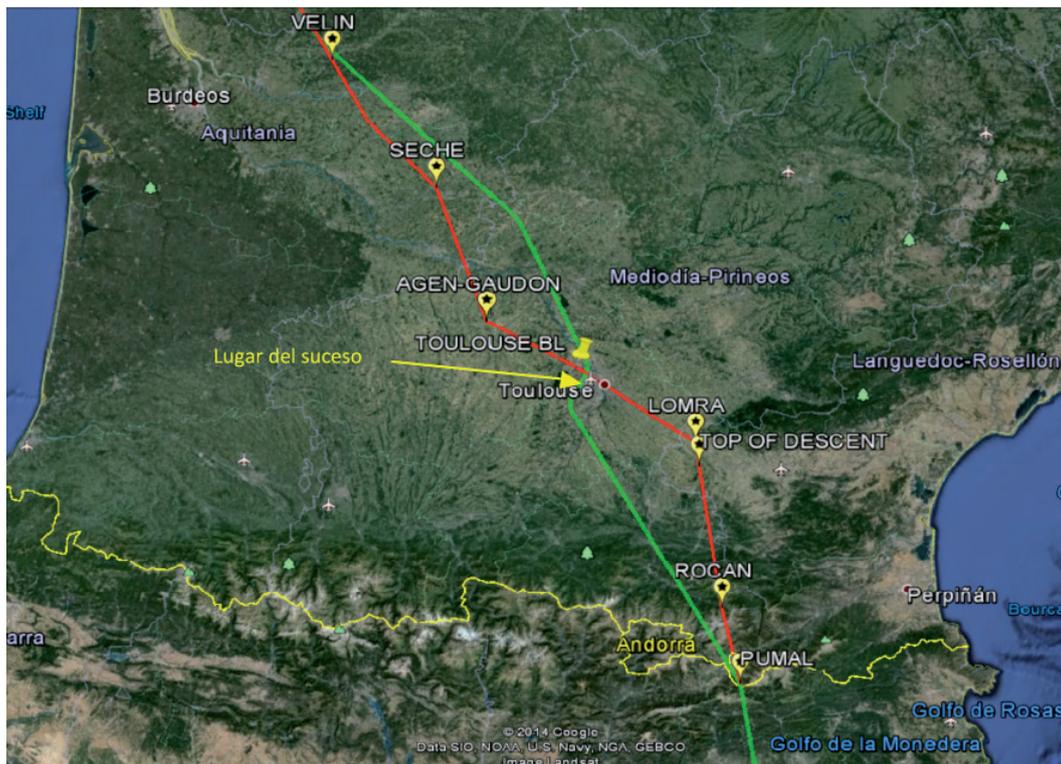
Figure 6. The flight path as per the operational flight path is shown in red and the actual path taken in green
