**DATA SUMMARY**

Date and time	<b>Sunday, 27 May 2012; 05:00 UTC<sup>1</sup></b>
Site	<b>Barcelona-El Prat Airport (LEBL) (Spain)</b>

Registration	<b>F-GJVG</b>	<b>EI-EBN</b>
Type and model	<b>AIRBUS A320</b>	<b>BOEING B737-800</b>
Operator	<b>Air France</b>	<b>Ryanair</b>

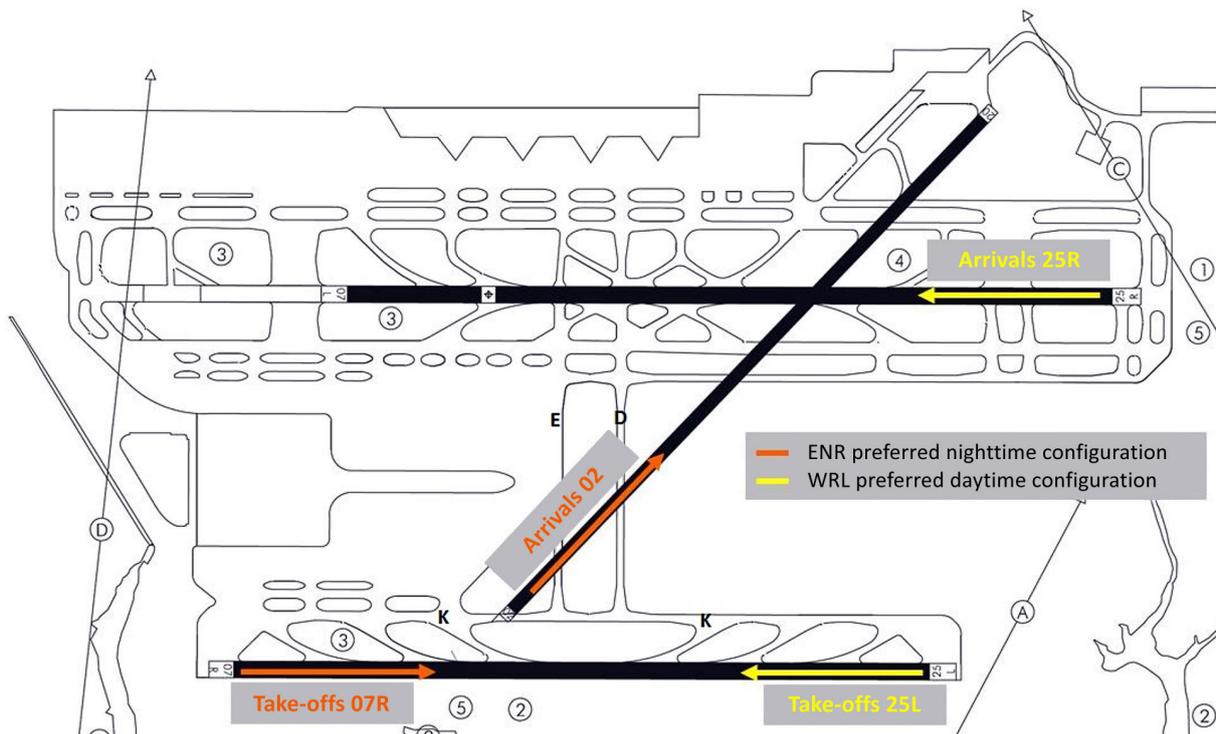
Figure 1. ENR and WRL configurations at LEBL

<sup>2</sup> As shown in the AIP, the preferred nighttime configuration (from 23:00 to 07:00 local time) is the so-called ENR (runway 02 used for landings and runway 07R used for takeoffs), while the preferred daytime configuration is referred to as WRL (runway 25R used for landings and runway 25L used for takeoffs). See figure 1.

The Barcelona/El Prat Airport has three asphalt runways, two of them parallel (07L/25R and 07R/25L), and a runway in a 02/20 orientation that crosses runway 07L/25R. Runway 02/20 is also crossed by mutually parallel taxiways D and E and by taxiway K, which runs parallel to runway 07R/25L (Figure 1).

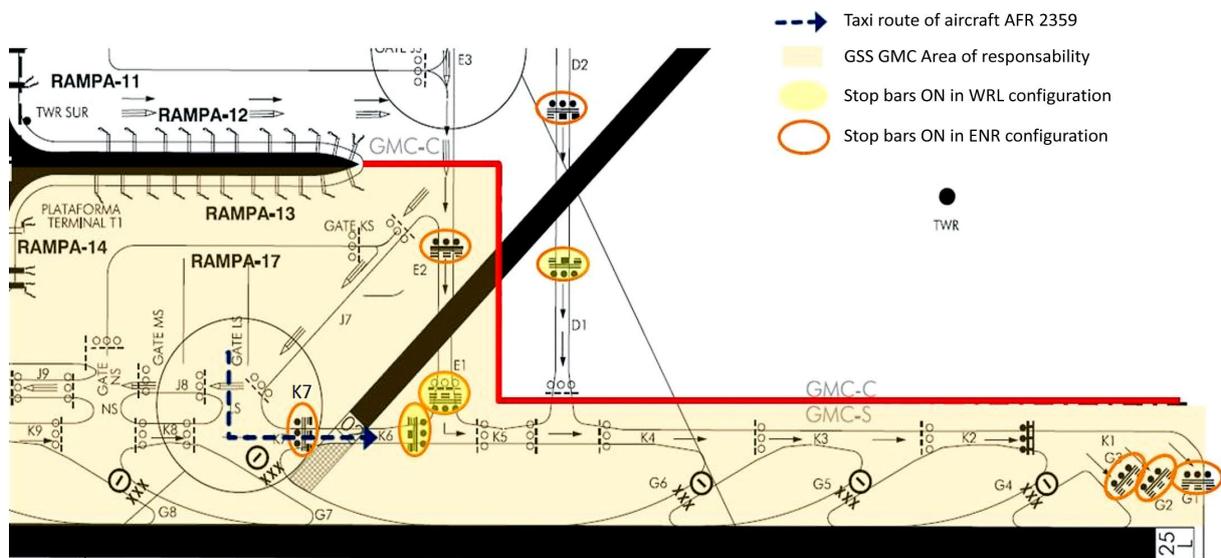
Figure 2. Taxi route of aircraft AFR2349

<sup>3</sup> Every operational configuration at the Barcelona Airport features four mutually independent areas of taxi responsibility. The SS controller (GSS) is responsible for ground movements in the area furthest south and controls traffic entering and exiting runway 25L/07R, as well as ramp movements south of Terminal 1 (Figure 2).

The recording of the communications between the SS controller and aircraft AFR2349 did not reveal any mention of the stop bar situated on taxiway K7, which protects the intersection of the taxiway and runway 02 (Figure 2).
