Technical report

IN-044/2020

Incident involving a Boeing 737-800 aircraft, registration EI-EBC, and a Beechcraft B200 aircraft, registration EC-MUP on 23 October 2020 at Málaga Airport

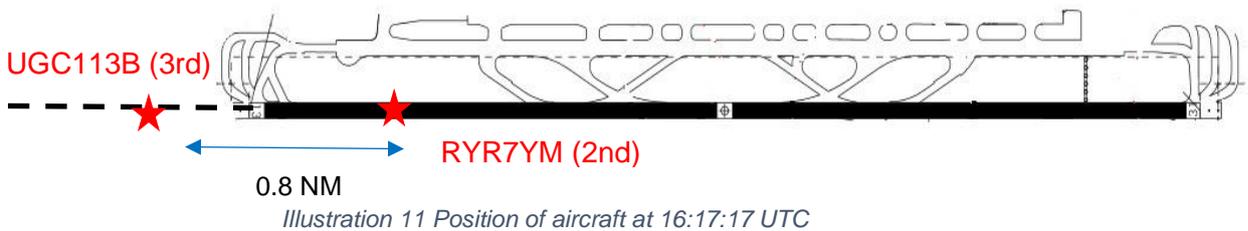
At 16:17:17 UTC, the trace shows aircraft RYR7YM on take-off run at a speed of 90 kt and aircraft UGC113B on short final proceeding at a speed of 130 kt. This was the point of minimum separation between the aircraft, it being 0.8 NM.

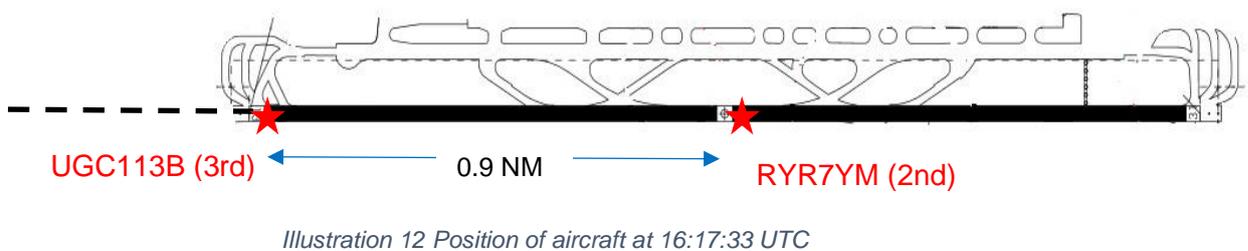
At 16:17:33 UTC, the trace shows aircraft RYR7YM on take-off run at a speed of 140 kt and aircraft UGC113B overflying the threshold of runway 13 at 300 ft AMSL and at a speed of 120 kt. At this point, the horizontal separation between the aircraft was 0.9 NM.

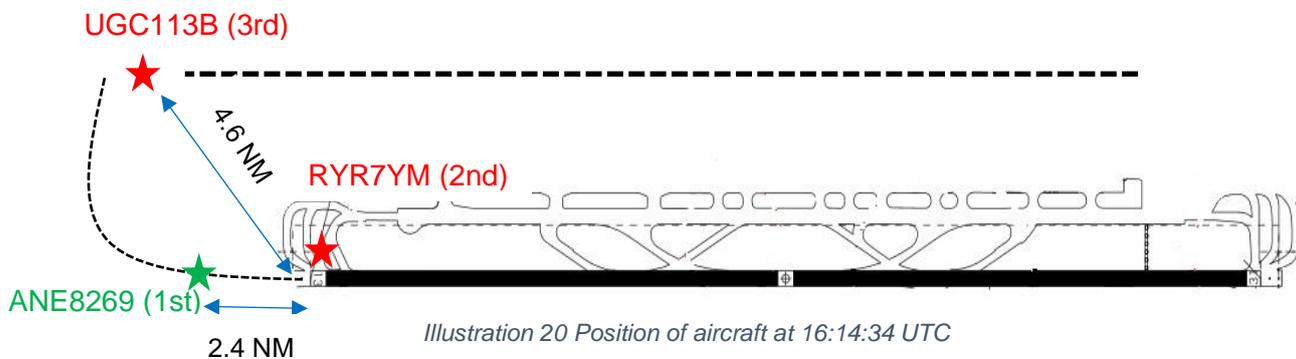
Illustration 20 Position of aircraft at 16:14:34 UTC

The LCL position controller planned to take advantage of the gap between two visual approaches to clear the take-off of the EI-EBC aircraft with callsign RYR7YM. The following figure shows the relative positions of the aircraft at 16:14:34 UTC, when the air traffic controller instructed the second aircraft in the sequence, RYR7YM, to line up and hold on runway 13 behind the traffic on final. At that moment, the first aircraft in the sequence was 2.4 NM from the threshold of runway 13 on final, and the third aircraft in the sequence was completing the downwind leg of the visual approach.

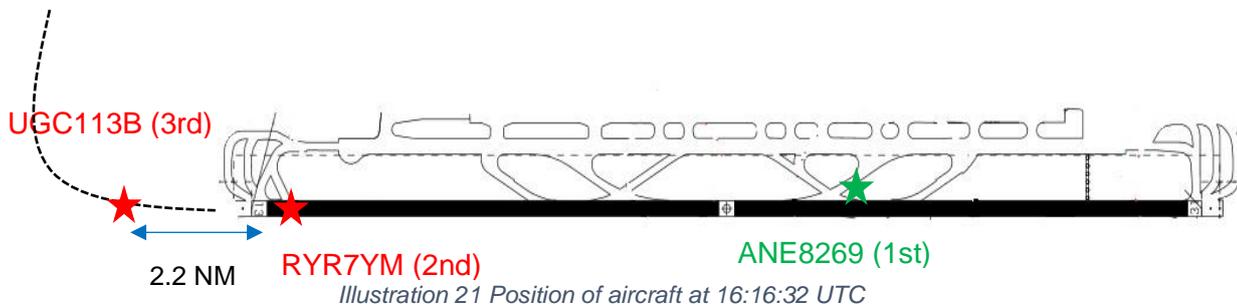
At 16:16:32 UTC, the air traffic controller cleared aircraft RYR7YM for take-off when aircraft UGC113B was on final, 2.2 NM from the runway threshold. The departing aircraft started the take-off run (at a speed of 20 kt) 23 seconds after acknowledging the clearance. Given the time required to select take-off power and the time it takes for the aircraft to begin to move, we have concluded that the crew did not take an excessive amount of time to begin the take-off run.

The following factors are considered to have played a decisive role in reducing the separation between the aircraft:

- The air traffic controller's plan to take advantage of a gap between two aircraft on visual approach to clear the take-off of another aircraft, while the last approaching aircraft was 4.6 NM from the threshold, completing the downwind leg.
- The air traffic controller's conditional instruction to align the aircraft on take-off when the first approaching aircraft was 2.4 NM from the runway threshold.
- The air traffic controller's decision to take-off an aircraft lined up on the runway when the aircraft on approach was 2.2 NM away.

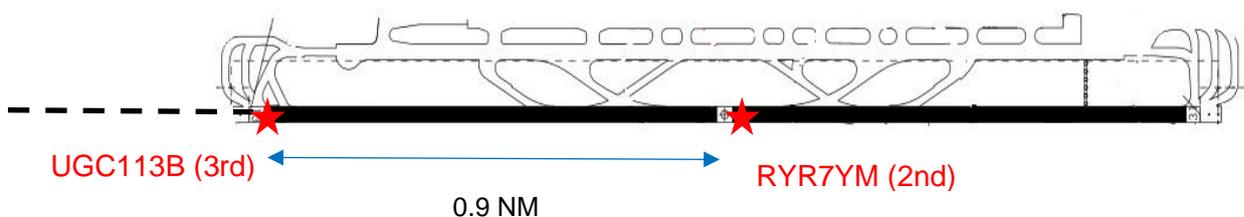
Illustration 22 Position of aircraft at 16:17:34 UTC

At 16:17:34 UTC, the air traffic controller cleared aircraft EC- MUP with callsign UGC113B to land as it passed over the threshold of runway 13 at 300 ft AMSL. The RYR7YM aircraft on take-off was completing its rotation manoeuvre. The horizontal separation between the two aircraft was 0.9 NM.

The air traffic controller authorised the approaching aircraft to land when it was over the runway threshold, thereby allowing it to cross the threshold when the aircraft taking off was still on the runway initiating rotation, with no degree of assurance that regulatory separation could be maintained. The air traffic controller failed to anticipate the required separation between the aircraft.

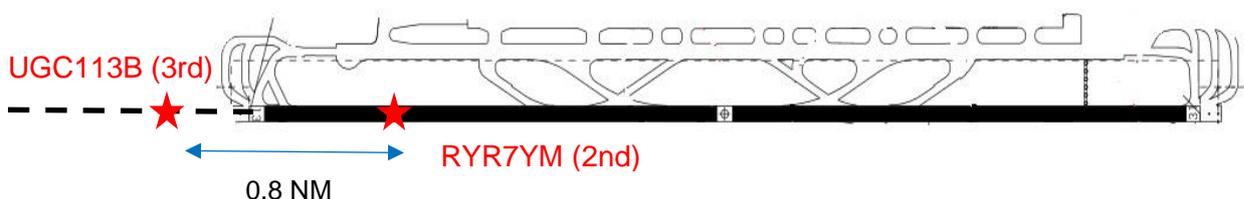
Illustration 24 Position of aircraft at 16:17:17 UTC

The moment of minimum separation between the aircraft occurred at 16:17:17 UTC when aircraft RYR7YM was on take-off run at a speed of 90 kt, and aircraft UGC113B was on short final at 130 kt. The horizontal separation between the aircraft was 0.8 NM.

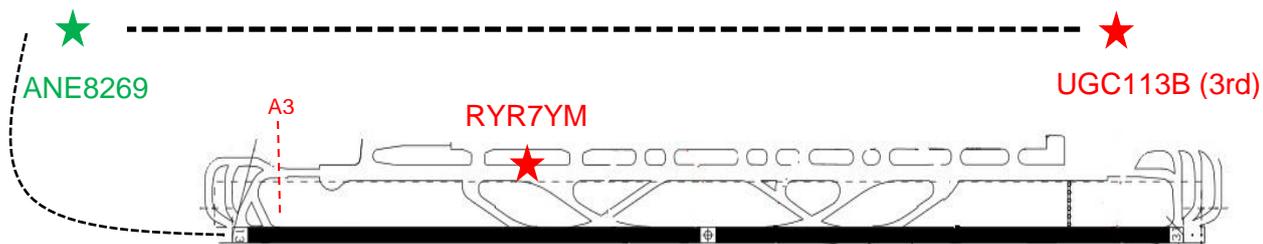
Illustration 25 Operational scenario of the incident

In the operational scenario that occurred in this incident, the radar trace shows three traffics in the sequence for runway 13:

- 1st aircraft [ANE8269] lands - not involved in the incident.
- 2nd aircraft [RYR7YM] taxis
- 3rd aircraft [UGC113B] lands
