TECHNICAL REPORT

A-022/2022

**Accident occurring on 26 April 2022
during disembarkation of a Boeing 737-
800 aircraft bearing the registration EI-
ENK, operated by RYANAIR, at Almería
Airport (Spain)**

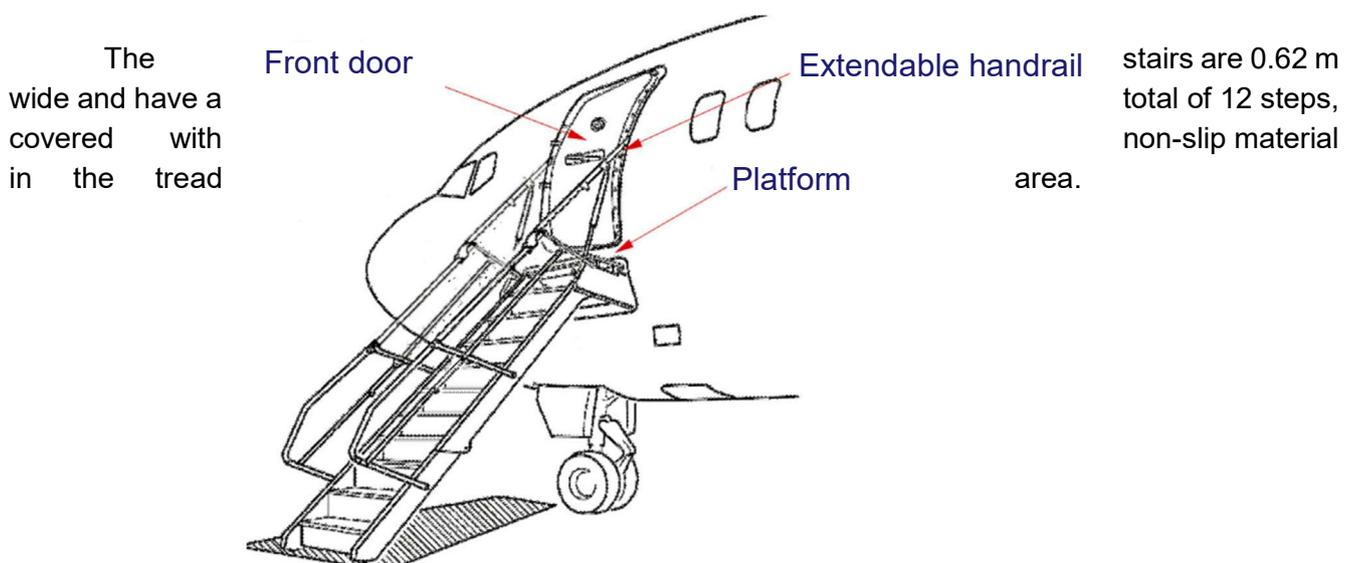
According to the information provided by BOEING, the retractable stairs built into the front of the aircraft are an option that was only included on the 737 NG and 737 MAX models. Ryanair was the first airline to incorporate these models into its fleet.

These types of stairs have narrower steps and thinner and lighter handrails than the external stairs that are normally provided by airport handling services³.

Figure 1. Extendable front stairs on the Boeing 737-8SA

In recent years, Ryanair has introduced the following safety measures to the built-in stairs on its BOEING 737-8SA aircraft, in order to reduce the risk of passengers falling.

1. The steps are covered with a non-slip material: specifically, 3M Safety Walk 710 - Coarse⁴ and 3M Safety Walk 610 - General Use⁵.
2. In June 2010, retractable, high-visibility safety barriers were installed in the lower part of the forward bulkhead and the lower part of the side wall of the cabin.
3. In December 2010, the built-in stairs were fitted with detachable rails, which serve as an additional visual aid for the handrails on the stairs. They are installed during boarding and disembarkation via the front door; the ends of the rail are attached to the support strut, which is located on the cabin floor by the doorway, and to the stairs themselves.
4. The aircraft involved in this accident had been fitted with warning signs as per Special Airworthiness Information Bulletin (SAIB) NM-07-47⁶, issued by the FAA in September 2007.

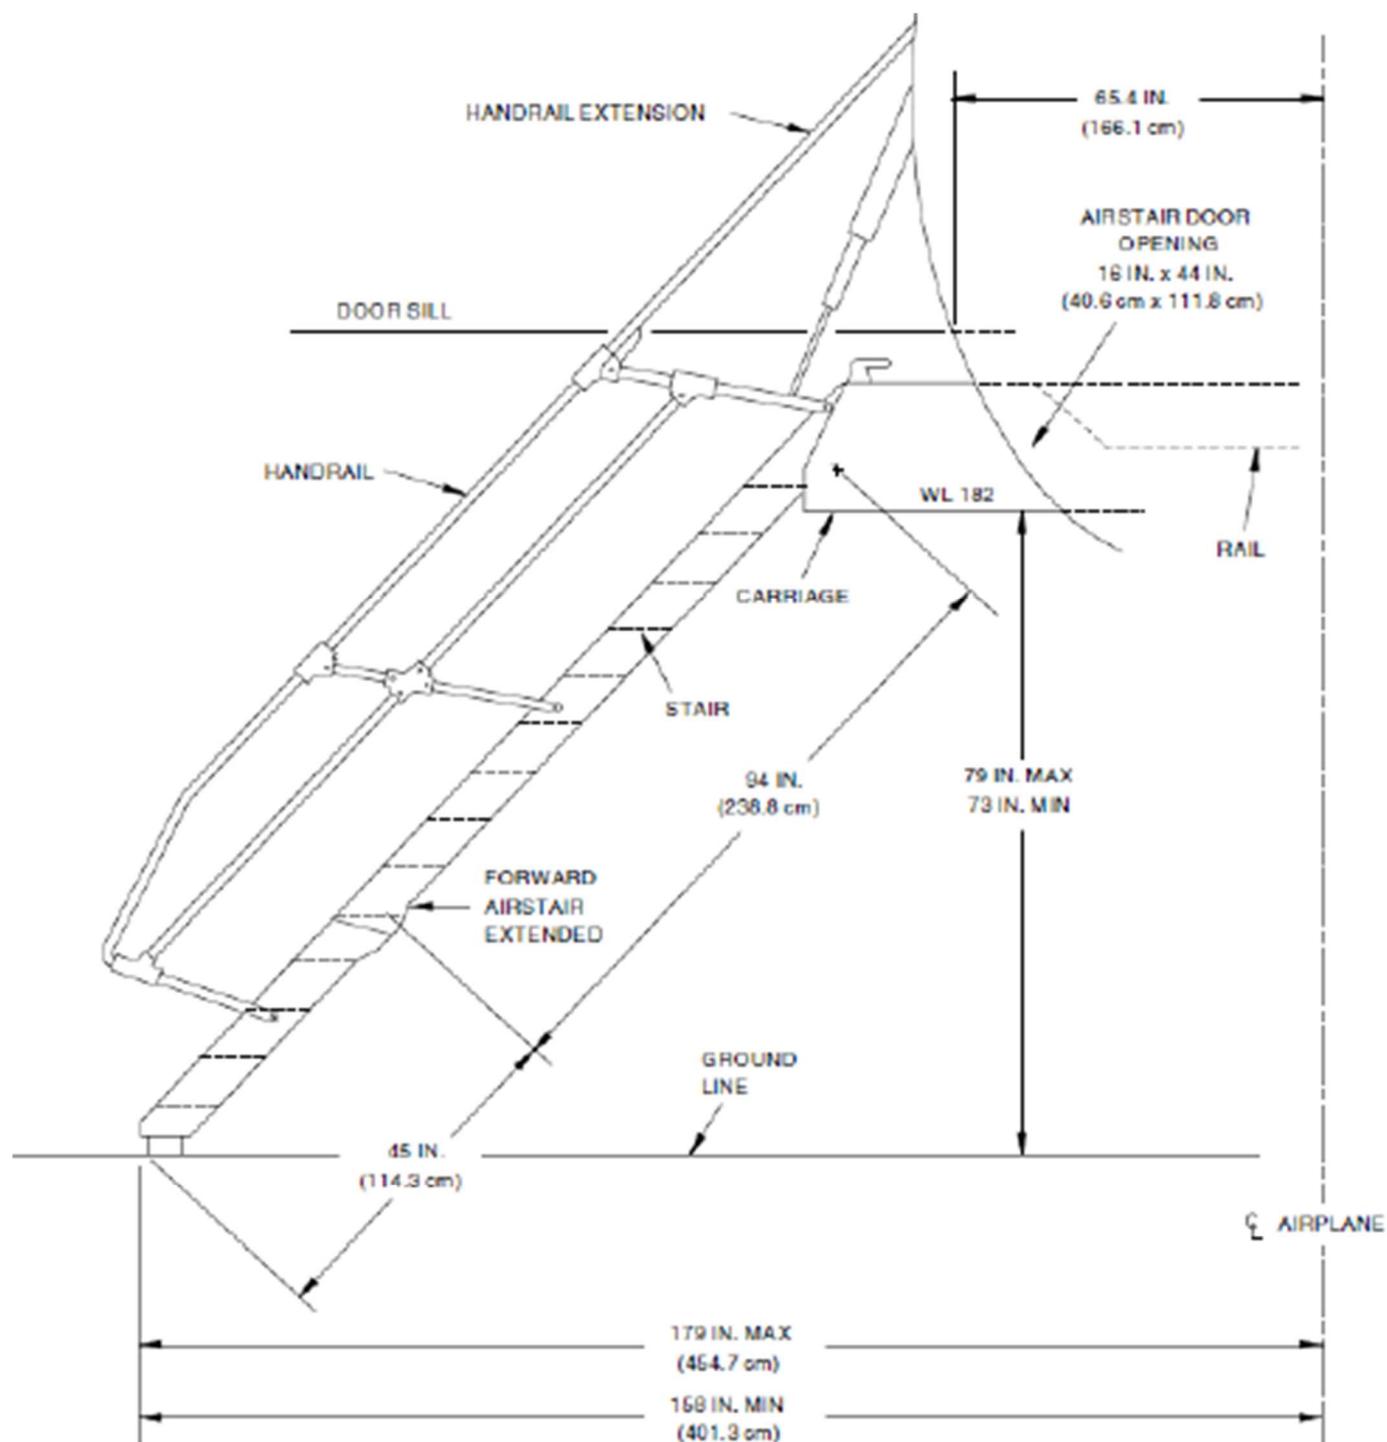
The dimensions of the stairs are defined in the BOEING document titled "Airplane Characteristics for Airport Planning". The height of the stairs can vary, ranging from 1.85 m to 2 m, with a length of 3.53 m. Consequently, the gradient of the slope ranges from 62% to 69%, respectively.

Figure 2. Dimensions of the extendable front stairs on the Boeing 737-8SA
