Investigation Report

Type of Occurrence:	Serious incident
Date:	25 April 2013
Location:	Near Regional Airport Frankfurt-Hahn
Aircraft:	1. Transport aircraft 2. Powered glider
Manufacturer / Model:	1. Boeing Company / B737-800 2. Alexander Schleicher GmbH & Co / ASH 25 Mi
Injuries to Persons:	None
Damage:	None
Other Damage:	None
State File Number:	BFU EX005-13

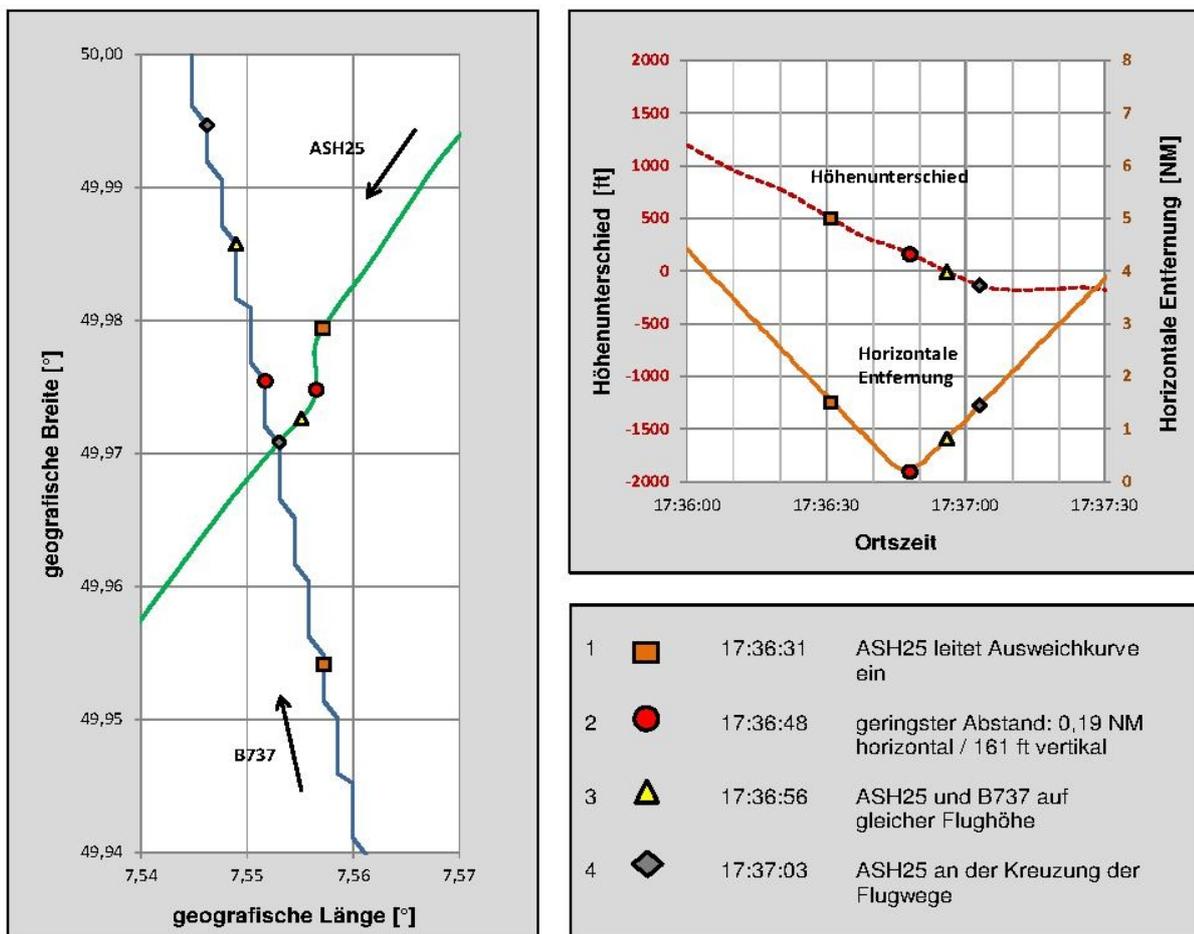
The read-out of the Quick Access Recorder (QAR) and the GPS device of the powered glider showed that the two aircraft passed each other in a distance of 0.19 NM and at an altitude difference of 161 ft.

Image 1: Flight paths of the Boeing B737-800 and the powered glider

After about one minute the Boeing B737 had been approximately 150 m beside and about 50 m above the ASH 25 (see Image 1, at: 1736:48 hrs). Only at the last moment, while the two aircraft were passing each other, the Boeing B737 co-pilot had turned his head to the right.

After the two aircraft had passed each other, the powered glider returned to its original course. The powered glider crossed the flight path of the Boeing 19 seconds after the B737-800 had been at that particular point and about 300 ft below its original altitude (see Image 1, at: 1737:03 hrs). Depending on the atmospheric situation and the profile of the aircraft, the wake vortexes it generates descend with a rate of 300-800 ft/min. The powered glider was in immediate proximity to the wake vortex of the Boeing B737-800. Had the powered glider flown into it, the worst case scenario would have been a crash.

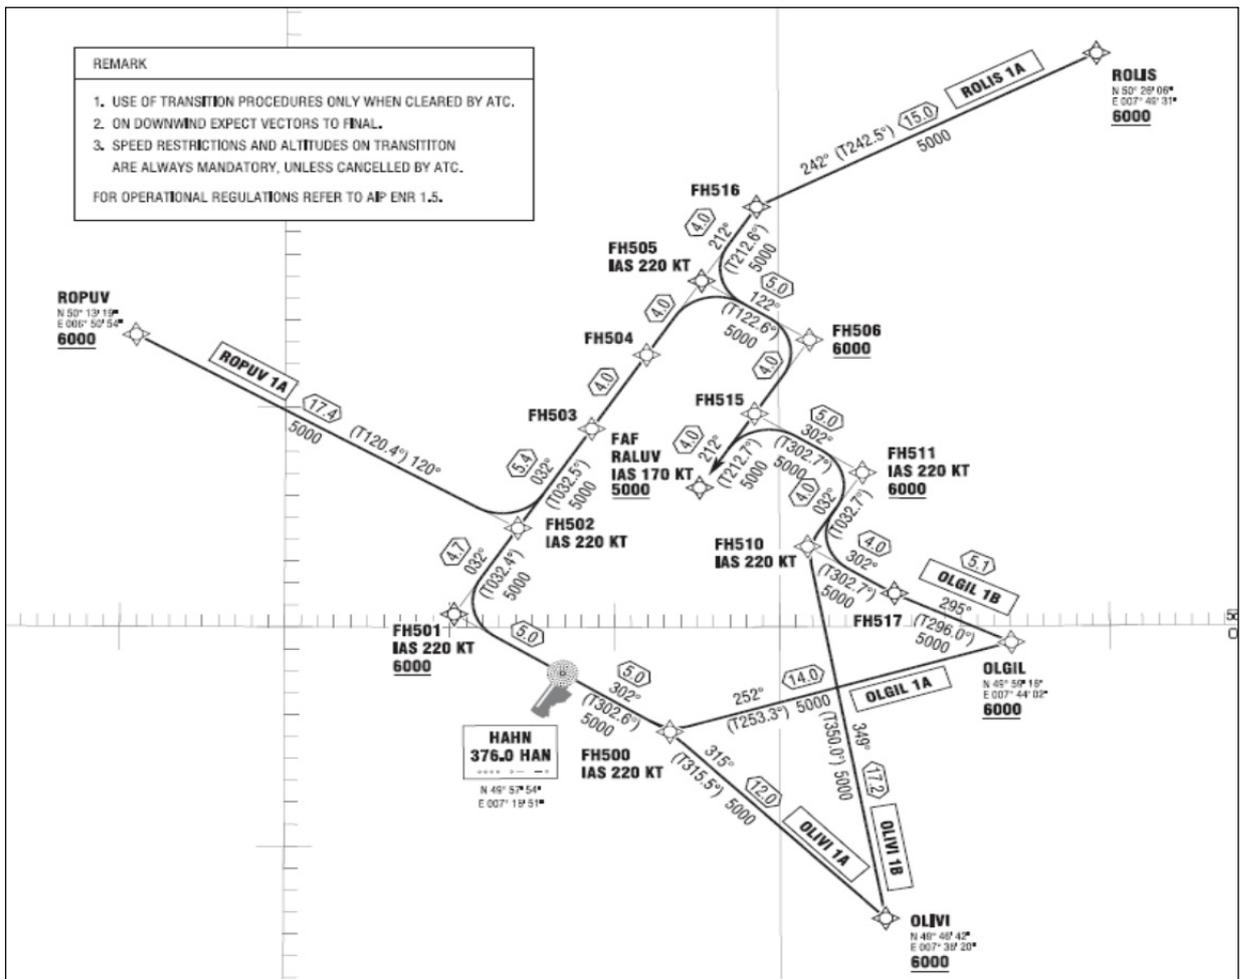
At 1733:04 hrs the controller issued descent clearance to 5,000 ft AMSL with the words: “[...] descend altitude 5,000 feet, QNH 1,021.” At that time the Boeing B737-800 was cleared for transition OLIVI 1B (see Image 2).

Image 2: GPS/FMS RNAV Arrival Chart Transition to Final Approach (Overlay to Radar Vector Pattern) RWY 21
