# **Final Report of the Aircraft Accident Investigation Bureau**

to the Saab 340B aircraft, registration HB-AKK

of Crossair flight CRX 498

on 10 January 2000

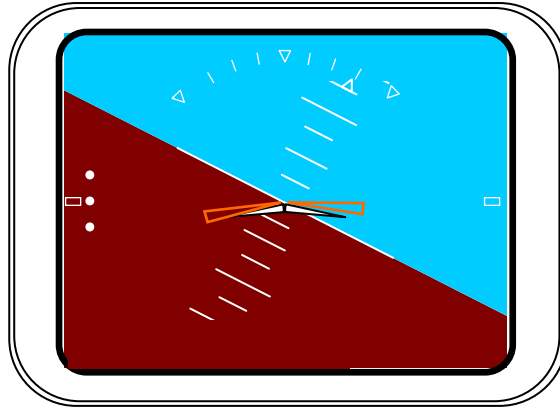
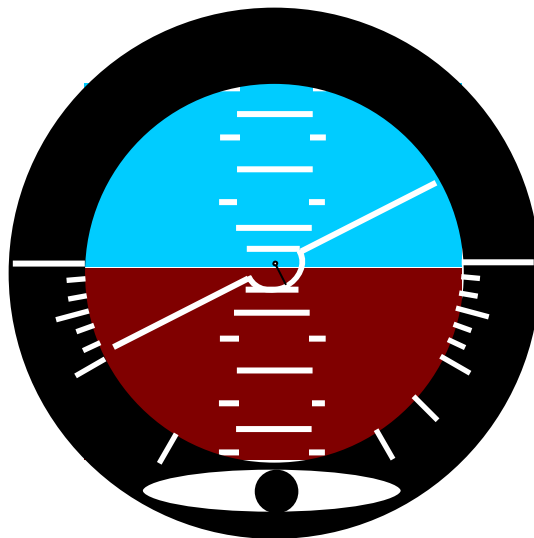
In addition to the inverse representation of roll, mention should also be made of the decoupled representation of roll and pitch in the Russian instrument compared with the combined representation in the western type.

In Russia, the risk of confusion when interpreting the artificial horizon display and when reading off the roll angle is well known since the introduction of the western type horizon on a number of aircraft types (TU-154, all western types). Several accidents have been caused by this.

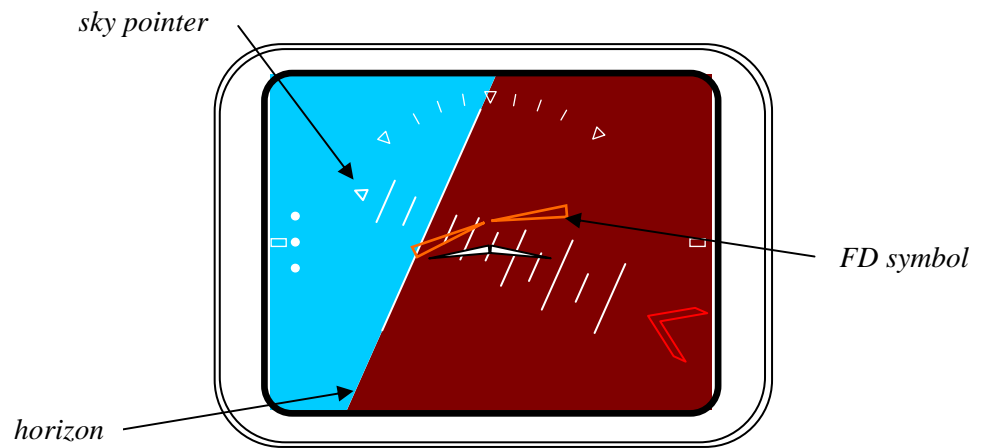
The EADI display was now already difficult to interpret. The combined representation of two parameters (bank attitude and pitch) made it essential to perform mental extrication. This applies especially in comparison with the Russian-type horizon with a decoupled representation where attitude and pitch can always be read independently of each other. The bank angle was shown in the angle of the horizon line (blue-brown dividing line) of the EADI compared with the instrument case. With the dominant display of the brown element and the slipping of the horizon line to the top left corner, this became increasingly difficult. The sky pointer had exceeded the scaling limit at 60° bank angle. The pitch display was now no longer represented as the position of the horizon line in vertical reference to the neutral line of the instrument. With vertical bank, for instance, a change in pitch caused a lateral movement of the horizon line.

Illustration: representation of the EADI with FD symbol for a right bank angle of  $65^\circ$  and a pitch of  $15^\circ$  AND

It is conceivable that in this period the commander's confusion about the current attitude dominated his perceptions and that he was having trouble interpreting the EADI display at all and reconciling it with his mental picture of flight path and attitude. Once again, an enhanced effect due to the medication cannot be excluded.

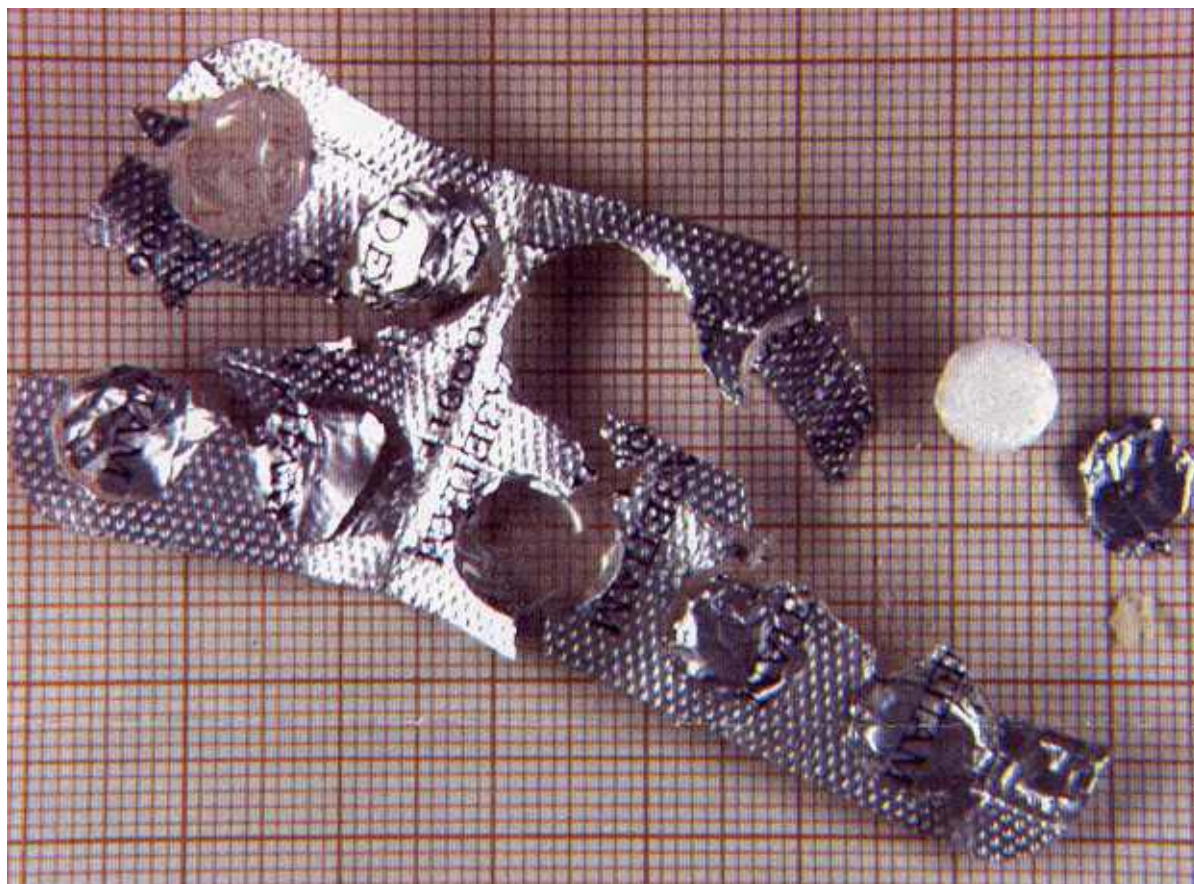
## Annex 4

Pack of Phenazepam, found in the commander's crew bag

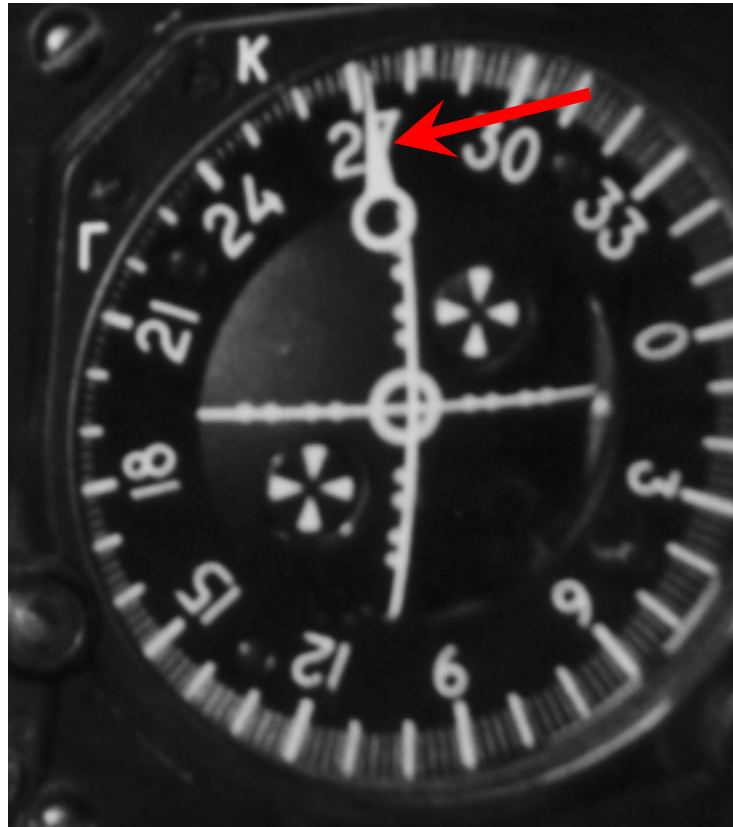
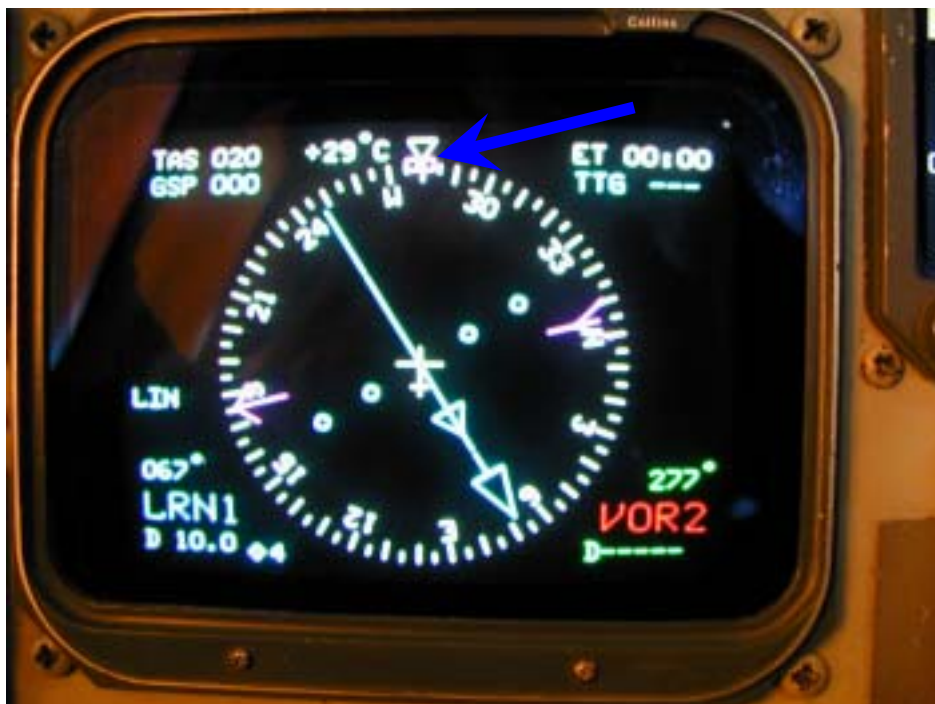
## Annex 6

Gyro compass of russian design (above) in comparison with the EHSI of the SF-340 B (below). The pointer (red arrow) rotates with respect to the fixed scale, whereas on instruments of western type, the heading bug (blue arrow) is fixed with respect to the rotating compass card.

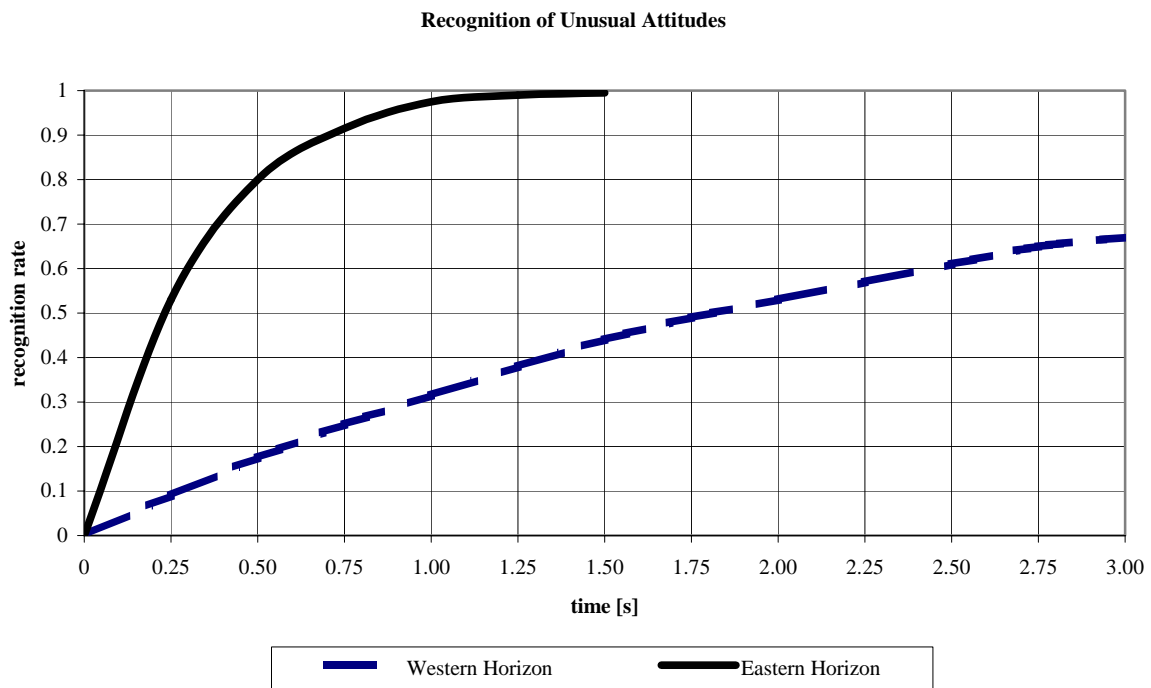
## Annex 7

The diagram below shows the results of a study which registered the time needed by pilots trained on eastern horizons to detect an attitude with certainty. The rigid curve represents the situation in which eastern horizons were used, the dotted curve represents the one, when artificial horizons of western make were used.

For instance after one second, 98% of pilots were able to interpret the attitude, if it was represented by eastern horizons. But only 32% of the same pilots could reliably determine attitude after one second on western instruments.
