FINAL REPORT

AAIU Synoptic Report No: 2009-026

Aircraft Type and Registration:	Piper - PA 28-181 (ARCHER II), D-EAOB
No. and Type of Engines:	1 x Lycoming O-360-A4M
Aircraft Serial Number:	28-90082
Year of Manufacture:	1988
Date and Time (UTC):	11 March 2009 @ 08.50 hrs
Location:	Athboy Airfield (EIMH), Co. Meath
Type of Flight:	Private
Persons on Board:	Crew - 1 Passengers - 2
Injuries:	Crew - Nil Passengers - Nil
Nature of Damage:	Substantial
Commander's Licence:	PPL (A) issued by the Irish Aviation Authority
Commander's Details:	Male, aged 51 years
Commander's Flying Experience:	1,659 hours, of which approx 40 were on type
Notification Source:	Pilot and ATC Duty Manager, Shannon Airport
Information Source:	Pilot Report, AAIU field inspection

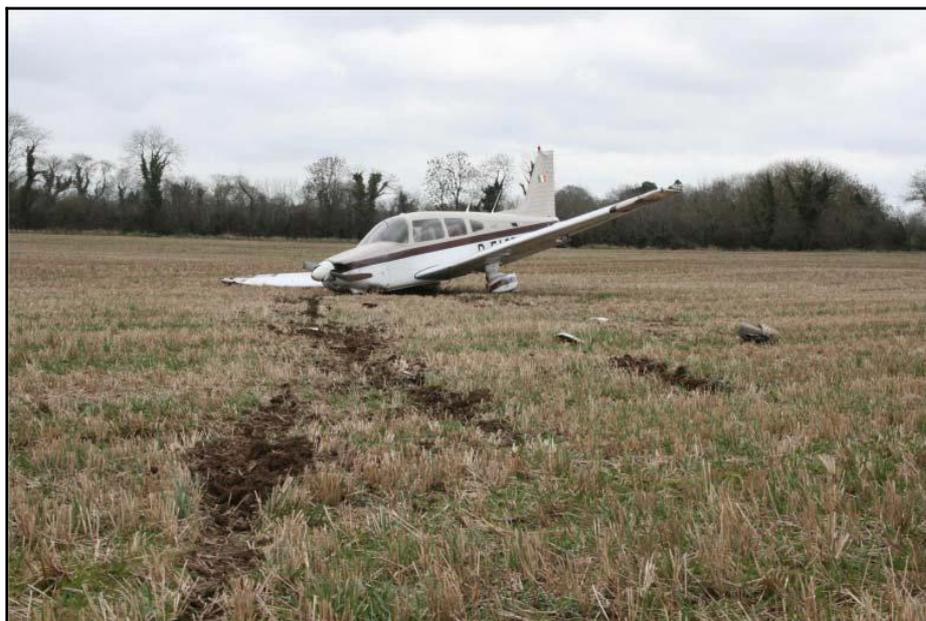
The Pilot instructed his passengers to brace for a sudden stop landing and he retarded the Power and Mixture controls. The aircraft made first ground contact 135 m beyond the Airfield boundary. The aircraft travelled another 30 m (approximately) fracturing its nose wheel before slewing anti-clockwise and coming to rest on a heading of 300° magnetic with the main starboard undercarriage collapsed towards the aircraft centreline (**Photo No. 1**). The Pilot selected master switch and fuel to off.

Photo No. 1: General disposition of the accident site

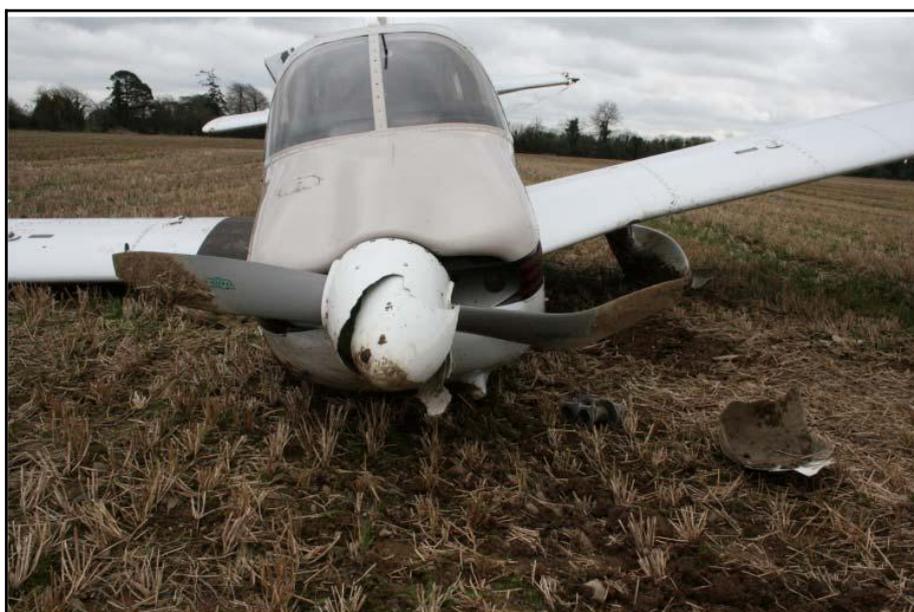
The propeller blade tips were folded back, damage which was consistent with the low power setting which the Pilot reported using for the forced landing (**Photo No. 2**). The port stabiliser had suffered significant damage from the impact with the boundary hedge (**Photo No. 3**). Vegetation found on the outboard tip of the port stabiliser was matched to the vegetation in the airfield boundary hedge.

Photo No. 2: Propeller damage consistent with low power setting

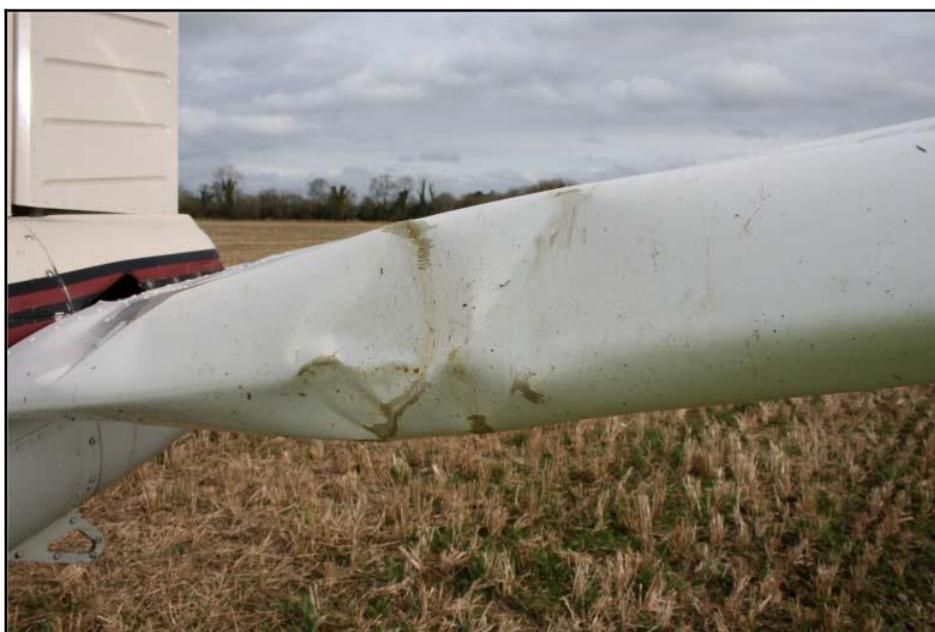
Photo No. 3: Port Stabiliser damage from boundary hedge impact

11. Once airborne the aircraft failed to climb and accelerate as the Pilot expected.
12. The aircraft's port stabiliser struck an airfield boundary hedge causing significant damage and mis-alignment of the aircraft's tail section.

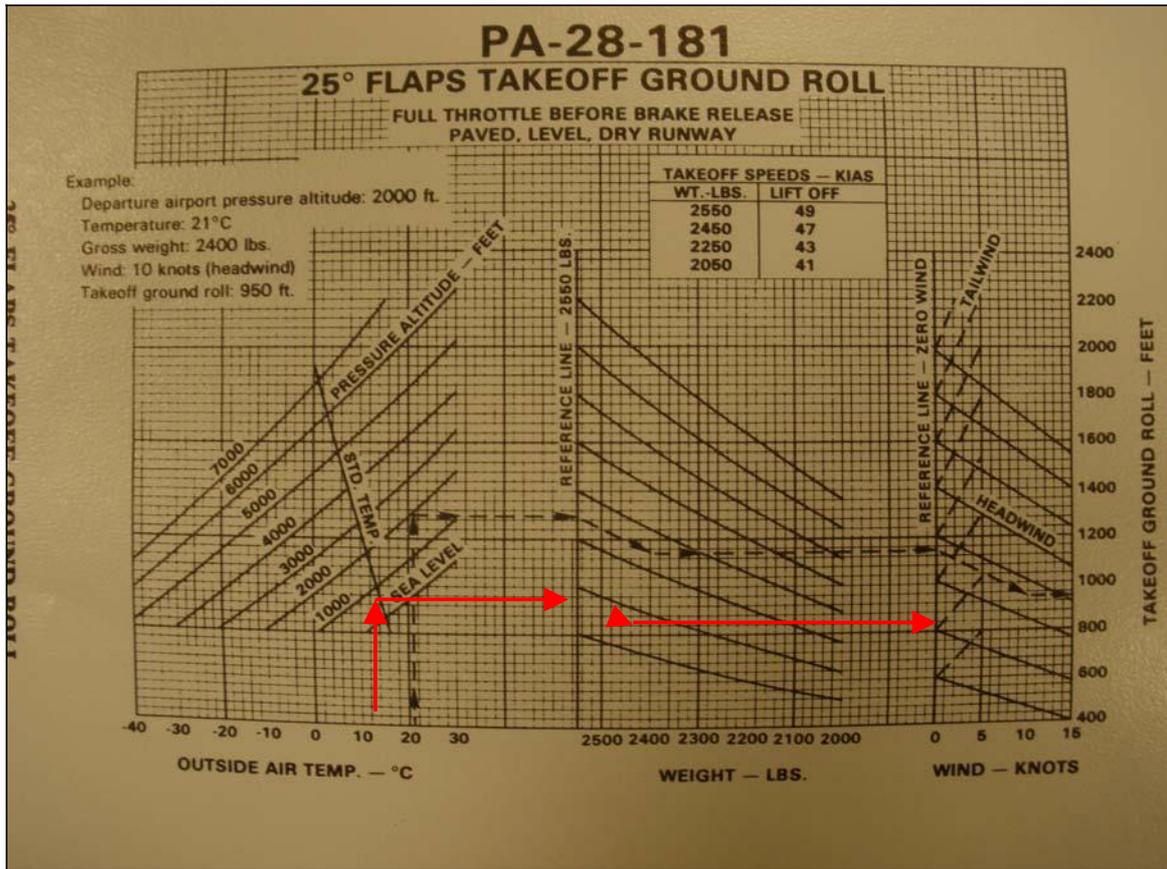
RWY 11 at EIMH has a slight downward slope but the “*SafetySense leaflet*” cautions “*Do not attempt to use the factors to reduce the distances required in the case of downslope on take-off*”. The parameters for D-EAOB were entered on the Ground Roll performance chart (**Figure No. 1**). The chart predicts that for a paved, level, dry runway, an 840 ft ground roll is required. Applying the CAA guidance documents combined safety factor of 2.16, this indicates a guidance distance of 1,814 ft, assuming that the aircraft lifts off at 47 KIAS.

Figure No. 1: Unfactored Ground Roll performance for accident aircraft.

The "*Ground Roll*" performance chart (**Figure No. 1**) predicts that on a paved, level, dry runway, an 840 ft ground roll is required. Applying the CAA guidance documents combined safety factor of 2.16, this indicates a ground roll of 1,814 ft, assuming that the aircraft will take-off at 47 KIAS. Given that the runway length is 1,650 feet take-off roll performance in this case was at best marginal, a situation which was exacerbated by the higher than recommended take-off airspeed and possibly a tail wind.
