## FINAL REPORT

**AAIU Synoptic Report No: 2009-025**

<b>Aircraft Type and Registration:</b>	Boeing 737-8AS, EI-DYD
<b>No. and Type of Engines:</b>	2 x CFM 56-7B26
<b>Aircraft Serial Number:</b>	33632
<b>Year of Manufacture:</b>	2008
<b>Date and Time (UTC):</b>	11 September 2008 @ 10.33 hrs
<b>Location:</b>	Dublin Airport, Co. Dublin
<b>Type of Flight:</b>	Public Transport
<b>Persons on Board:</b>	Crew – 6      Passengers – 148
<b>Injuries:</b>	Crew – Nil      Passengers – Nil
<b>Nature of Damage:</b>	Nil
<b>Commander's Licence:</b>	JAA Airline Transport Pilot Licence
<b>Commander's Details:</b>	Male, aged 41 years
<b>Commander's Flying Experience:</b>	10,114 hours, with 7,680 on type
<b>Notification Source:</b>	Airside Duty Manager, Dublin Airport
<b>Information Source:</b>	AAIU Field Investigation

### **SYNOPSIS**

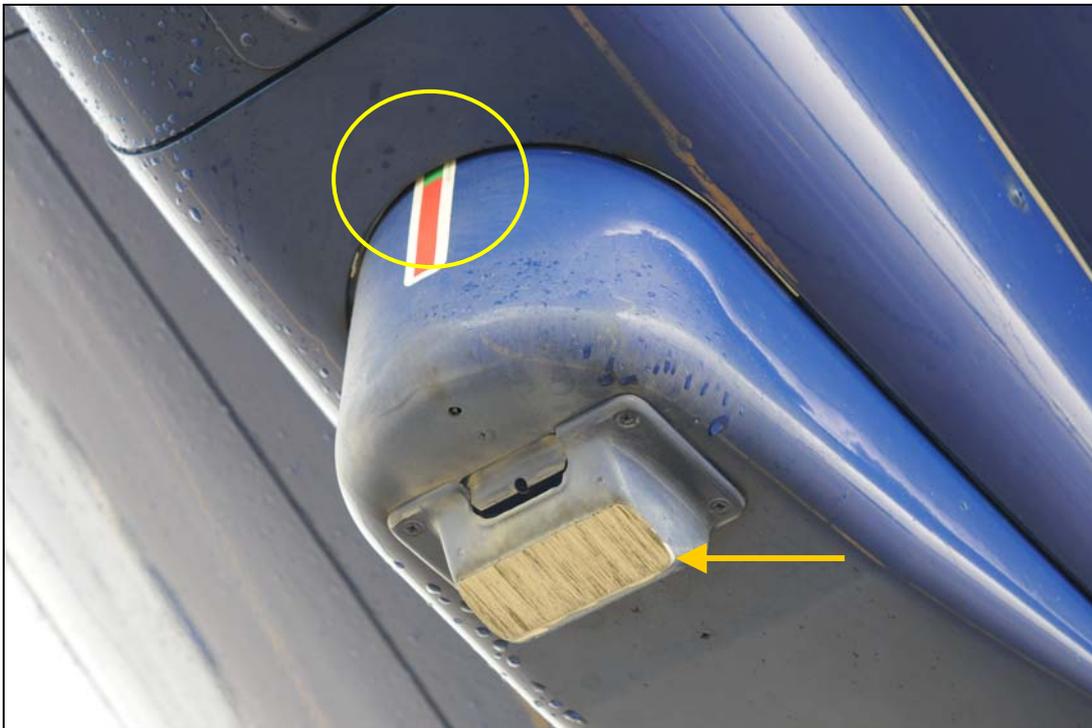
**Photo No. 1:** Tailskid Skirt Assembly as inspected by the AAIU.  
Note contact shoe scraping (indicated by arrow) and green decal visible.

The AAIU were informed of the occurrence by the Airside Duty Manager, Dublin Airport Authority (DAA) shortly after the aircraft landed and by the Operator. One Inspector of Air Accidents inspected the aircraft at Dublin Airport and interviewed the Flight Crew and Cabin Crew. External inspection of the aircraft revealed no damage to the underside of the fuselage, with superficial scoring of the tailstrike 'shoe' and the Tailskid indicator green band visible (**Photo No. 1**).

Regarding the tailstrike itself, the longer Boeing 737-800/900 series is more susceptible to tailstrikes than the shorter-fuselage versions. A tailstrike is not necessarily a serious event, in this particular case the tailstrike shoe contact was light enough for the indicator to remain in the green band. Inspection of the aircraft by the Investigation revealed only a light scoring of the tailskid 'shoe' with no damage to the underside of the aircraft.
