AAIU Report No. 2001/003

Aircraft Type and Registration:	B737-500 EI-CDH
No. and Type of Engines:	CFM 56 – 3B1
Aircraft Serial Number:	25739
Year of Manufacture:	1992
Date and Time (UTC):	12 May 1999, 05.20 hrs.
Location:	Stand 38, Dublin Airport
Type of Flight:	Public Transport
Persons on Board:	Pax 25 Crew 5
Injuries:	Pax Nil Crew Nil
Nature of Damage:	Damage to upper surface area port wing tip for a distance of approx. 3 ft in from the wing tip. Extensive damage to the underside of airbridge mechanism.
Commanders Licence:	ATPL
Commanders Age:	54 years
Commanders Flying Experience:	12000 hours, 4500 hours on type.
Information Source:	Duty Officer, Aer Rianta Dublin Airport. AAIU Field Investigation.

SYNOPSIS

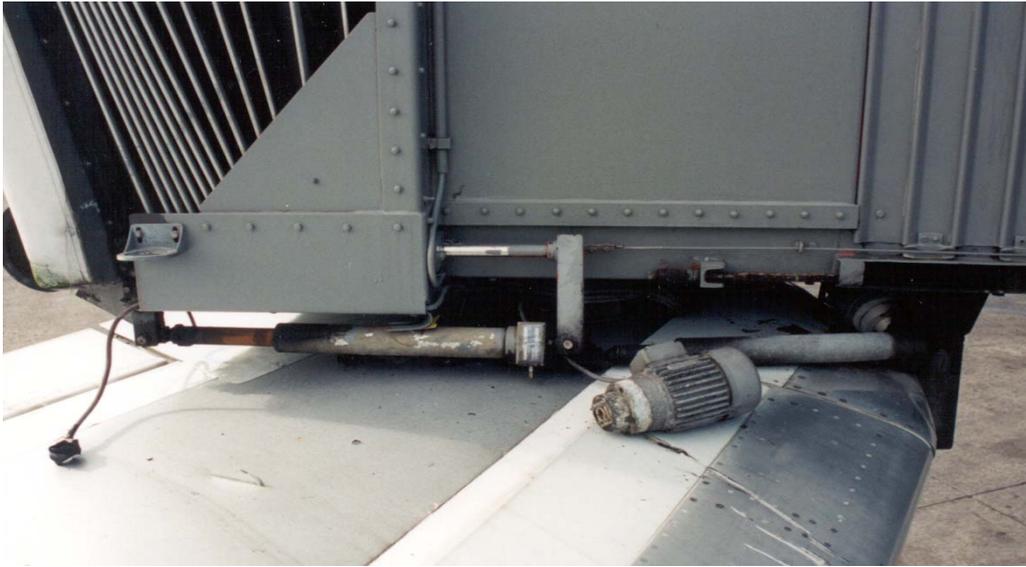
The port wing of the aircraft slipped under the airbridge platform (see Photo1). The top surface of the wing outboard of the ailerons was scored and damaged by the underhanging electrical mechanism of the airbridge. Considerable crushing of the top wing tip sheet metal was evident which would require repair/replacement. The nose wheel was offset about 15cm from the yellow taxiline centre as a result of the impact.

Photo.1 The port wing of EI-CDH following the aircraft's impact with the airbridge on Stand 38.

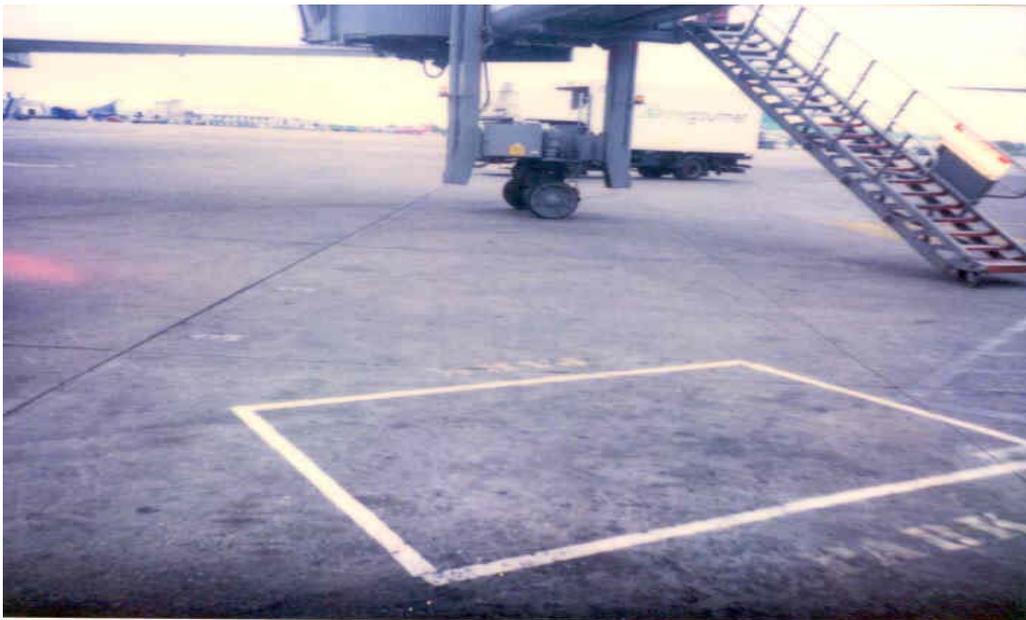
Just as the aircraft was being brought to a halt at the hammerhead, the upper surface area of the port wing, outboard of the aileron, collided with the underneath electrical mechanism of the airbridge. There were no injuries to passengers or crew and the aircraft's airstairs was used to allow the passengers to disembark. The Investigator-in-Charge noted on his arrival that the airbridge was 12.3 metres from its normal parked position.(see Photo 2)

On inspection the investigators found the airbridge bogey extended 12.3 metres from the "Park" position.

Photo.2 Position of airbridge relative to the PARK area.
