Air Accident Investigation Unit Ireland

INCIDENT REPORT
Tecnam P2002-JF, EI-WAT,
Inis Mór Airfield, Aran Islands,
Co Galway, Ireland
15 April 2010

AAIU Report No: 2011-012

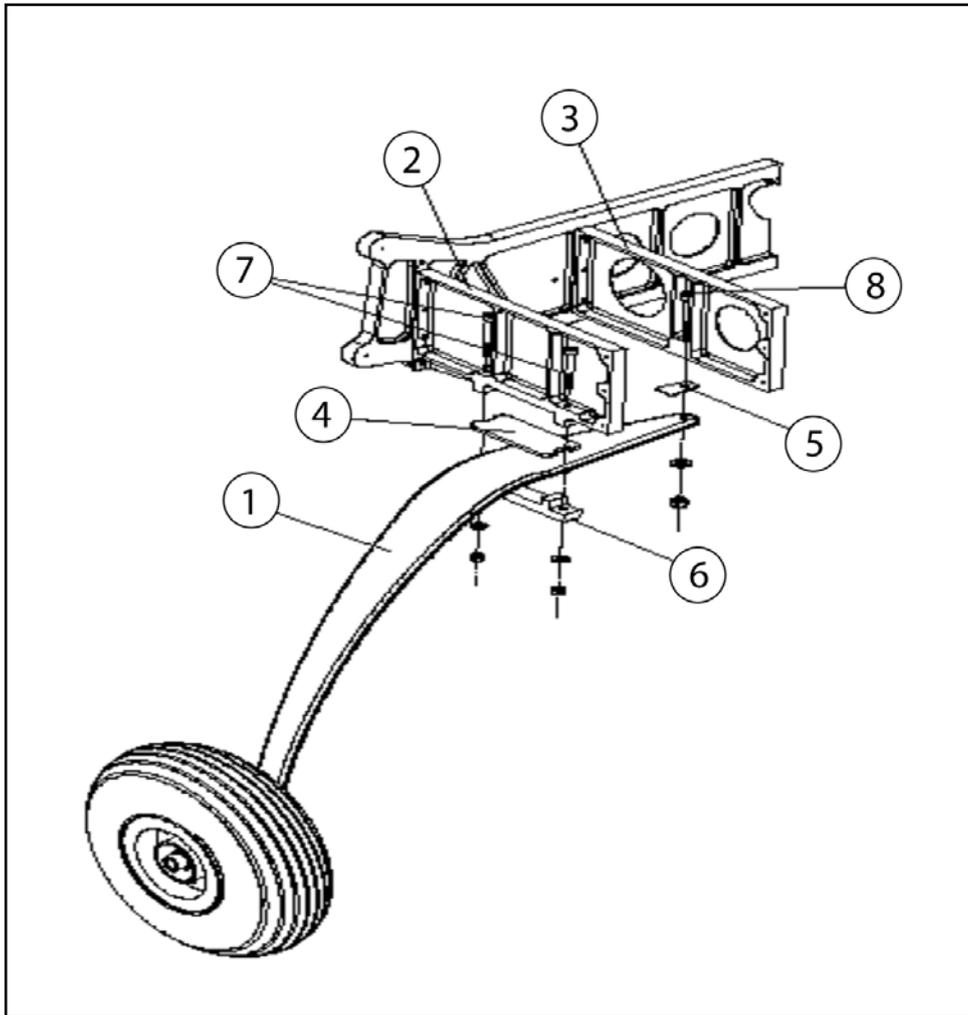
Figure No. 1: Main Landing Gear Assembly

A schematic diagram of one side of the main landing gear is shown in **Figure No. 1**. Each main landing gear consists of a steel spring-leaf strut (Item 1), which is connected to the fuselage utilising two longitudinally mounted structural members (2 and 3) described in the aircraft documentation as *"keelsons"*. Two spacers (4 and 5) are inserted between each spring-leaf strut and the keelsons, and the aircraft inner lower skin is between the keelson and the spacer (5). Two bolts (7) with torqued self-locking nuts secure the individual strut to the edge of the outer keelson via a light alloy tie (6) while a single bolt (8) with a torqued self-locking nut, with a deformed thread locking feature, secures the inboard end of the strut to the inner keelson (3).

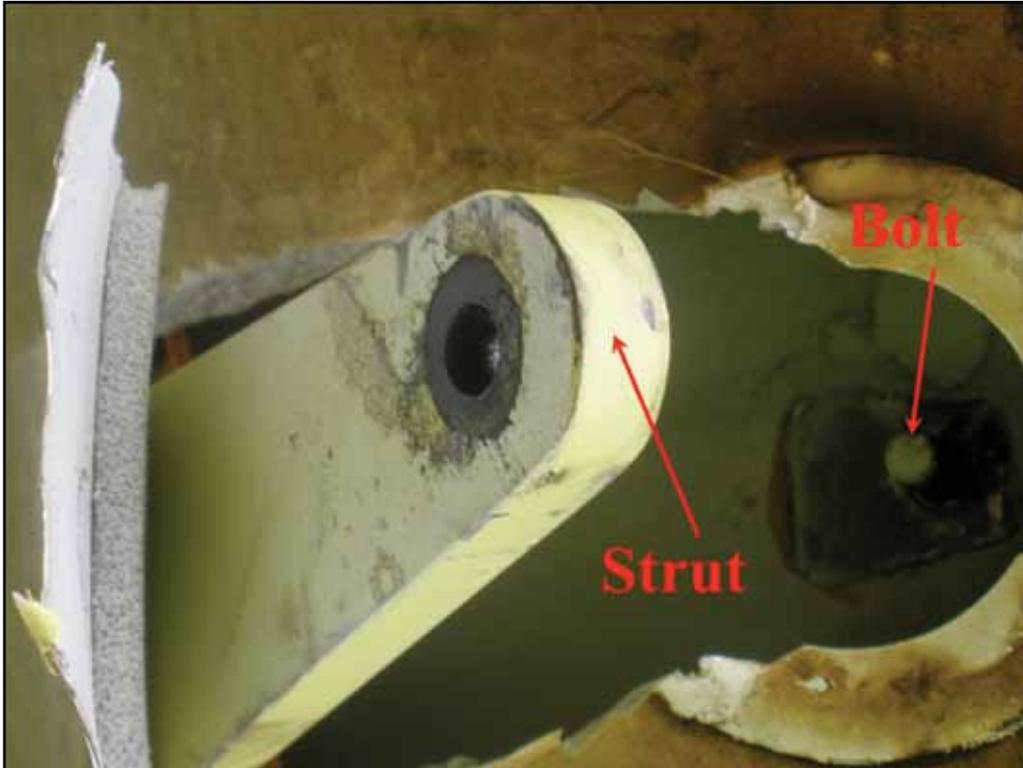
Photo No. 1: Damage to Fuselage Outer Lower Skin

The Investigation surveyed the aircraft on the day following the Incident. The inboard end of the left landing gear strut had dropped down off the securing bolt (Item 8 in **Figure No. 1**) and had punctured the fuselage outer lower skin, **Photo No. 1**. The inboard securing bolt was still in place. The self-locking nut was missing. The spacer (measuring 40 mm by 34 mm) and washer which had been found on the taxiway were confirmed as being the spacer identified as Item 5 in **Figure No. 1** and a washer from the inboard strut securing assembly. Part of the strut, just outboard of the outer keelson had come into contact with the lower surface of the port wing, which was pushed up and wrinkled.

A search back along the ground track over which the aircraft had travelled on the runway and taxiway was carried out and the missing self-locking nut was found on RWY 14 approximately 50 m before the taxiway turn-off. The threads on both the bolt and nut were intact, as was the nut deformed thread locking feature.

The inboard landing gear securing mechanism was reliant on the self-locking nut remaining in place on the bolt. As the threads on the bolt and nut had not been stripped, it is probable that the nut gradually unwound itself off the bolt over a period of time.

The separation of a self-locking nut from its bolt caused the port landing gear to partially collapse.

1. Costruzioni Aeronautiche Tecnam s.r.l. should consider the introduction of a modified locking arrangement at the inboard end of the landing gear struts. **(IRLD2011008)**
2. Costruzioni Aeronautiche Tecnam s.r.l. should instigate a review of manufacturing quality procedures, with particular emphasis on the eradication of defects such as the extraneous drilled hole identified in this Report. **(IRLD2011009)**

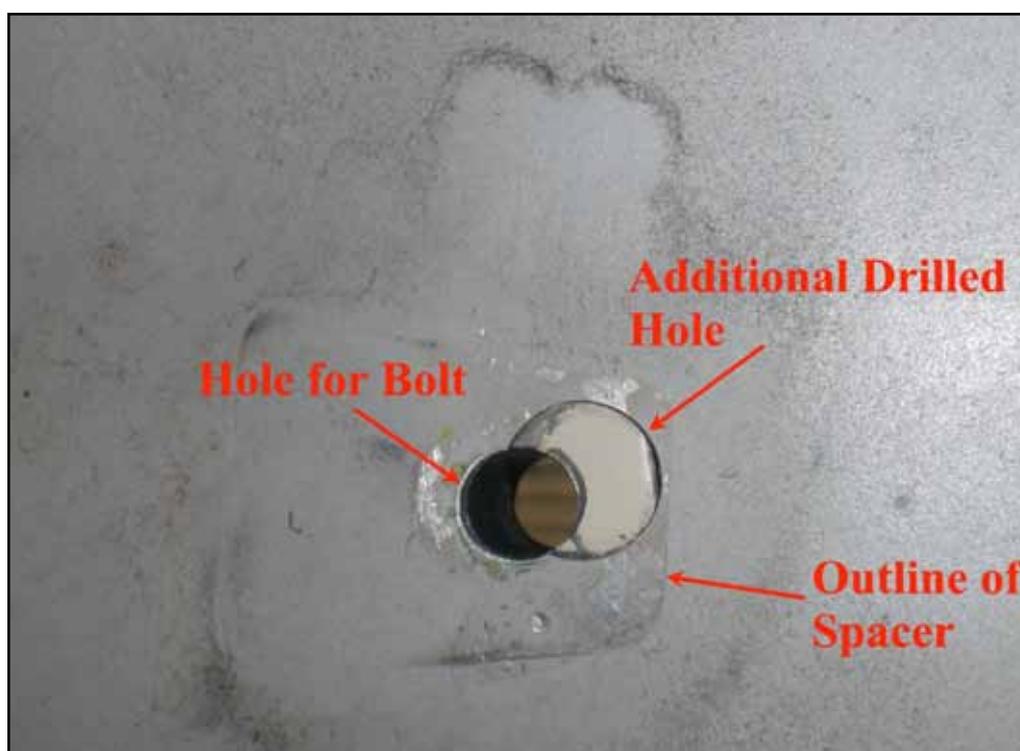
Photo No. 2: Drilled Holes in Skin

On inspection of the aircraft during its strip-down for repair, the Investigation noted that a hole, approximately 14 mm in diameter, had been drilled in the aircraft inner lower skin, overlapping the hole for the retaining bolt, **Photo No. 2**.

The keelson is visible through the 14 mm hole. Since the keelson is not drilled at this location, and since the landing gear had not been removed subsequent to the aircraft's delivery to Ireland, it is most probable that this hole was drilled in the skin during the aircraft's manufacture.

The outline of where the spacer had been is also visible in the photo. There were also some surface deformities visible on the aircraft skin in the area where the spacer was in contact with the skin.

It is possible that the extraneous 14 mm hole drilled in the aircraft skin allowed some flexing of the spacer, which was installed directly beneath the hole, **Photo No. 2**. Such flexing of the spacer may have facilitated a loss of tension in the bolt/nut threads. In turn, this may eventually have caused the self-locking nut to loosen and to finally come off the bolt, thus causing the landing gear to partially collapse on that side.

The Investigation was also concerned by the drilling of an extraneous hole in the aircraft's inner lower skin, apparently during manufacture. The presence of this hole suggests a lapse in quality oversight during the manufacturing process and accordingly a second Safety Recommendation is issued to the aircraft manufacturer.

7. The drilled hole in the aircraft's inner lower skin may have allowed some flexing of a spacer, which in turn may have facilitated a loss of tension in the bolt/nut threads.
