Air Accident Investigation Unit Ireland

ACCIDENT REPORT
Avid Mk. IV Flyer, EI-HAM
Leegane, Co. Wexford
3 October 2010

AAIU Report No: 2011-018

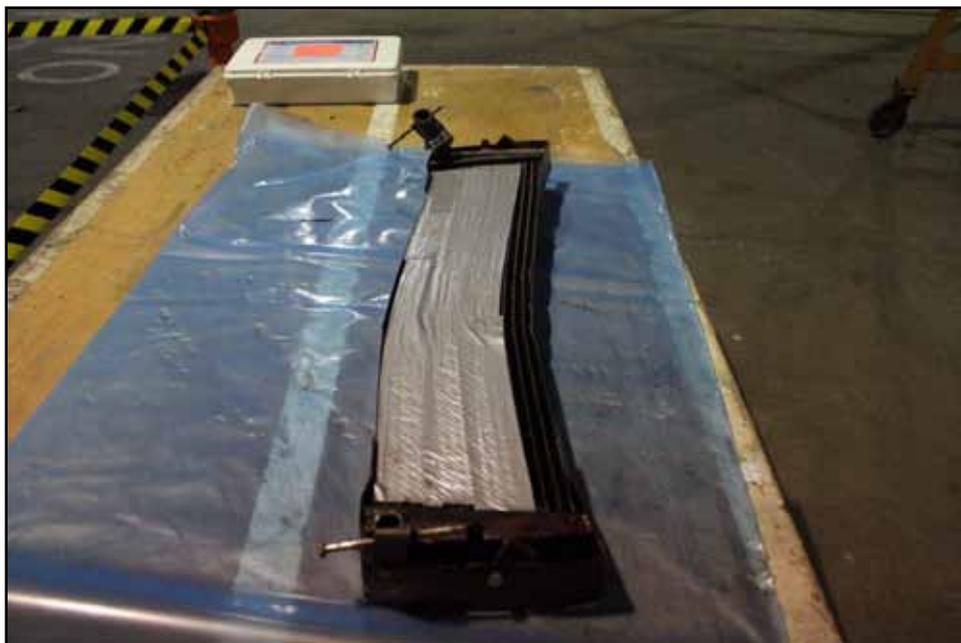
The cooling system pipework had fractured on the port side of the aircraft at the entry point to the radiator. The fracture was due to impact forces. A small amount of coolant remained in the radiator. The expansion bottle had detached from its support bracket and contained no coolant. The expansion bottle pressure vent cap, complete with the cap seat, was located under the right seat. The radiator and associated pipework had distorted due to impact. Approximately 80% of the upper radiator surface was covered by strips of grey duct tape (**Photo No. 1**).

Photo No. 1: Radiator showing the taped upper surface

Before the accident flight, approximately 80% of the upper radiator surface had been covered with duct tape, in an attempt to reduce air-flow through the radiator, reducing its cooling efficiency and raising the engine operating temperature.

The primary cause of the engine over-temperature condition was probably due to the taping over of a large portion of the radiator core, thus causing a significant reduction in the radiator's ability to cool the engine. Operation of the engine at climb power with a relatively high gross weight (with two occupants on board) was likely to have increased the demand on the engine cooling system during the climb. The onset of overheating may also have been affected by the lower rate of available cooling air over the radiator during the climb.

Taping over of a large portion of the radiator surface lead to inadequate cooling of the engine, resulting in failure of the expansion bottle pressure cap seal.

The Irish Light Aviation Society advise its members of the risks associated with carrying out unauthorised modifications to aircraft operating under a Flight Permit. **(IRLD2011010)**

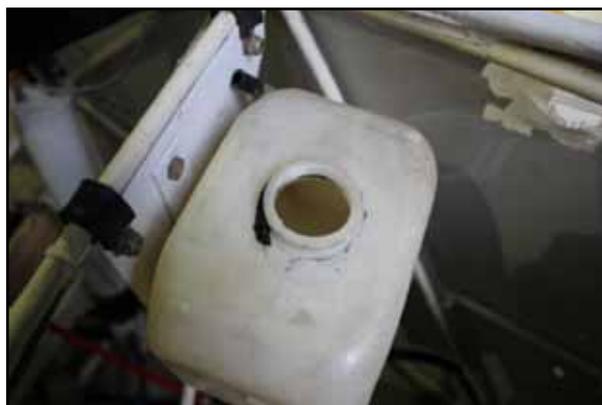
Except for the pipe fracture adjacent to the radiator, there was little damage to the cooling system pipework. On examination, it was found that the rubber seal around the expansion bottle pressure vent cap had failed under pressure from the cooling system. The expansion bottle installed on its mounting bracket and the failed vent cap are illustrated in **Photo No. 2** and **Photo No. 3** respectively.

Photo No. 2: Expansion bottle

1. Positioning of the expansion bottle in the aft cockpit area.
2. Operation of the engine at climb power with a relatively high gross weight (two occupants on board) may have increased the demand on the engine cooling system during this period.
3. The onset of overheating may also have been affected by the lower rate of available cooling air over the radiator during the climb.

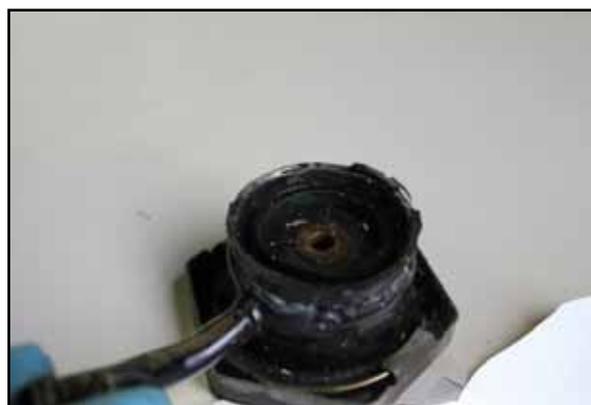
Photo No. 3: Vent cap with failed seal

4. The over-cooling of the engine on previous flights was probably caused by a leaking thermostat valve.
5. On the accident flight the engine suffered an over temperature condition resulting in the failure of the expansion bottle pressure vent cap seal, permitting coolant vapour to directly fill the cockpit. This vapour condensed on the cold window surfaces and faces of the instrumentation in the cockpit obscuring them.
