Air Accident Investigation Unit Ireland

FACTUAL REPORT

**Enstrom 280FX, N531TJ
Carrahane Strand, Co. Kerry**

16 July 2018

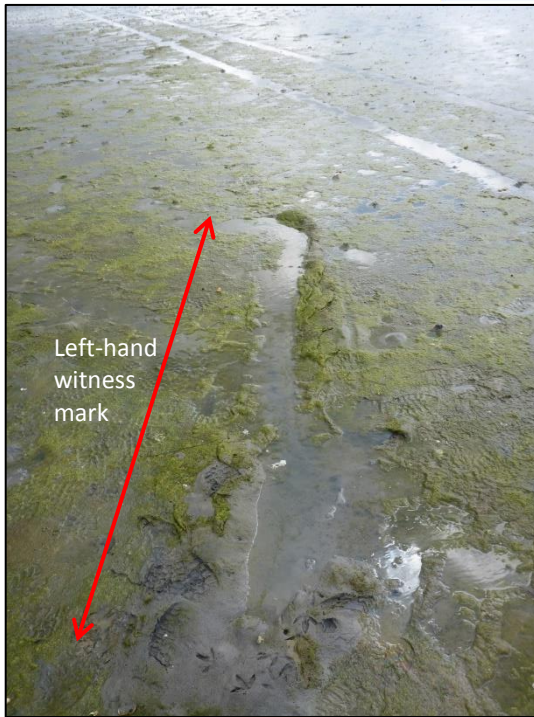
Following the occurrence, two Inspectors of Air Accidents deployed to Carrahane Strand and inspected the accident site. Even though the accident site had been subjected to tidal flow, there were still clear witness marks from the two skids (**Photos No. 1 and 2**), which indicated that the helicopter had pivoted about the left-hand skid. The Investigation also inspected the helicopter, which had been recovered to a local warehouse, and interviewed the Pilot.

Photo No. 1: Witness mark from left-hand skid

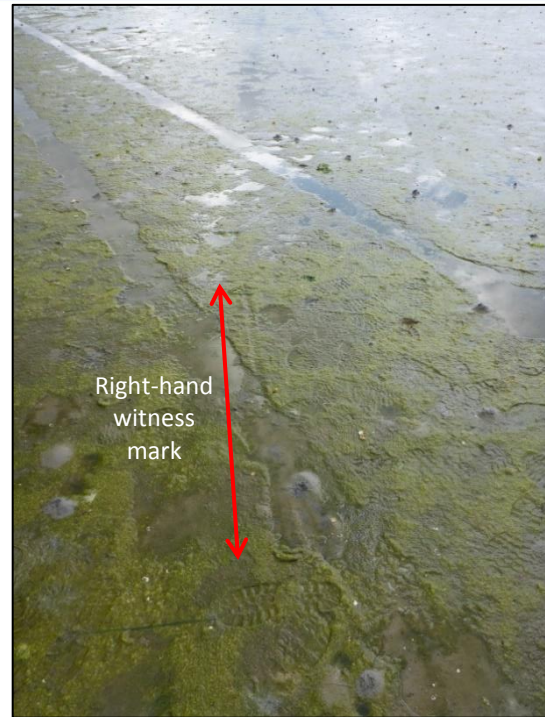
Photo No. 2: Witness mark from right-hand skid

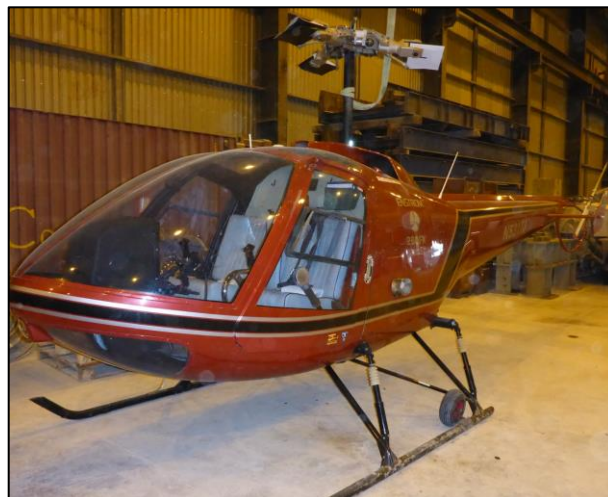
Photo No. 3: The occurrence helicopter following recovery

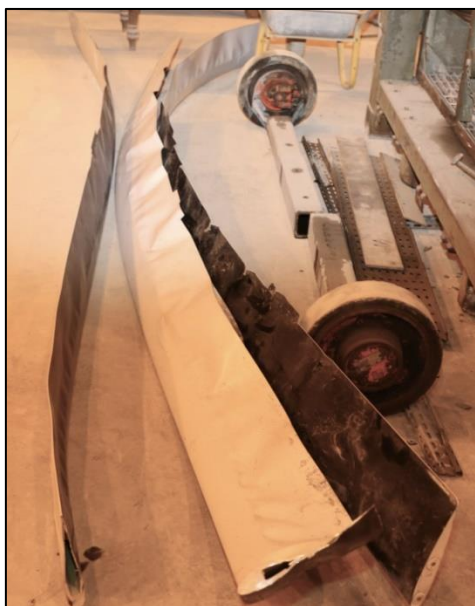
The helicopter sustained damage to the rotor blades (**Photo No. 4**), rotor head, rotor mast, main rotor gearbox, tail rotor, horizontal stabiliser and vertical stabiliser (**Photo No. 5**). It is also likely that the engine suffered shock loading.

Photo No. 4: Rotor Blades

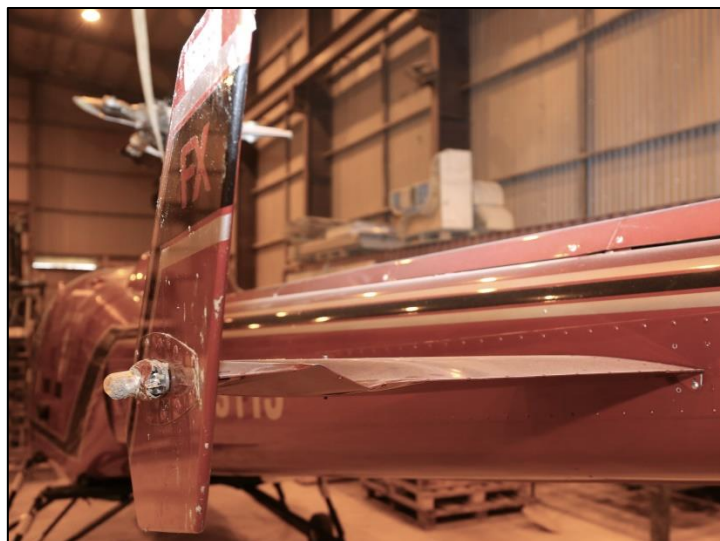
Photo No. 5: Vertical and Horizontal Stabiliser
