Air Accident Investigation Unit Ireland

PRELIMINARY REPORT

**Robinson R44 Raven II, N999RL
Kennycourt, Co. Kildare, Ireland**

11 December 2022

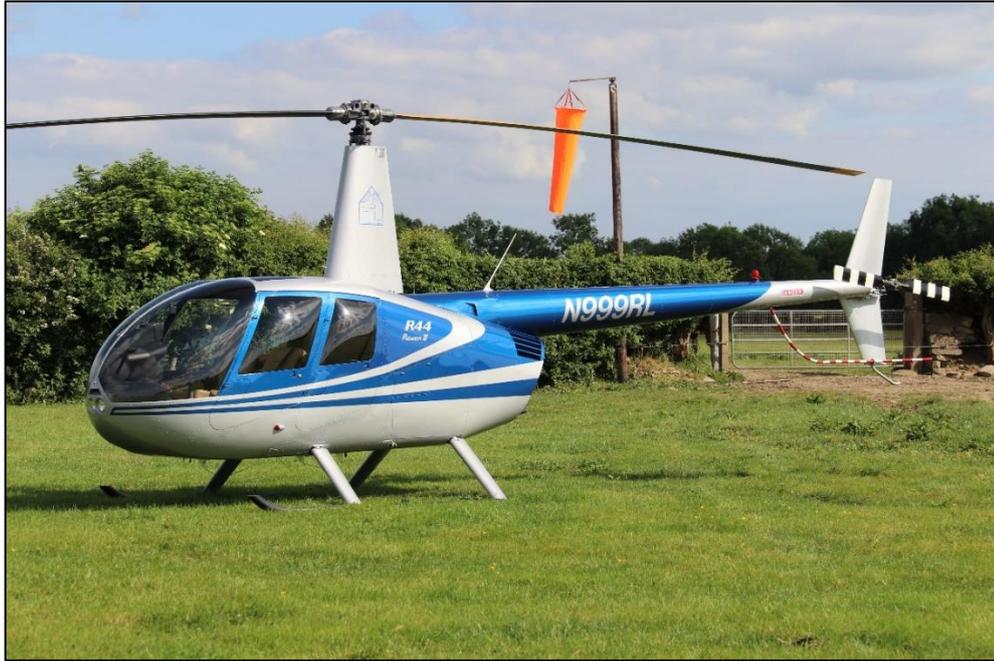
The subject helicopter, registration N999RL (**Photo No. 1**), was manufactured in 2005.

Photo No. 1: The subject Robinson R44 helicopter (*used with permission of photographer*)
