AAIU Report No.:2002/012
AAIU File No.: 2000/0027
Published Date: 11/10/02

Operator: Aerial Advertising Limited
Manufacturer: Piper
Model: PA-34-200 T
Nationality: Irish
Registration: EI-EIO
Location: Dublin Airport. Runway 11/29
Date/Time (UTC): 6 May 2000; 1612 hours

SYNOPSIS.

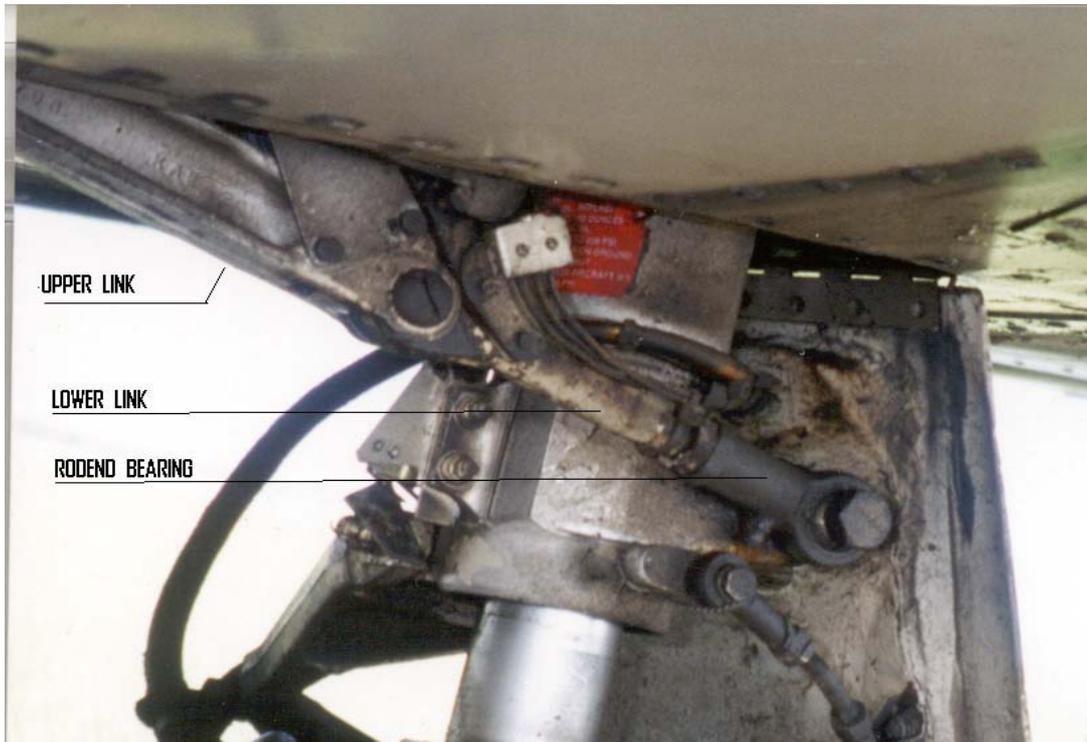
APPENDIX A

Undamaged port undercarriage of EI-EIO. The starboard undercarriage had similar components such as the upper link, lower link and rod end bearing bolt, all damaged in the incident

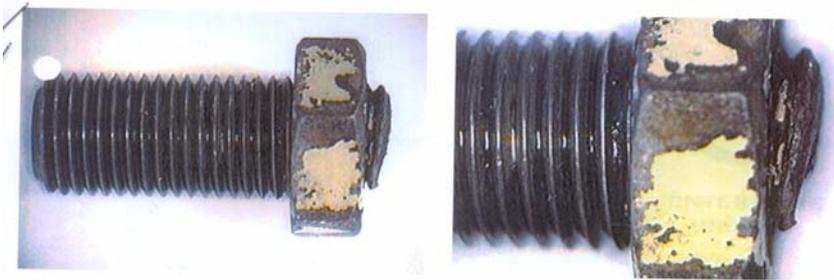
“Fracture in the rod end has occurred through ductile overload. There was bending associated with the fracture, possibly resulting from compressive loads. There was no indication of any material or manufacturing defect, or of any pre-existing, in-service defect such as fatigue cracking.

Hardness tests carried out on the rod yielded values of 329 to 337 Vickers (HV/30). These values are typical of a strength grade 10.9 bolt, which would have a minimum tensile strength of 1040 N/mm². This would approximate to a minimum breaking load of 117700 N (~ 11.9 tonf) for a 12 mm diameter rod, in tension.

The load necessary to cause failure could be considerably lower in bending.”

Figures 1 and 2 Fractured rod end. Note bending, through approximately 10°, associated with fracture.

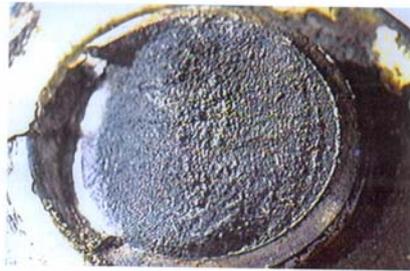
Figure 3 Fracture surface.

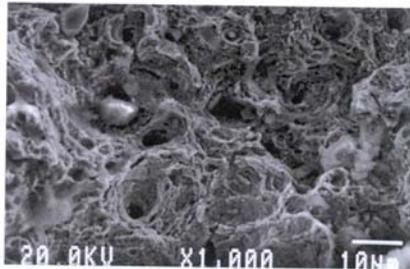
Figure 4 SEM image showing microvoid features on fracture surface.

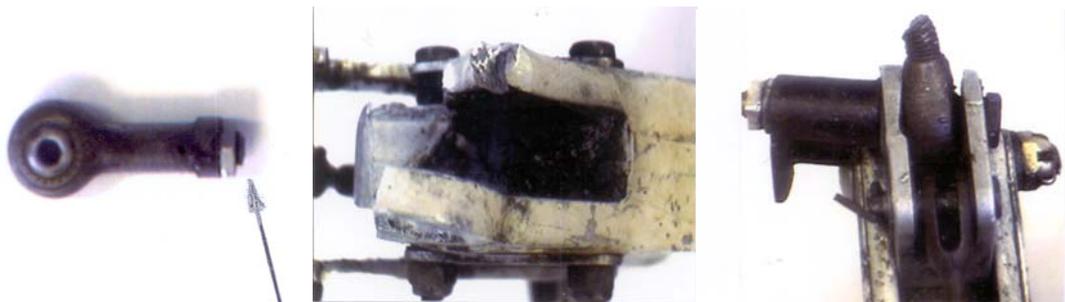
“The fracture surfaces at (1) and (2) were bright/fibrous and were stated to be typical of overload failure. The fracture surface at (3) was also bright and typical of overload failures. There was considerable localised distortion associated with the failures at (2) and (3)”

- *The mode of failure at the three fracture sites is that of ductile overload.*
- *The bright fracture features (with no indication of a pre-existing defect) suggests that the above fractures occurred in the same incident.*

The fracture at (2) on the triangular upper side brace link shows bright marks on the inside of the housing where the bushing would normally be fitted. The forward side of the housing was torn away and there is evidence of bending and distortion of the housing from compressive forces acting towards the rear of the wheel well. The fracture at (3) also shows bending with the threads on the retraction fitting showing compression on one side. The fitting is distorted towards the rear of the wheel well.

- Photo (1) Part of the undercarriage door attachment to the leg.
Photo (2) Fracture at joining of upper and lower links.
Photo (3) Fracture at hydraulic piston retraction attachment.

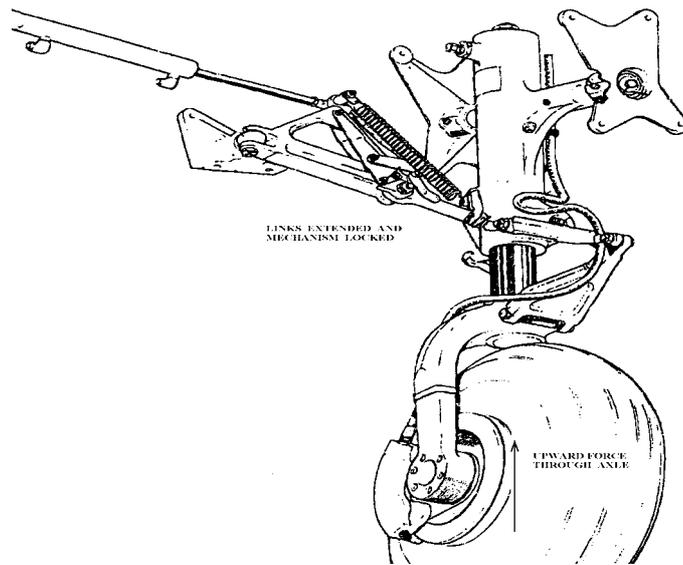
The Commander and his student both confirm that the three green lights were obtained prior to touchdown. If this was the case then the main and nose undercarriages were confirmed “down and locked”. In such a case the impact forces on touchdown would act in an almost vertical direction through the trunnion supporting the right leg. This force would have to be considerable to disturb the trunnion in its brackets, unlock the mechanism and cause the fracture of that mechanism.

Above: Schematic sketch of starboard undercarriage in fully extended position on contact with the runway surface. Upward force acts vertically through the trunnion axle.

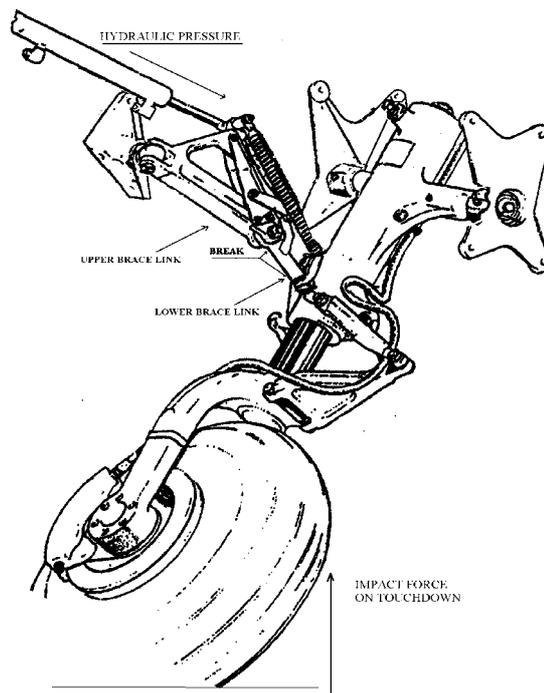
On the other hand, if the right leg was not locked down on touchdown, then the vertical impact forces would be multiplied by the leverage exerted by the extended leg. (See Appendix C). However, the crew would have been aware of the absence of the starboard green light and the presence of the red “gear unsafe” warning light. Even in strong sunlight one or other of these factors would have been noted by either the instructor or student. The above forces would cause the retraction mechanism and rod end to fracture first and may have also caused damage to the trunnion brackets as a secondary event. If the impact was sufficient to fracture only the upper and lower brace links, then the leg would have taken up a “hanging” configuration during the circling of the military airfield. Witnesses at the military airfield said that, following the incident, the starboard undercarriage appeared half extended in its normal arc.

Above: Undercarriage leg not vertical. The upward force applies leverage about the trunnion axle, increasing the compressive forces on the upper and lower brace links the
