*AAIU Report No. 2001/0012*  
*AAIU File No. 2000/0058*  
*Published: 10 Sep 2001*

**Name of Operator:** Aer Lingus  
**Manufacturer:** Fokker Aircraft B.V. The Netherlands  
**Model:** Fokker 50  
**Registration:** EI-FKD  
**Nationality:** Irish  
**Location:** Runway 17, Cork Airport (EICK)  
**Date and Time (UTC):** 29 October 2000, 1619 hrs

### **SYNOPSIS**

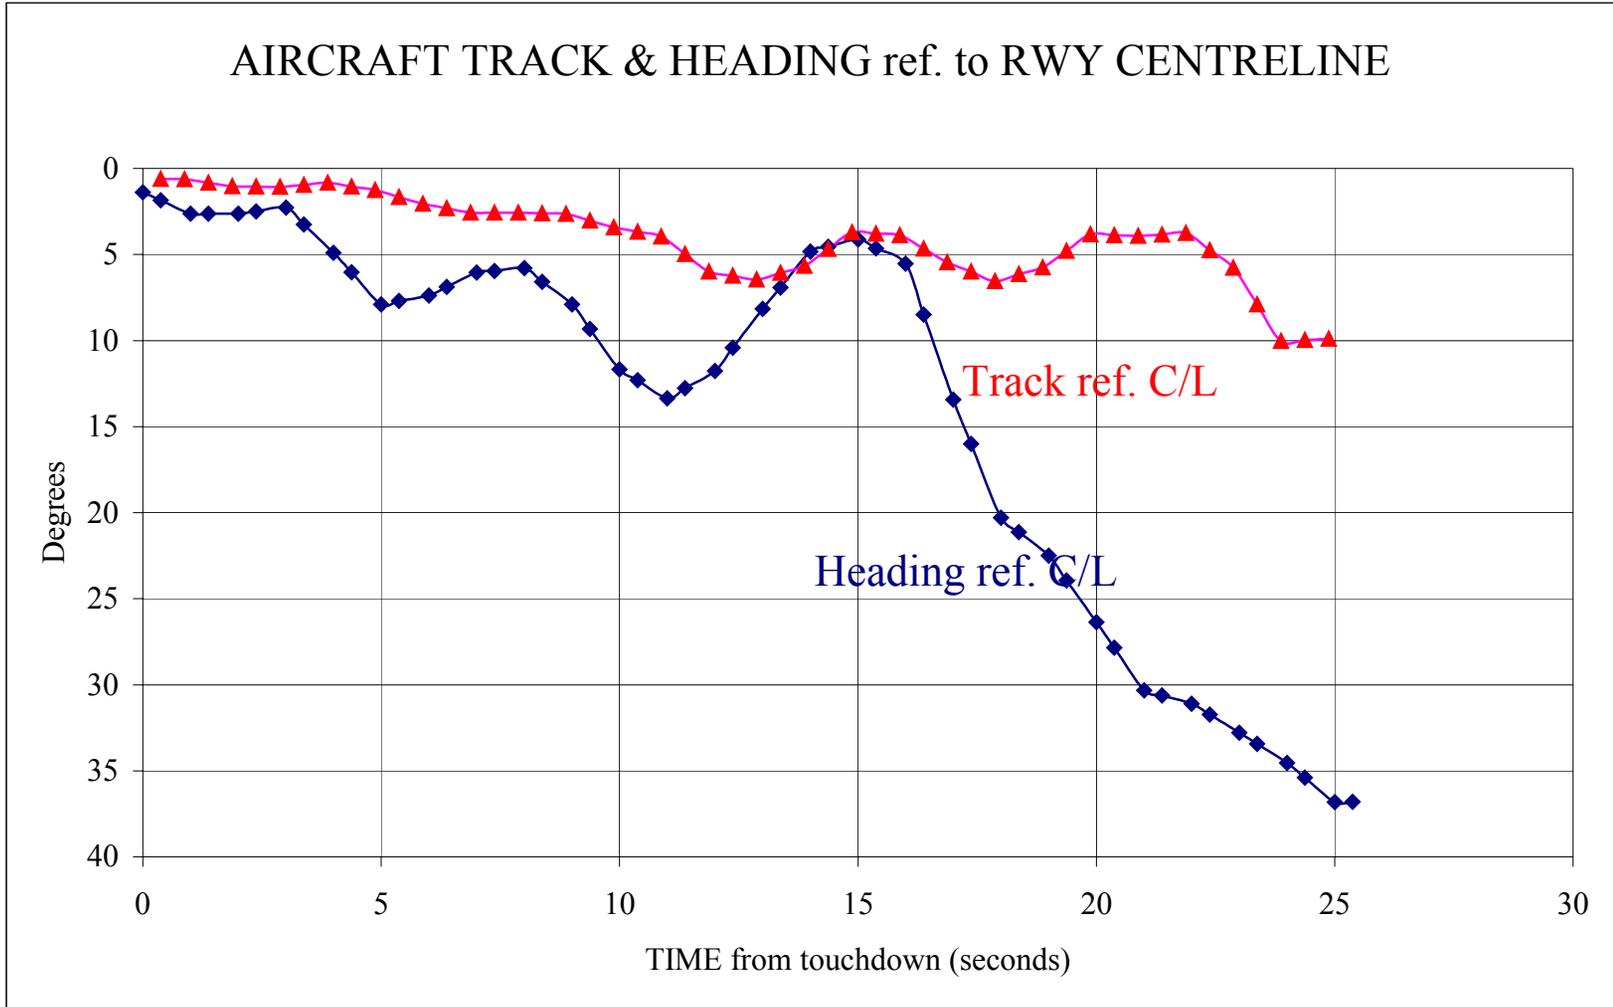
AIRCRAFT TRACK & HEADING ref. to RWY CENTRELINE

When the aircraft track and heading is referenced against the runway centreline (**Appendix G**), it can be seen that the aircraft is continuously moving towards the right hand edge of the runway from just after touchdown and the aircraft heading oscillates about the aircraft track. When in the air, an aircraft is allowed to freely rotate about its axes because it is not fixed to any point. If influenced by wind, the heading can vary about the track (drift). On the ground, in particular under dry or non-slippery conditions, the aircraft’s undercarriage will restrict lateral movement about the central axis, so heading and track remain the same. Under reduced runway friction or aquaplaning, the aircraft is less restricted in lateral movement and heading can increase or decrease about the aircraft track.

When the aircraft track and heading are referenced against the runway centreline (**Appendix G**), the aircraft is seen to be continuously moving towards the right hand edge of the runway from just after touchdown and the heading oscillates about the track. This is a clear indication that the aircraft is suffering from a lack of traction with the runway surface. The cause of this lack of traction is considered to have resulted from a combination of the wet runway, crosswind, landing roll out technique used by the PF and the presence of standing water in the general area of the intersection of both runways.
