*AAIU Report No. 2000/014*  
*AAIU File No. 2000/0016*  
*Published. 12/09/2000*

**Aircraft Type and Registration:** Piper Cherokee PA-28-140

**Reg No.** EI-CGP

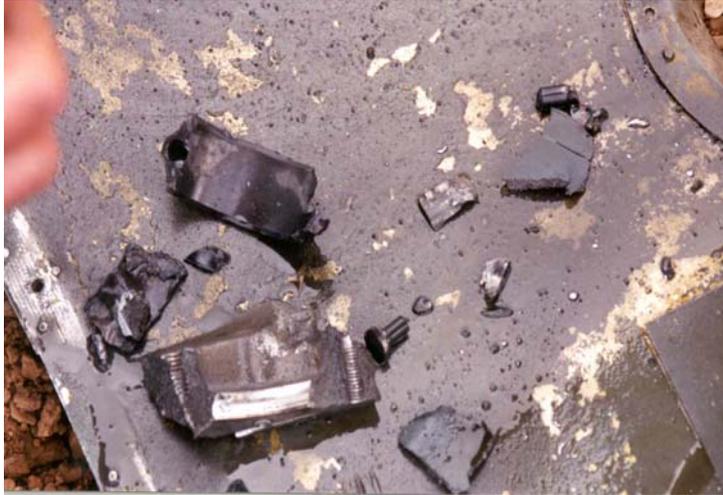
Following the incident the investigators visited the aircraft in situ in the company of the aircraft's registered owner. Pieces of the engine crankcase, along with parts of the crankshaft forward bearing and No.1 connecting rod big end bearing, were found lying on the bottom engine cowling. One of the engine oil bungs was missing whilst the other was in place and wire-locked.

The cause of this incident was the departure of the oil sump bung in flight, allowing oil to be drained from the engine, followed by rough running and a rapid break-up of the front crankshaft bearing and its housing and No.1 connecting rod and its big end bearing.

Fragments from the front main bearing housing and No.1 connecting rod big end as found on lower engine cowling.

- 4.1 It is recommended that the maintenance contractor put in place a duplicate inspection procedure for specific tasks such as wirelocking of fundamental engine components. **(SR 43 of 2000)**
- 4.2 The contractor, in conjunction with FAS, should arrange a formal training scheme for the apprentice, involving textbook instruction in order that he be qualified as a full aircraft mechanic. **(SR 44 of 2000)**
