AAIU Report No. 2000/012
AAIU File No. 2000/0025
Published 07 September 2000

Aircraft Type and Registration: HS. 748 Series 2A. G-BVOV

Date and Time (UTC): 28 April 2000 20.47 hours

Location: Dublin Airport

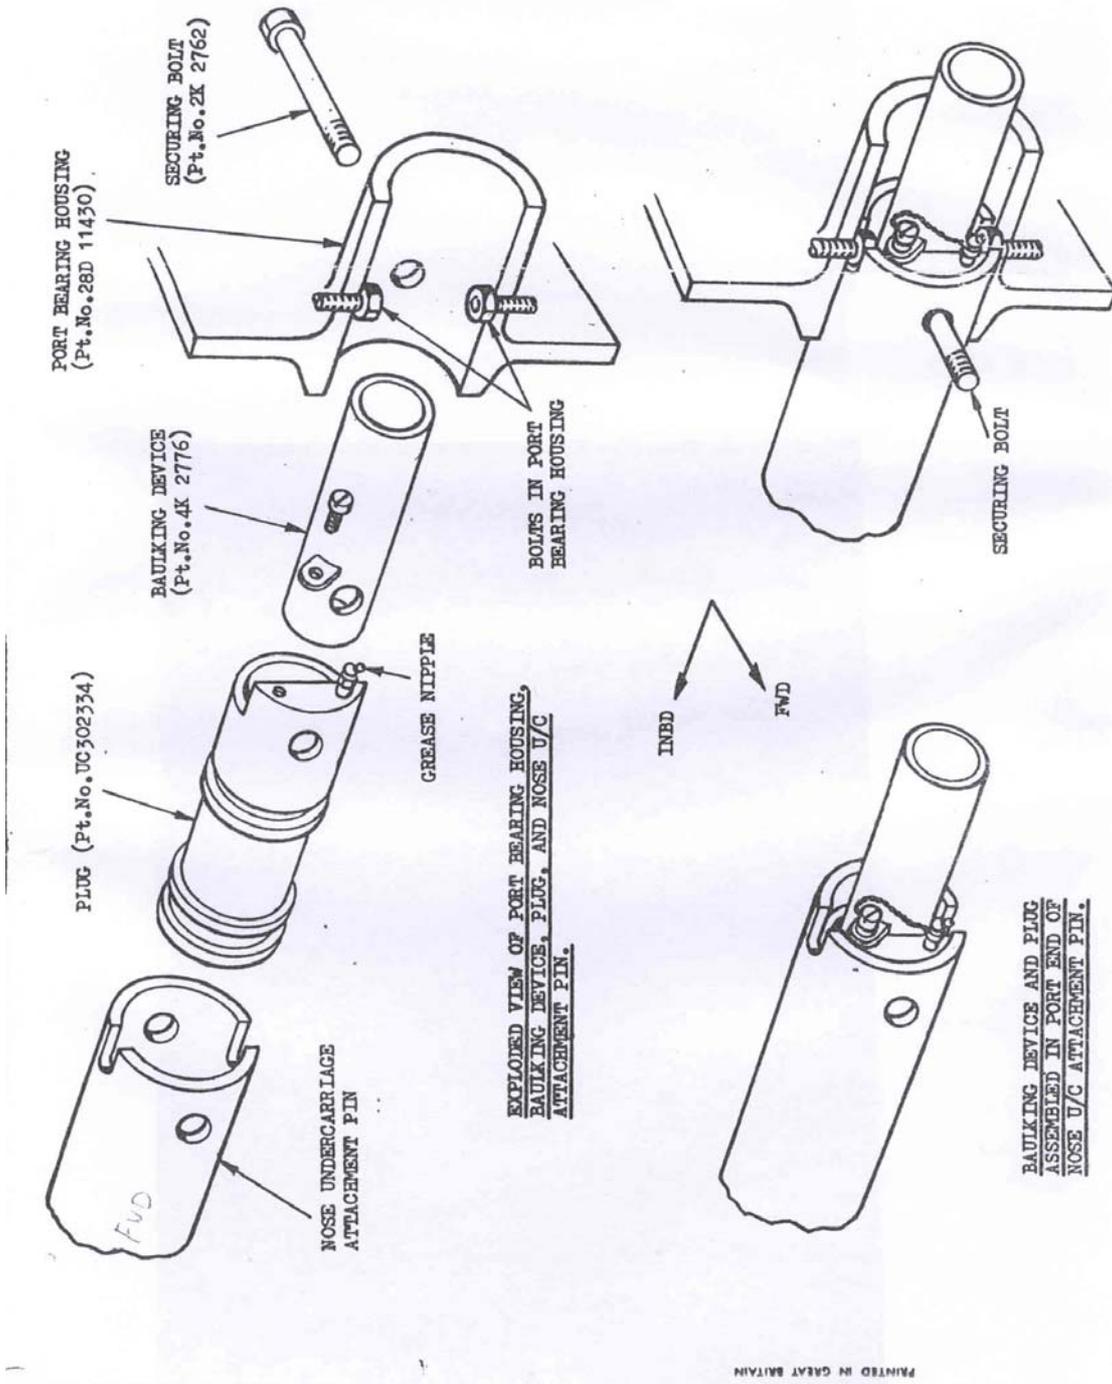
FIG.1

The nose strut of the BAe 748 is attached to the fuselage through a nose undercarriage attachment pin (*left*). This pin is inserted through an opening in the starboard side of the front fuselage. It is secured on the port side using a securing bolt, which secures the pin through holes in the port bushing housing. The port bushing is secured to the housing using two bolts. The attachment pin incorporates slots to facilitate the bolt heads. The pin also incorporates an internal greasing plug and the greasing

plug receives a baulking device incorporated by Mandatory Modification 4046 (S.B. 32/45). The baulking device, when fitted properly, should ensure that the holes in the attachment pin, port bearing housing and baulking device all line up in order to receive the securing bolt. In this way it would be impossible to insert the attachment pin and secure it to the bush housing using the slots intended to facilitate the bearing housing bolts. If, however, the baulking device is excluded, it is possible to fit the attachment pin at 90 degrees from its correct position and attempt to secure the pin with the securing bolt running through the attachment pin slots. In service the attachment pin would then work its way out of the housing. The starboard bearing housing would then take all forces transmitted through the nose leg, pulling the housing from its securing structure. (*see Fig.1 for complete breakdown of assembly*)

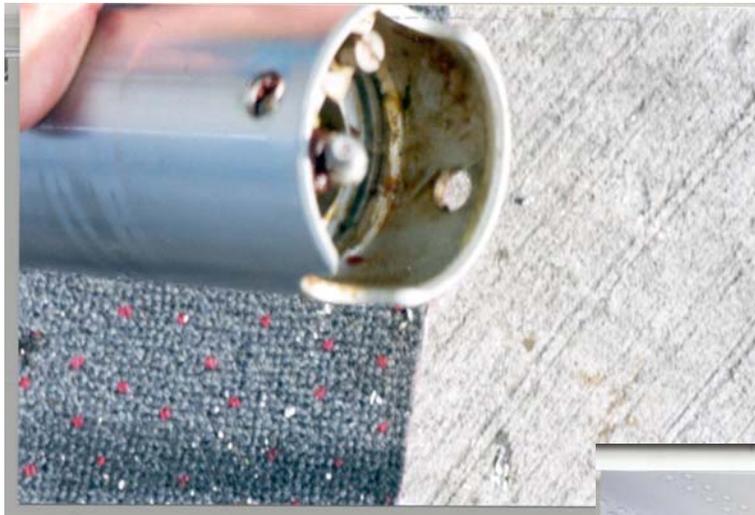
- (a) The attachment pin was found with the face marked "FWD"(forward) facing downwards. The holes in the pin were therefore in the vertical rather than in the horizontal.

- (b) If the pin had been fitted in this way the slots would have been in a position to receive the securing bolt.
- (c) The greasing plug was found moved in the attachment pin such that the hole in the plug could not line up with the hole in the pin.

**Attachment Pin-
following the incident**

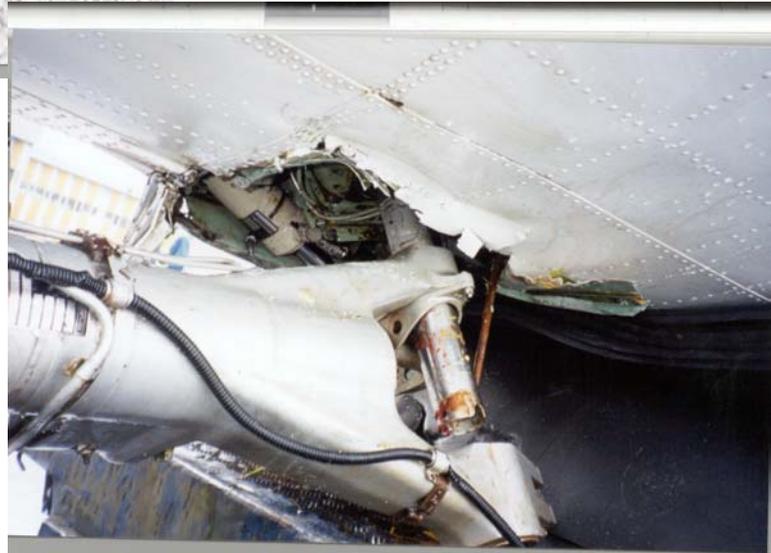
The nose undercarriage strut was found pushed rearwards, with the whole of the strut exposed beneath the fuselage. The attachment pin was found attached to the starboard side of the strut but had come away from the port side such that the end of the pin was visible with the slots at about 90 degrees to what would be their normal position when the pin is attached to the port bearing housing.

**Attachment Pin – following collapse of
nose undercarriage**

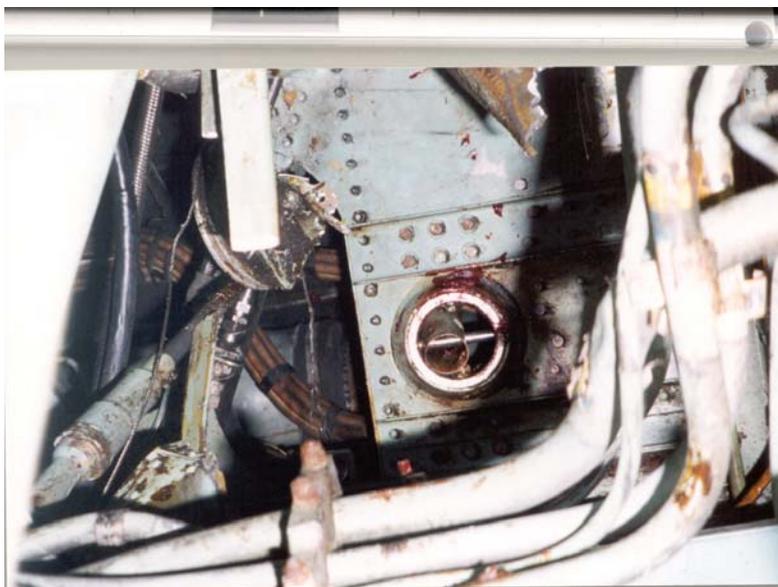
On removal of the strut from the aircraft, further examination revealed that the baulking device, complete with the securing bolt, remained in the port bearing housing. The attachment pin, which had been removed from the strut, was then examined. It was found that the greasing plug had rotated therein so as to block the passage of the securing bolt into and through the holes in the attachment pin. The lug on the baulking device used to secure that device to the plug had broken off and remained with the plug.

Examination has shown that only the baulking device was secured by the bolt in the port housing. The attachment pin complete with greasing plug was free to migrate out of this housing. The securing bolt did not go through the hole in the greasing plug. It has to be concluded that the attachment pin was fitted with the slots horizontal and with the securing pin inserted through these slots.

**Securing Bolt in
Baulking Device as
found by investigators**

- 4.1 In the short term, Service Bulletin 32/71 should be reissued by the aircraft manufacturer, British Aerospace. It should be requested that, following a survey of all Bae748 aircraft, that feedback on the survey be returned to the manufacturer together with the aircraft serial number and registration number. (SR 36 of 2000)

- 4.2 British Aerospace should issue instructions that when nose gear fitting takes place two separate duplicate inspections should take place to ensure:-

- (a) verification that the slots are correctly positioned and
 - (b) that the securing bolt passes through the bolt holes in the attachment pin. (SR 37 of 2000)
