AAIU Report No. 2000/0010
AAIU File No. 2000/0019
Published: 20/08/2000

Aircraft Type and Registration:	Piper Cub J3C65, EI-CUB
No. and Type of Engines:	One Continental A65-8
Aircraft Serial Number:	16010
Year of Manufacture:	1946
Date and Time (UTC):	26 th March 2000, 1120 hours
Location:	Galway Airport
Type of Flight:	Private
Persons on Board:	Pilot – One Passenger – One
Injuries:	Pilot – None Passenger - Minor
Nature of Damage:	Aircraft extensively damaged
Commanders Licence:	German, Private Pilot Licence (Aeroplane)
Commanders Age:	48 years
Commanders Flying Experience:	310 hours (including 87 hours on type)
Information Source:	ATCO Galway Airport. AAIU Field Investigation

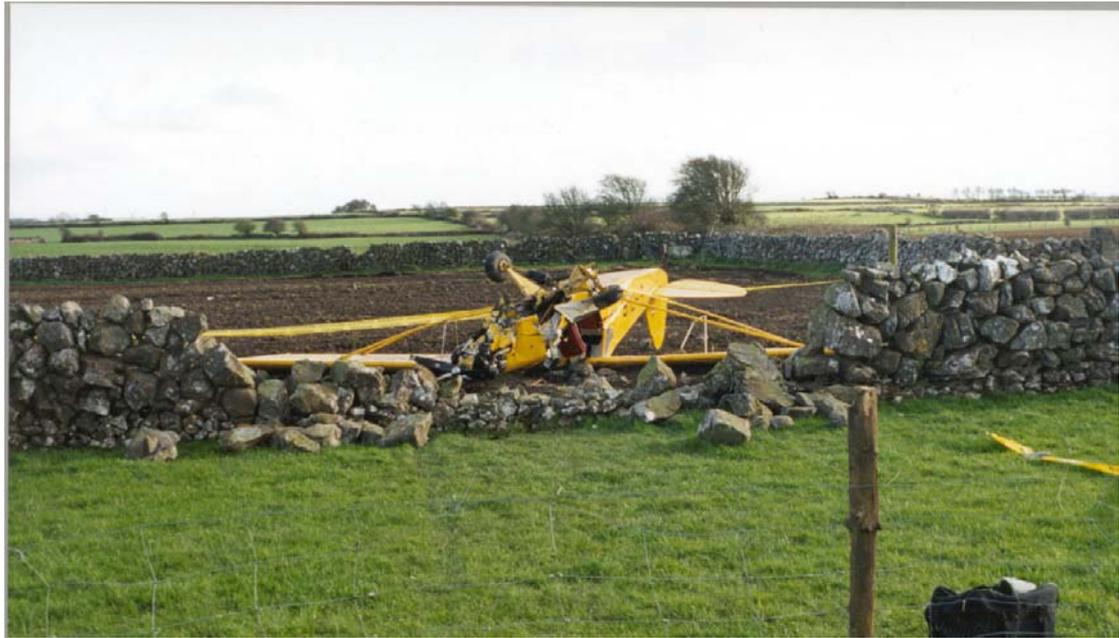
Runway 26 was the active runway. The pilot stated that after getting airborne the right wing of the aircraft was lifted by a gust of wind. Despite his full control input the aircraft was blown some 90° left of the runway direction and flew about 80 metres over the grass perimeter and impacted the airfield boundary stone wall. The aircraft demolished part of this wall and came to rest inverted in the adjacent ploughed field. There was no fire, the pilot exited the rear of the aircraft unharmed.

Photograph of crash scene, EI-CUB
