AAIU Report No. 2000/008
AAIU File No. 19980066
Published: 02/08/2000

Aircraft Type and Registration: B737-400, EI-BXB

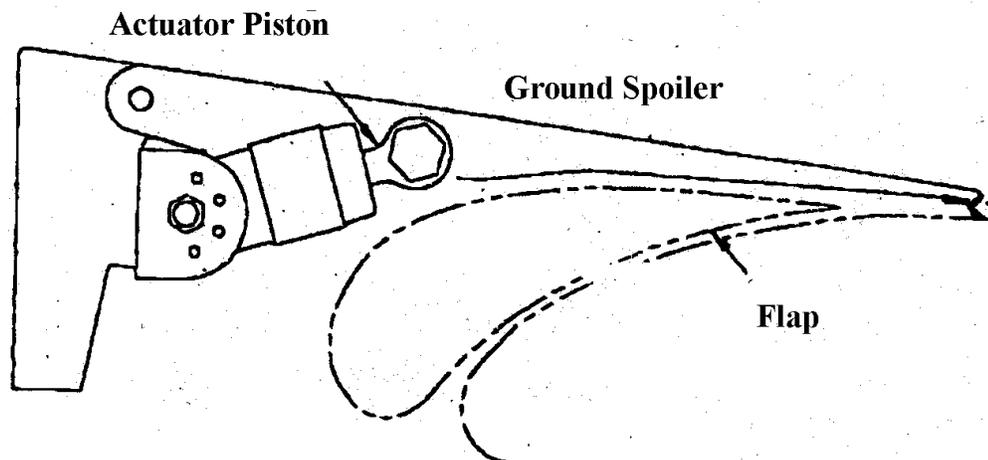
Fig 1 (Above) Spoiler Configuration EI-BXB

Spoiler panels are installed to supplement the ailerons for lateral control and also to provide increased drag and reduced lift when used as speed brakes. Five hydraulically powered spoilers are installed on each wing. They are numbered from left to right for identification, 0 to 4 on the left wing and 5 to 9 on the right wing.

Spoilers used in flight are 2,3,6 and 7. The remaining six (0,1,4,5,8 and 9) are used on the ground only as lift dumping i.e. when landing. The failed spoiler was one of these. The ground spoilers have two positions, fully retracted (see sketch) or fully raised. The fully raised position for all the ground spoilers is 60 degrees. Ground Spoilers "0" is actuated directly by a single-acting actuator. Hydraulic power is supplied by aircraft System A. The ground spoiler is attached to the wing structure by four hinge fittings aft of the rear spar and is located forward of the outboard flap. The actuator is attached directly to the spoiler and wing structure at the centre of the spoiler. When the spoiler is down, the down limit is provided by bottoming the piston in the actuator. When activated, the actuator piston extends fully and pushes the spoiler 60° into the airflow thus increasing the drag and reducing the lift. If the rod end separates from the actuator, the spoiler will move to an intermediate position that is neither fully retracted nor fully raised. The position of this aerodynamic neutral point varies with flight conditions and flap settings.

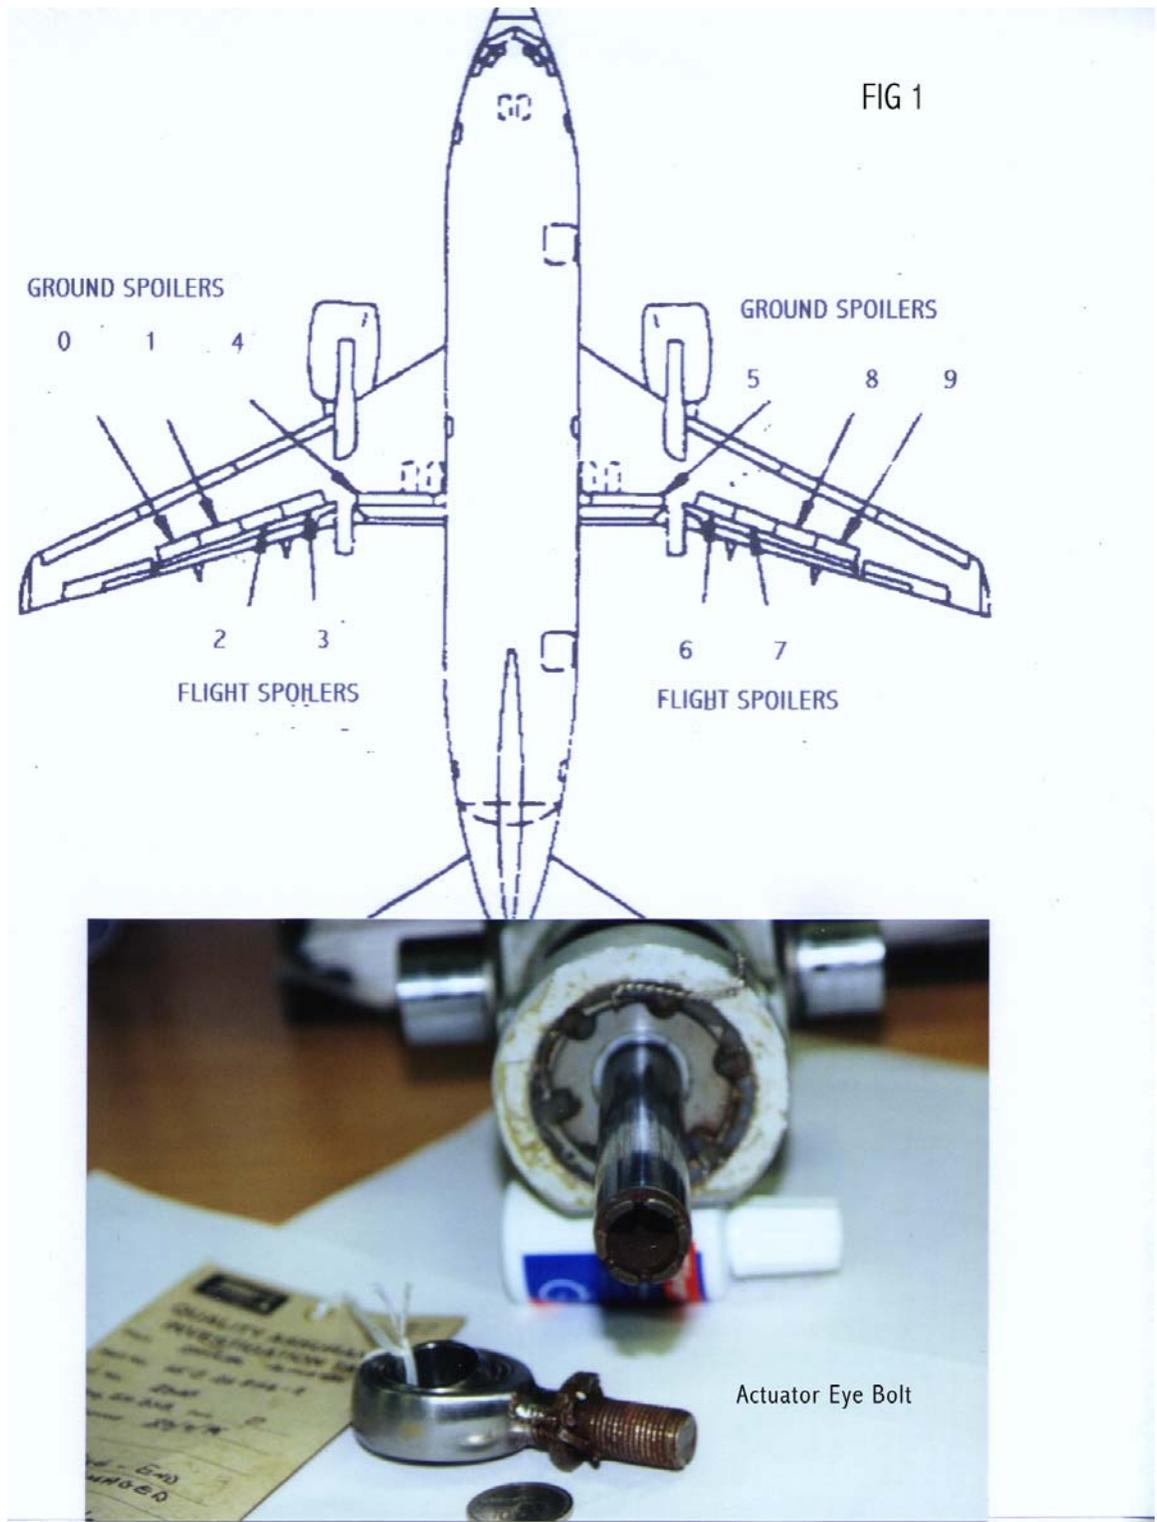
Fig 2 (Below) Position "0" Ground Spoiler Actuator EI-BXB

On examination of the aircraft the cause of the problem was traced to the outboard spoiler on the LH wing (position "0"--see Fig. 2). The spoiler was found with its control surface disconnected from its actuator. The spoiler actuator was found to have had the eye-end separated from the actuator shaft. This was caused by severe corrosion on the threaded portions of the shaft and on the eye-end. The actuator had been installed since delivery in Oct 1989.

The threads of the piston rod and rod end were corroded and damaged. The ball of the spherical bearing could not be rotated by hand. Corrosion products were present in the keyway of the rod end.

This incident was caused by corrosion on the threads of the eye-end bolt and internal corrosion on the threads of the actuator shaft. The eye-end departed from the shaft in flight and caused the spoiler to deploy of its own accord and interfere with the airflow over the wing. The onset of corrosion was facilitated by the absence of sealant.

The review and analysis in conjunction with the aircraft manufacturers focused attention on all outboard actuators. Outboard actuators were replaced with actuators that were put through the revised workshop process that included the application of the above compound in the shaft bore in addition to the sealant at the eye-end.

4.1 The aircraft manufacturer should issue a Service Bulletin to cover this problem, which would bring it to the attention of B737 operators worldwide. **(SR 10 of 2000)**
