AAIU Report No. 1999/018
AAIU File No. 19990016
Published 30/11/1999

Aircraft Type and Registration: Boeing 737-200 EI-CKR
Date and Time (UTC): 2 April 1999 at 08.54 hrs
Type of Flight: Public Transport
Persons on Board: 130
Injuries: Nil
Nature of Damage: No damage to the aircraft
Information Source: Aer Rianta Duty Officer, Dublin Airport

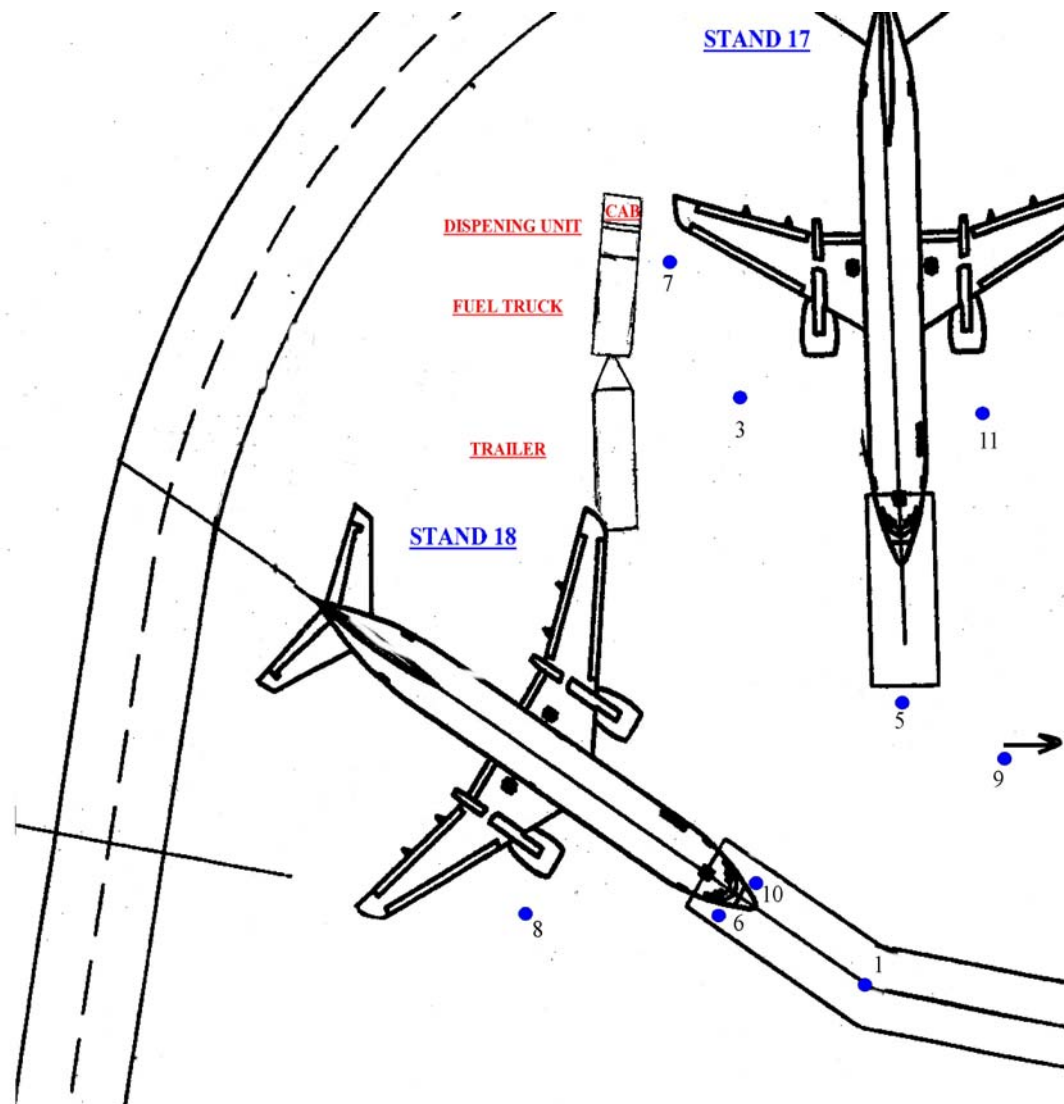
Fig 1

Personnel who were on or in the general vicinity of the stand at the time in question were interviewed, over a number of days, after the accident. See FIG 1. for probable location of witnesses.
