AAIU Report No. 1999/015
AAIU File No. 19980057
Published 8/11/1999

Aircraft Type and Registration: Boeing B747-136, G-AWNN

Nature of Damage: Nose Tyre Damage

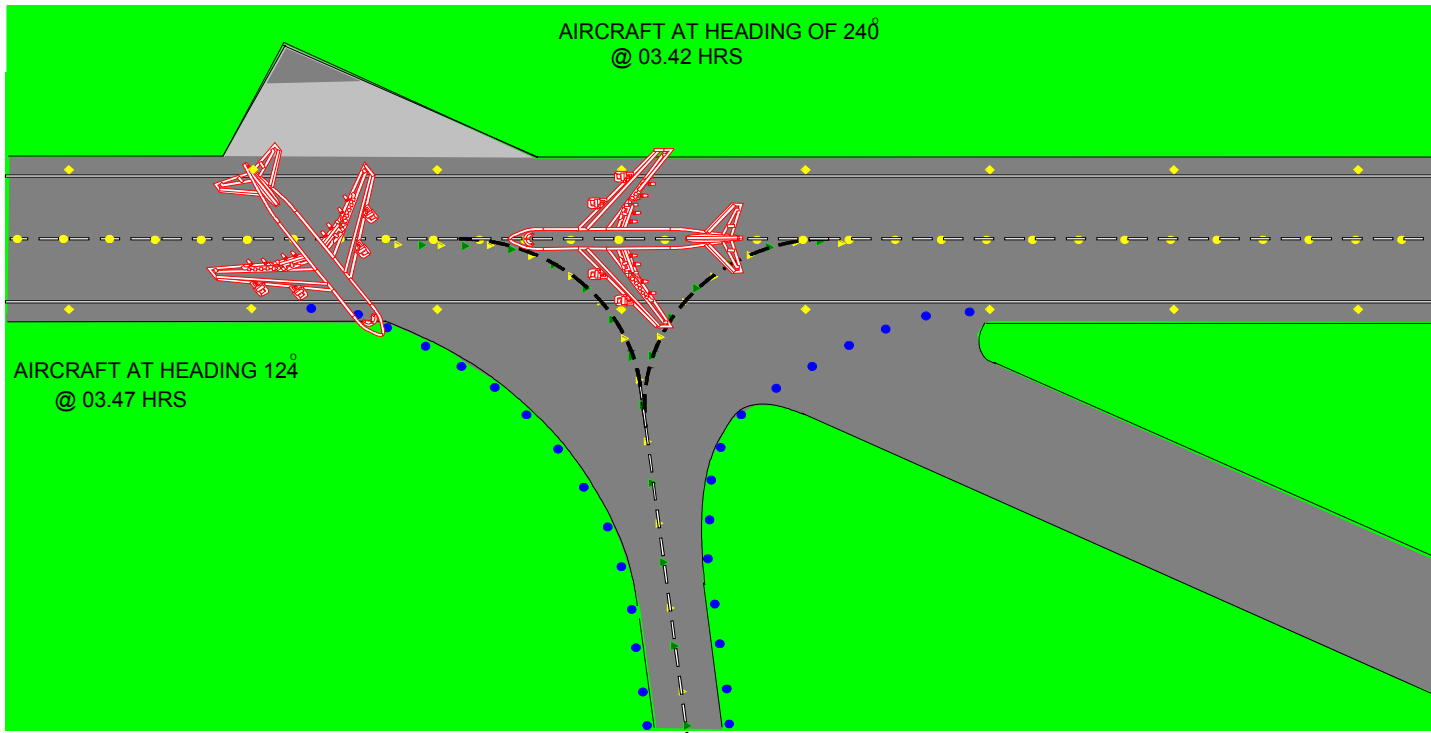
ANNEX A

The crew failed to execute a 180° on the runway, just beyond the intersection of Runway 24 and Taxiway Alpha. In order to complete the turn the aircraft's heading would have to have reached 060°, whereas the final heading recorded in the turn was 124°. The runway and taxiway lights are correctly positioned in accordance with the ICAO recommendations. The blue taxiway edge lights follow the curvature of the taxiway. The curvature line is continuous and integrates into the white runway lighting system without any discontinuity. If the wheels of the aircraft were kept within the area bounded by the integrated lighting system the aircraft would have been free to continue its taxi. As it was, the aircraft's nose wheel breached this line destroying one of the lights in the process before coming to rest on the grass.
