AAIU Report No. 1999/014
AAIU File No. 19970031
Published 8/11/1999

FINAL REPORT

HCL 34/97 Incident Aircraft: Boeing 737-500 Number and type of Engines 2 CFM 56-3B1 Crew: 2/4 - no injuries Location: Copenhagen Airport, Kastrup	Registered: EI-CDT Type of flight: Scheduled public transport, IFR Passengers 60 - no injuries Date and time: 20.07. 1997 at 1449 hrs
--	---

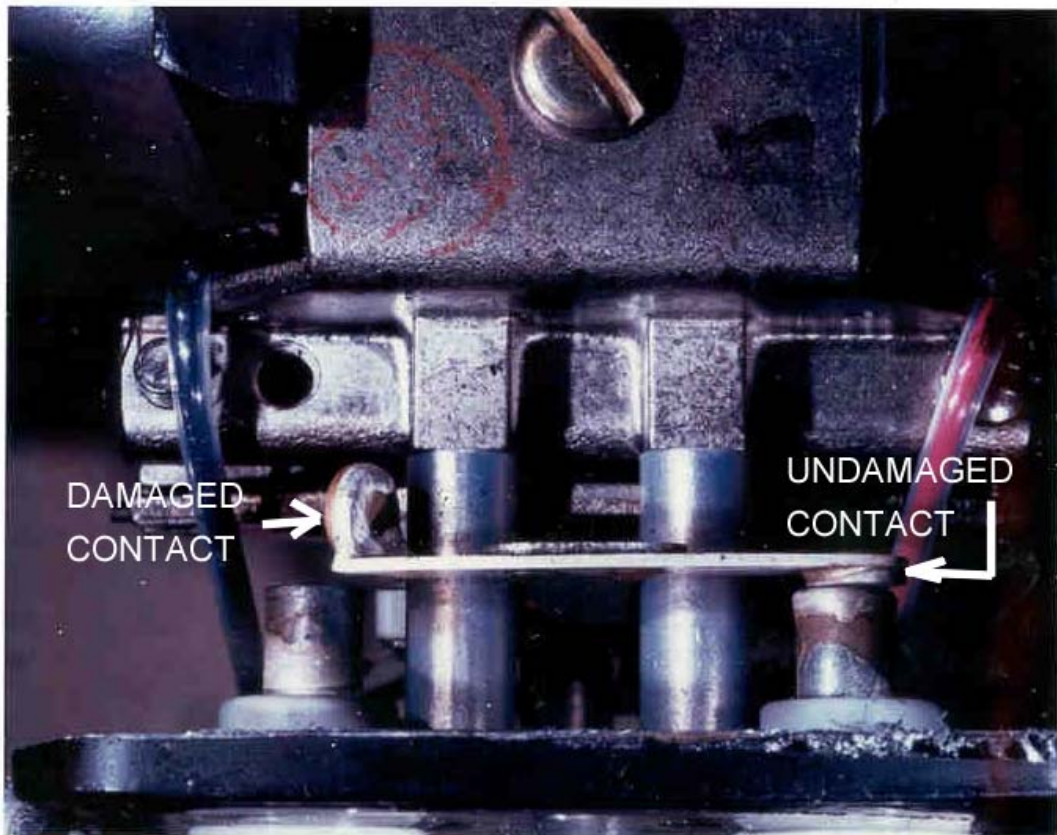
APPENDIX 2

The B1 movable contact blade was at a right angle to the B1 stationary contact.

The relay had evidence of the B2 contacts being welded. The welding of these contacts is suspected of causing electrical arcing which melted the contact arm. (AAIB: contact blade) (See appendix 2).

Closer inspection of the relay revealed that a contact blade had melted and bent at an angle of 90°. The contact blade showed signs of welding caused by arcing, which had caused so much heat that the contact blade had melted and bent.

VIEW OF DAMAGED RELAY

- a. **The Civil Aviation Administration takes the necessary actions to seek a reevaluation of the performance of the Battery Bus Relay (R1) in its installation in the Boeing 737 series aircraft to ensure proper function. (REC-04-97).**

3. Re recommendation "a":
On 11 June 1998 Boeing issued Service Letter 737-SL-24-120 concerning *Battery / Standby / DC Power System Relays - Preferred Spare*. (See Appendix 4)

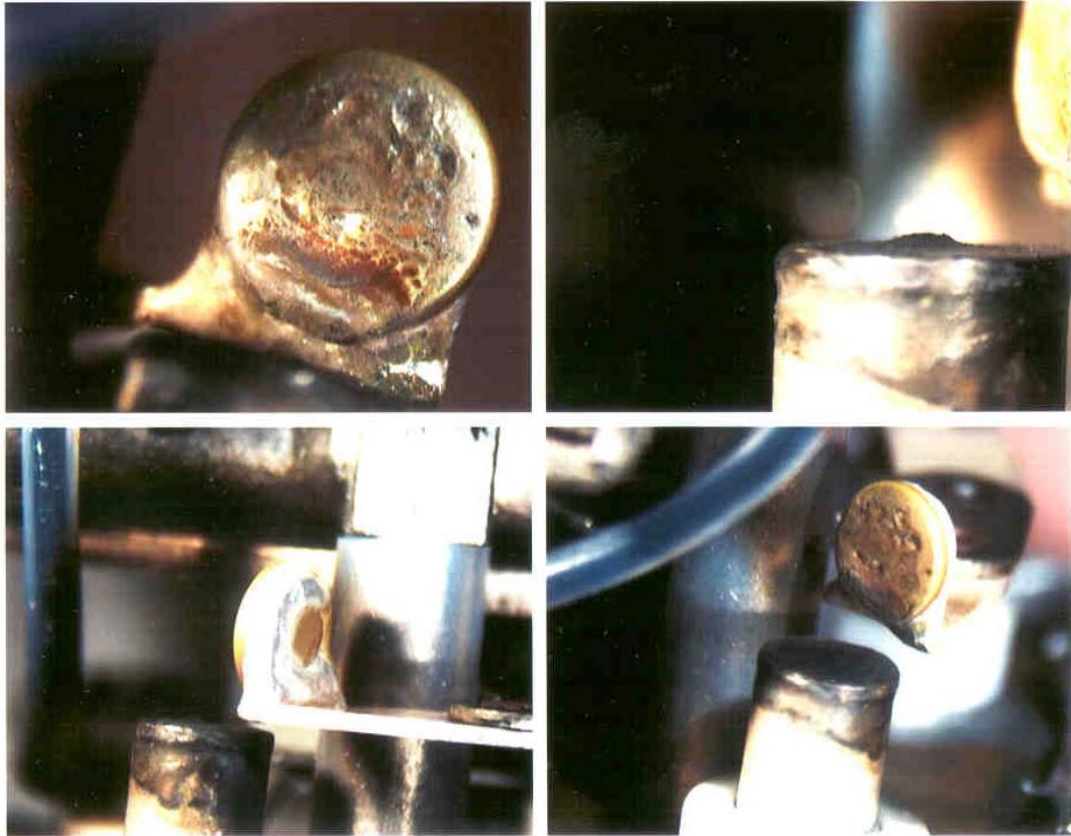
CLOSE UP VIEWS OF DAMAGED RELAY
