**AAIU Report No. 1999/013**  
**AAIU File No. 19990001**  
**Published 1/10/1999**

**Aircraft Type and Registration:** Socata TB 9, EI-FLY

**Location:** Lucan Golf Club, Co. Dublin

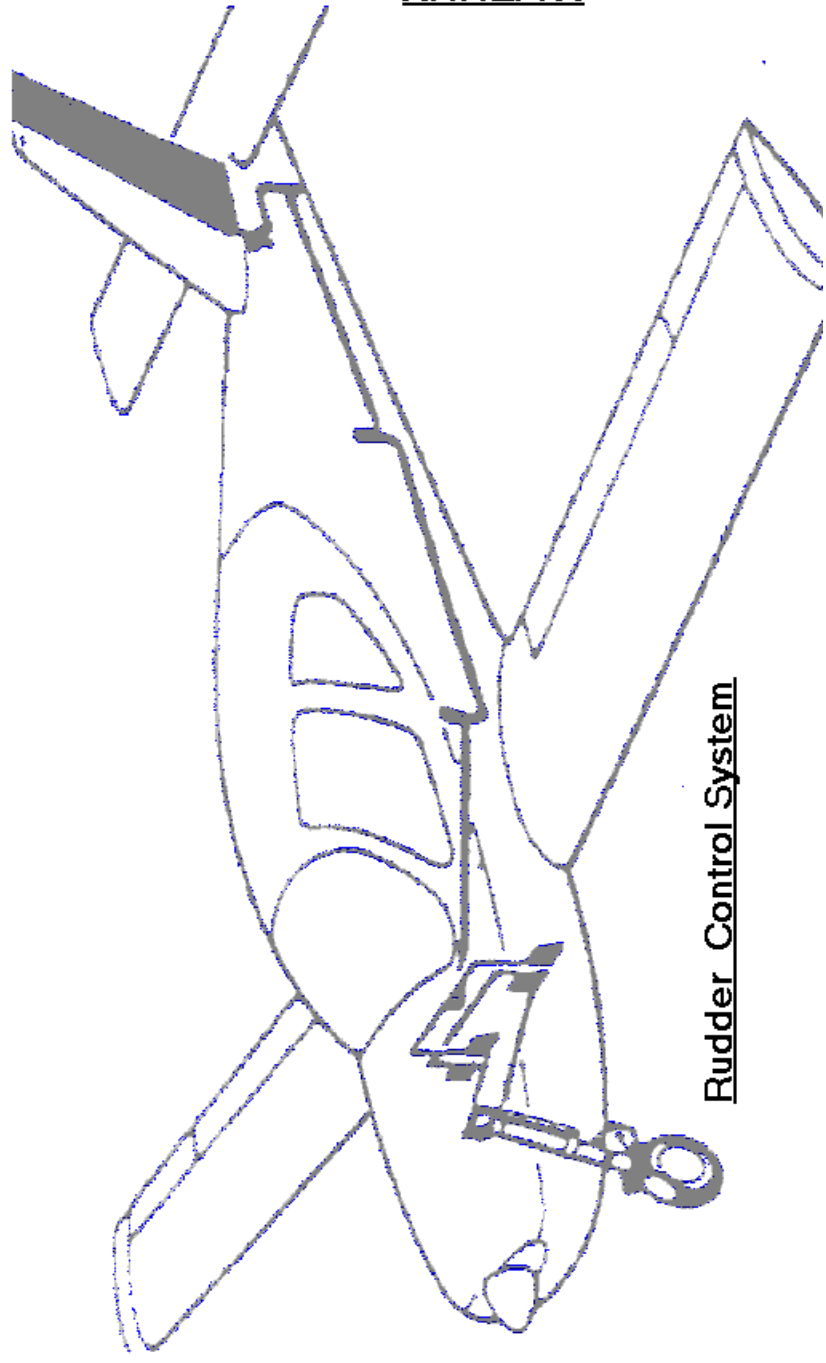
ANNEX A

- (i) The left rudder pedals are connected through a tubular cross rod with a single bellcrank at the centre of the cross tube. This bellcrank is connected by a series of rods and bellcranks to the rudder.
- (ii) The opposite deflection of the rudder is achieved through a rod connected to the Pilot A's right pedal, through the nose wheel turning mechanism to the Pilot B's left pedal which pushes this pedal in the opposite direction, thus turning the cross tube in the opposite direction and deflecting the rudder accordingly

Examination of the forward connecting rods to the nose wheel steering mechanism shows considerable damage to the forward bulkhead where the right hand rod protrudes through a slot in the bulkhead. The slot was expanded and elongated in the upward and downward direction as a result of the rod being forced against the bulkhead. Only slight damage was caused to the corresponding left hand slot.

The connecting lever arm which connects the rods to the nose wheel steering mechanism was also found broken at the right hand end.

The rudder deflection as found was hard over to the right at an angle of  $46.8^\circ$ . It remained in this position because of compression of the rigid control rod due to the rearwards movement of the forward bulkhead at final aircraft impact.

It cannot be said with certainty whether some or all of this damage was caused as a result of the first impact with the ground on the runway or the second and final impact with the ground in the golf course.

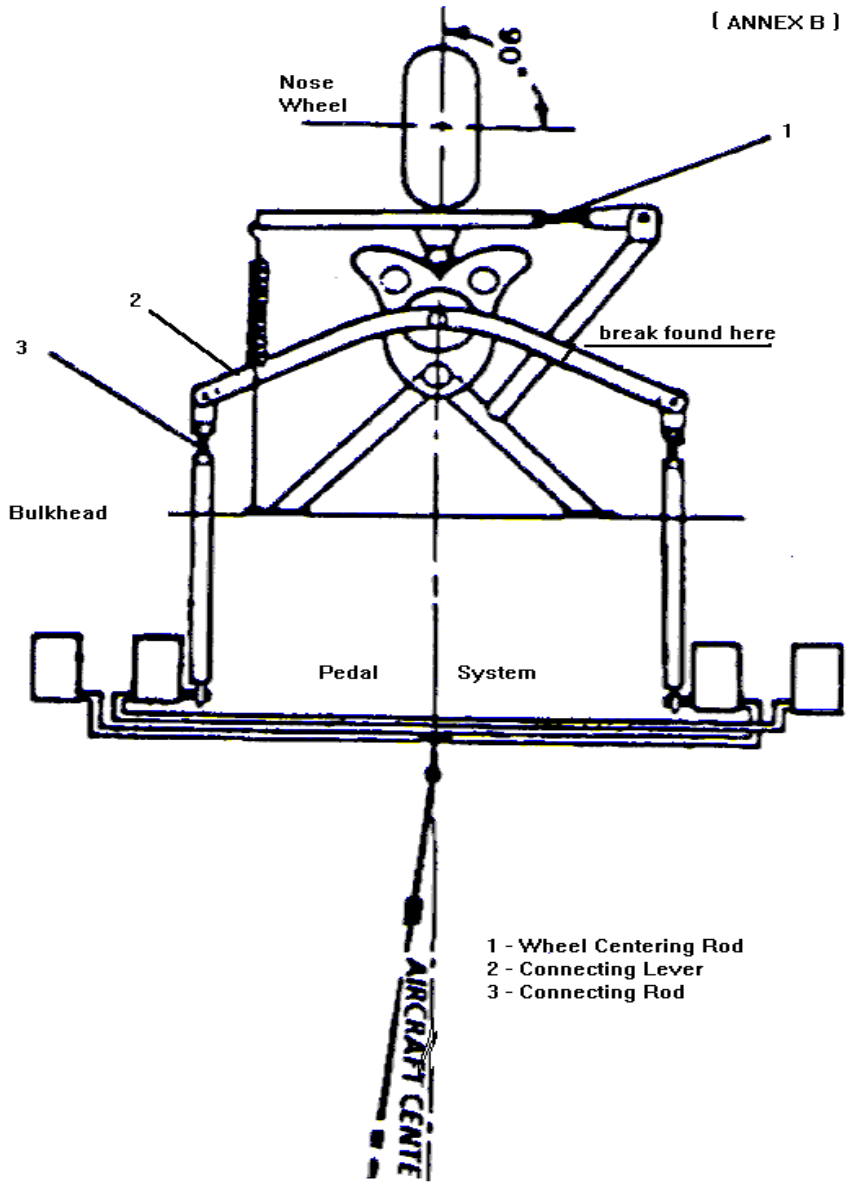
ANNEX B

- (i) If the connecting lever broke (*Annex B*) at the aircraft's first impact with the ground, then it would be impossible to apply right rudder in the conventional manner. Left rudder only would be possible in this case, by pushing on the left pedal.

- (ii) The rudder system was intact following the first impact but the movement of the rods was severely restricted due to distortion. As a result no movement of the rudder would be possible. If the aircraft had left rudder on at time of impact it is possible that the rod system remained in that position following the first impact with the ground.
