AAIU Report No:- 1999/009
AAIU File No:- 19980027
Published 31/07/1999

Aircraft Type and Registration:	Bolkow 105, EI-LIT
No. and Type of Engines:	Two, Allison 250-C20B
Aircraft Serial Number:	434
Year of Manufacture:	1981
Date and Time (UTC):	25th. June 1998, 0718 hours
Location:	Near Slane, Co. Meath
Type of Flight:	Private
Persons on Board:	Crew - 1
Injuries:	Crew - None
Nature of Damage:	Impact damage to Tail Rotor blade
Commanders Licence:	Airline Transport Pilots Licence (Helicopter)
Commanders Age:	47 years
Commanders Flying Experience:	3663 hours (of which 135 were on type)
Information Source:	Watch Manager, Shannon. AAIU Field Investigation

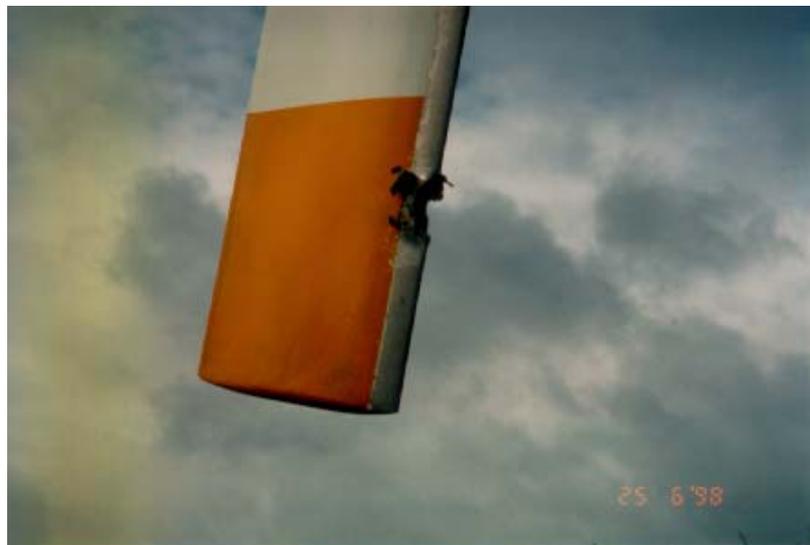
The pilot's post-flight inspection showed that one tail rotor blade had serious impact damage to the stainless steel strip on the leading edge and that the tail unit anti-collision light cover and its clamp were missing.

The visual and binocular examination of the impact damaged area revealed extraneous material in the form of a pink powdery material on the stainless steel cladding and particles of red/orange glassy material embedded in the composite material where the stainless steel had been perforated.

The findings of this examination confirmed the pilot's opinion that the anti-collision light cover departed the airframe and made contact with the tail rotor blade, causing an imbalance with subsequent vibration and noise.

The Operator advised that, in future, the anti-collision lights would be covered with heat shrink rubber to prevent a reoccurrence of this incident.
