AAIU Report No.2001-008
AAIU File No. 1999 0011
Published.: 17/07/2001

Aircraft Type and Registration:	BAe 146, EI-CLI
No. and Type of Engines:	Four, Allied Signal ALF502 R-5
Aircraft Serial Number:	3159
Year of Manufacture:	1990
Date and Time (UTC):	12th March 1999, 10.20 hrs
Location:	Stand 24 Dublin Airport
Type of Flight:	Public Transport
Persons on Board:	49 Transit Passengers and cabin crew.
Injuries:	None
Nature of Damage:	Port Aileron damaged
Commanders Licence:	Air Transport Pilots Licence
Commanders Age:	40 years
Commanders Flying Experience:	5000 hours, 2300 on Type
Information Source:	Airline Safety Officer

SYNOPSIS

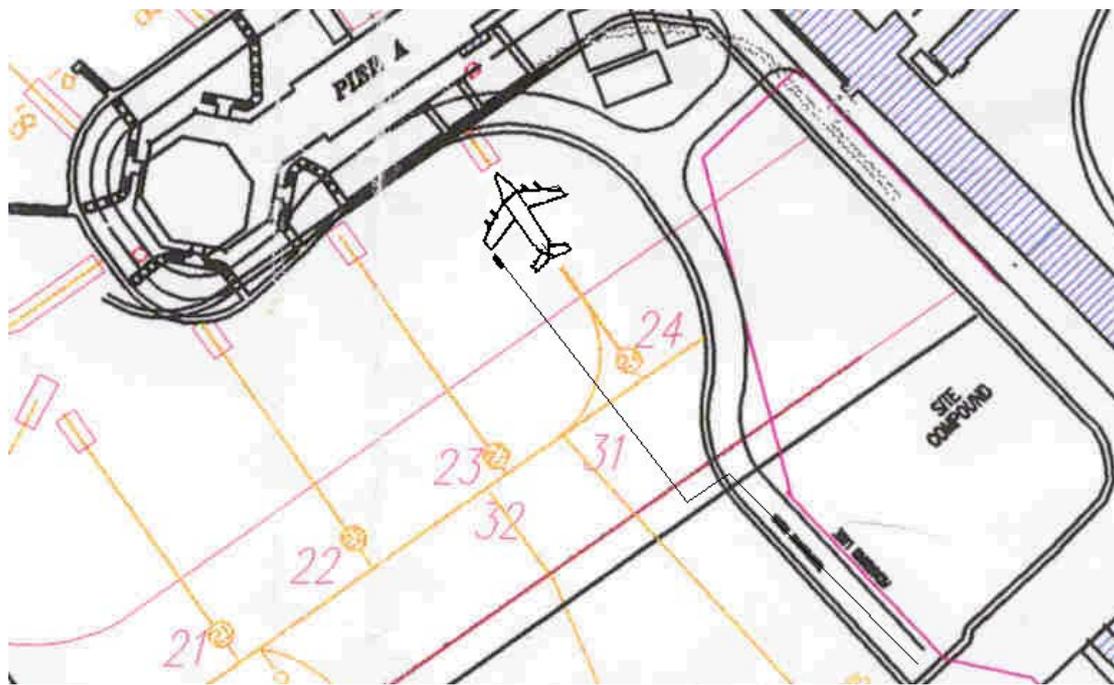
The driver of the cleaning vehicle said that as he approached the aircraft from the rear, transit passengers were leaving from the front exit. He thought he had sufficient clearance between his vehicle and the aircraft. As he drove past the wing of the aircraft he 'heard a bang'. He immediately stopped the vehicle and got out to find the vehicle's yellow beacon on the ground. He then became aware that his vehicle had struck the aircraft's wing tip. He reported this to the aircraft's engineer. The Engineer and Captain agreed, on inspection of the aircraft, that it was not fit for flight. The remaining passengers then left the aircraft. The driver said he was using the aircraft's red wing light to guide the vehicle past the wing tip. He did not see any boundary line around the Stand. He said that because of the building programme and the proximity of the portacabins, Stands had been 'changed around' and that the adjacent Stand 25 was not now in use. There was nothing painted on the ground to guide the vehicle in.

EI-CLI on Stand 24, showing the direction from which the vehicle came.
