FINAL REPORT

AAIU Report No.:2002/007

Operator:	Aer Arann
Manufacturer:	ATR
Model:	ATR 42-300
Nationality	Irish
Registration	EI-CPT
Location	Mt Errigal, Co. Donegal
Date/Time (UTC)	2 Dec 2001 at 1300 hrs

SYNOPSIS.

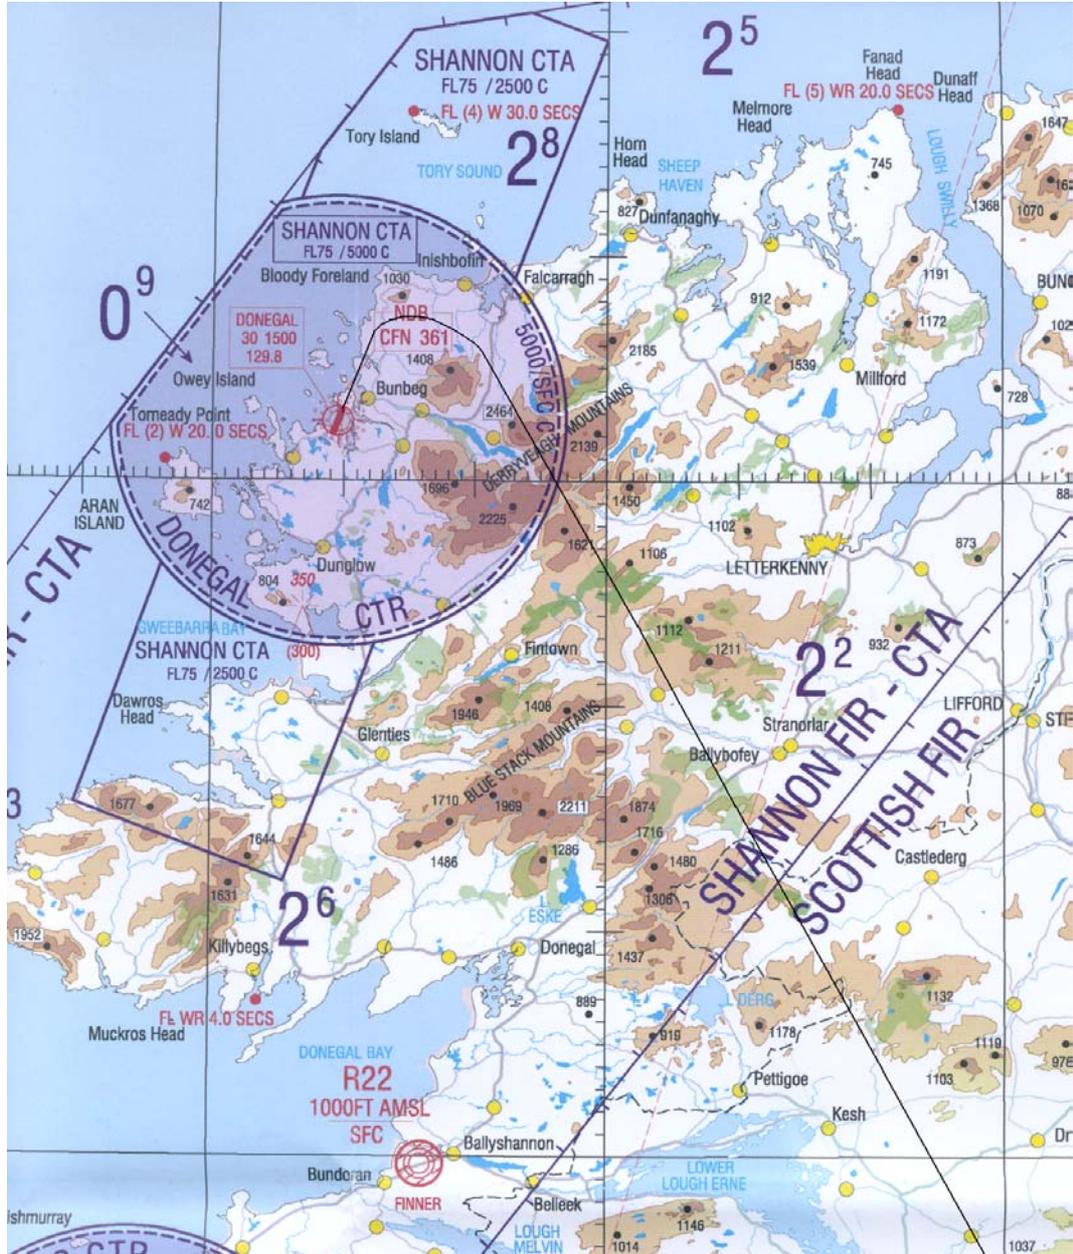
APPENDIX A

The Captain's report on a standard aeronautical chart (**See Appendix A**) indicates that the aircraft's track was east of another peak called Crocksallabagh, which has a height of 1621 ft (494 m), a further 1km east of Moylenanav. The small scale of the chart on which the track was recorded would account for this error in position. Whilst most peaks in the area are recorded and marked on the aeronautical chart, the peak of Moylenanav is not identified although it is higher than Crocksallabagh.

Aircraft track and DME arc approach to RWY 21 at EIDL reproduced from Captain's report.

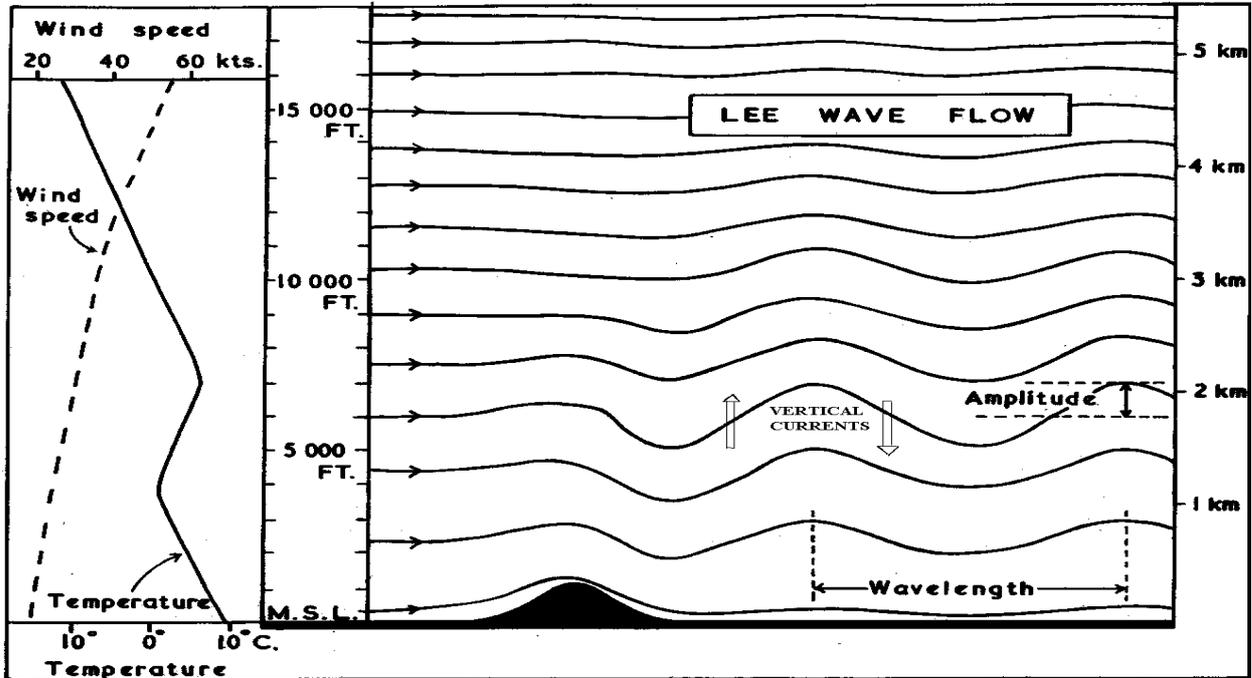
APPENDIX B

Lee waves are often associated with a stable layer sandwiched between air of lesser stability together with an increase with height of wind components across the ridge. In practice a ridge or peak produces waves where amplitude decreases rapidly downwind and it should not be assumed that all lee waves are as simple as those depicted.

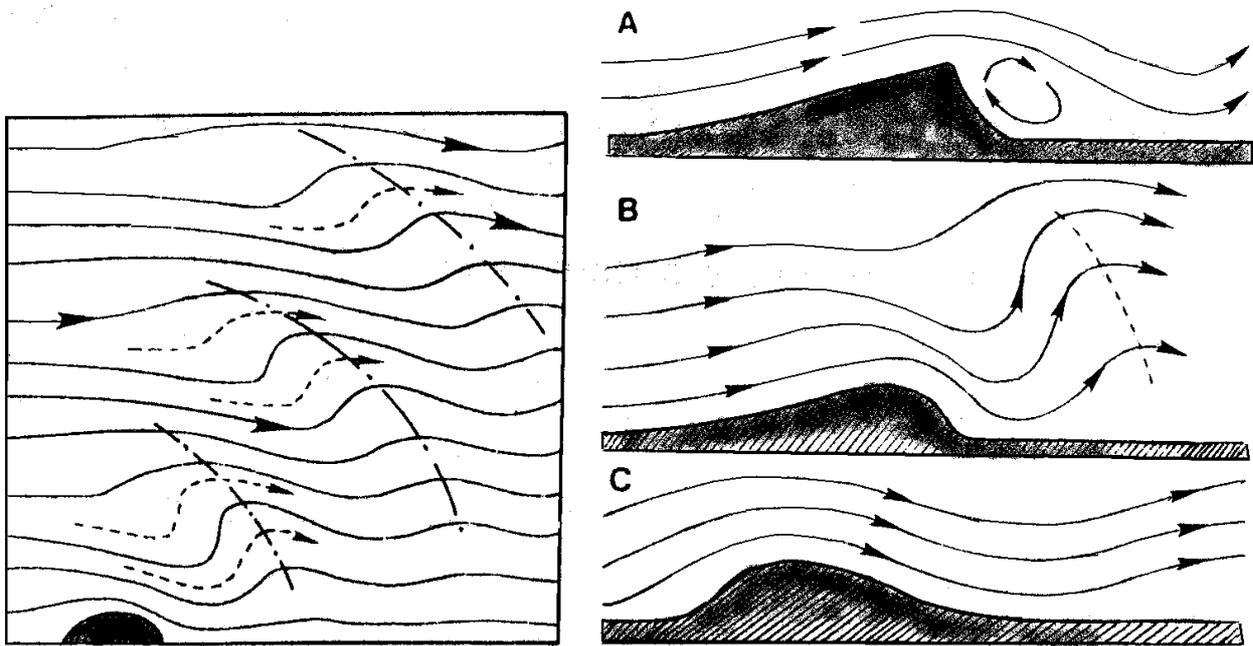
The above diagram shows a more realistic wave flow pattern. It can be seen that the waves are not symmetrical but tilt forward at a marked angle to the vertical. This can produce large sudden lift forces where the lines joining the trough to crest are almost vertical.
