*AAIU Report No.2001-010  
AAIU File No.2000-0062  
Published 30 August 2001*

<b>Operator:</b>	Futura
<b>Aircraft Type and Registration:</b>	B737-800, EC-HMK
<b>No. and Type of Engines:</b>	Two, CFM 56-7B27
<b>Aircraft Serial Number:</b>	28624
<b>Year of Manufacture:</b>	2000
<b>Date and Time (UTC):</b>	30 November 2000, 1236 hrs
<b>Location:</b>	Shannon Airport, Co. Clare, Ireland
<b>Type of Flight:</b>	Public Transport
<b>Persons on Board:</b>	Crew - 6                      Passengers -189 + 13 infants
<b>Injuries:</b>	Crew- One, minor      Passengers – Eight, minor
<b>Nature of Damage:</b>	Extensive. Nose landing gear collapsed, deformation of fuselage skin, both engines damaged by FOD. Other collateral damage.
<b>Commanders Licence:</b>	Airline Transport Pilot Licence (Spain)
<b>Commanders Age:</b>	46 years
<b>Commanders Flying Experience:</b>	7680 hours Last 90 days: 206 hours Last 28 days: 52 hours
<b>Information Source:</b>	ATC Watch Manager, Shannon Airport. AAIU Field Investigation

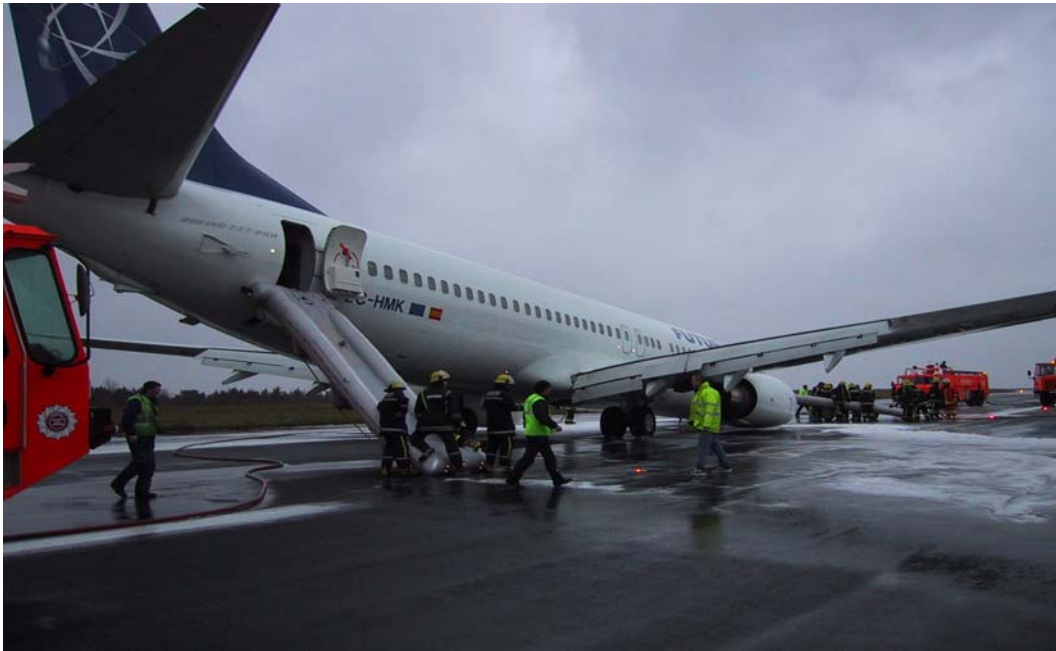
**The cabin crew** recalled that some of the overhead luggage bins in the cabin opened on the aircraft’s initial impact with the ground. When the aircraft came to rest they supervised the evacuation of the aircraft through the front right and rear right exit doors, using the two deployed escape slides. Because of the nose-down attitude of the aircraft, the front door exit was considerably closer the ground than the rear door exit (*Photo.1*).

**Photo 1.** Showing the escape slides deployed on the right hand side of the aircraft

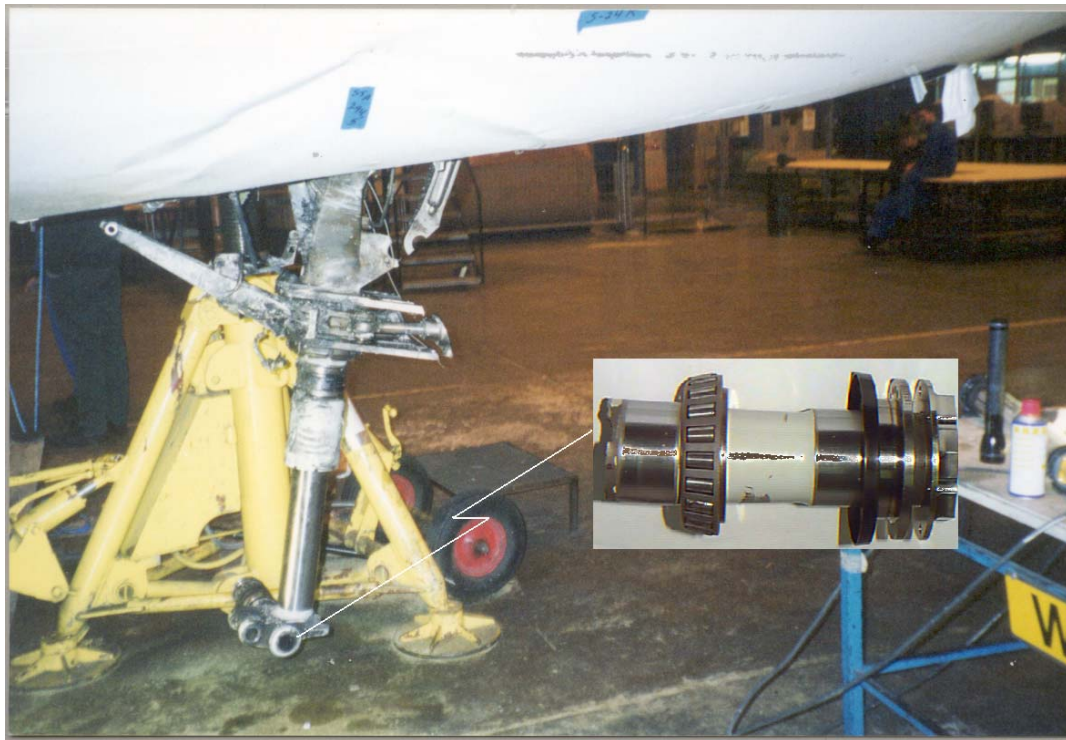
Skin panel located in cockpit area between Station 259.5 and 360 buckled. Nose wheel well doors, hinges, seals, seal retainers, upper and lower fuselage assemblies and bell cranks destroyed. *(Photo. 2)*

All associated nose wheel equipment such as steering cables, hydraulic pipelines destroyed. Nose landing gear destroyed including wheels, tyres and actuator. Lower drag strut fractured at lower bolt end. Half of the bolt plus one nut in place recovered from debris.

Also found was part of the main bolt and nut which holds the lower drag strut to the main undercarriage shock strut. Part of this bolt and nut assembly had been worn away by ground impact when the drag strut fractured following impulse loading on nose touch down.

The initial force on the nose caused the right axle complete with right wheel and tyre to snap off. The weight on the remaining wheel caused it to disintegrate leaving the bearing cages on the left axle. The axle then impinged on the ground until the forces on the drag brace caused the pin to shear and the nose strut to rotate 90° rearwards. The nose gear broke within 1 second of the second touchdown. The aircraft pitch attitude then decayed to 4° nose down for the remainder of the “rollout”.

**Photo 2.** Damage to the drag strut, shock strut and axle of the nose undercarriage assembly and to the nose cone skin of the aircraft. This photo was taken following the removal of the aircraft to the hangar. The damaged nose strut is shown in the normal down position, without its wheels, having been rotated forward from the belly of the aircraft by engineers. Also shown (insert) is the right hand axle, ruptured from the strut, and found in the grass alongside the runway following the accident.

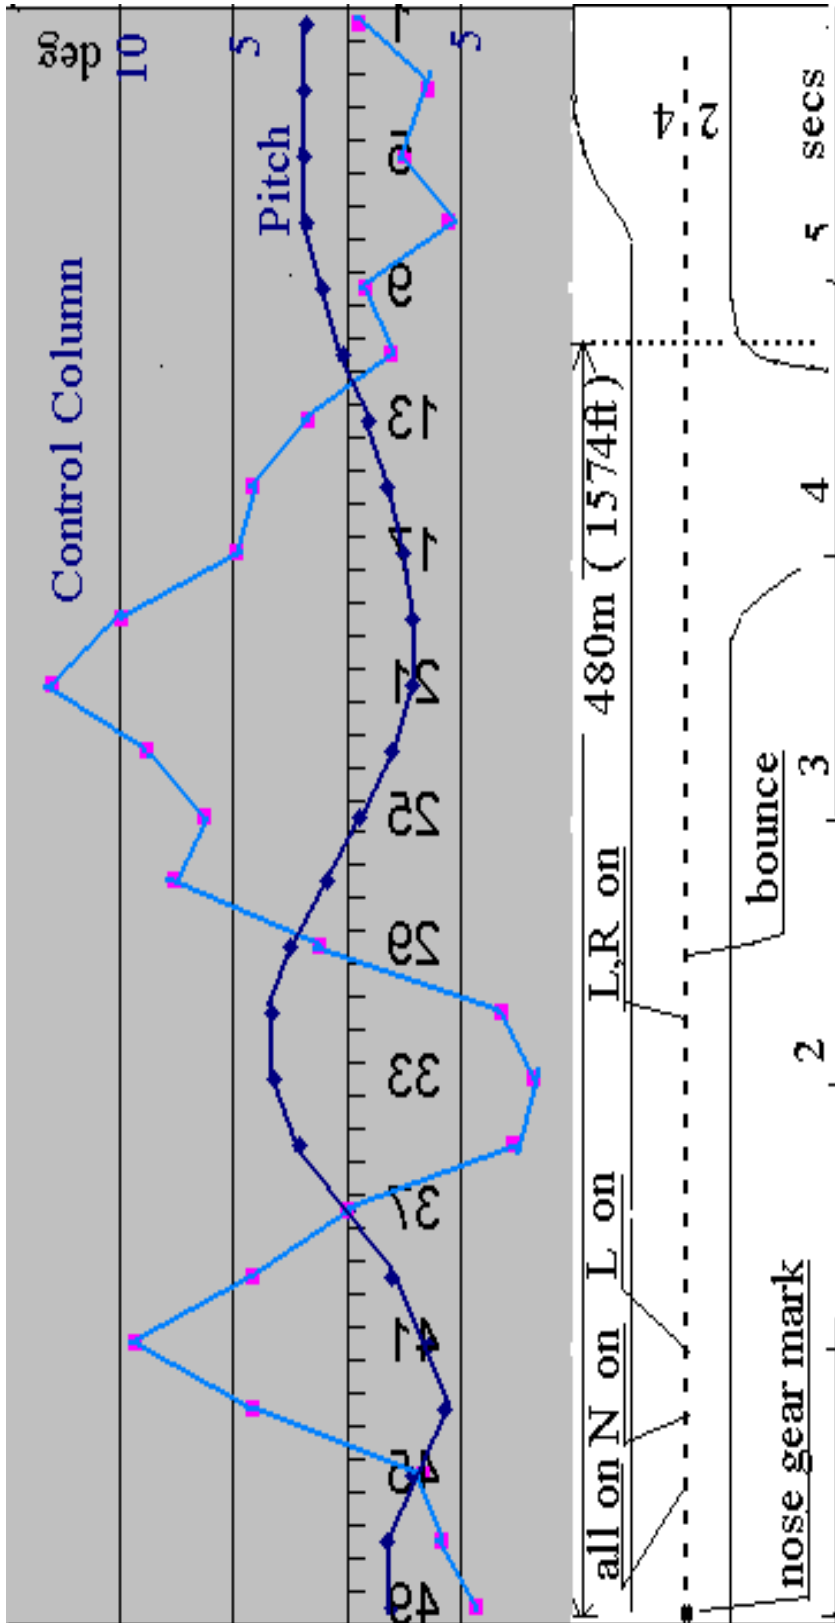
Graph of fwd/aft position of First Officer's control column with pitch of the aircraft superimposed during flare and landing of EC-HMK. + is control column aft and + is aircraft nose up. N = Nose gear, L = Left main gear, R = Right main gear.
