AAIU Report No. 2000/009
AAIU File No. 2000/0013
Published: 02/08/2000

Aircraft Type and Registration:	CFM Shadow, EI-CMF
No. and Type of Engines:	One, Rotax 582
Aircraft Serial Number:	050
Year of Manufacture:	1996
Date and Time (UTC):	27 February 2000, 1815 hours
Location:	Dunmore, Co. Galway
Type of Flight:	Private
Persons on Board:	Crew – One Passengers - None
Injuries:	Crew – Minor Passengers – N/A
Nature of Damage:	Aircraft Destroyed
Commanders Licence:	USA FAA, Licence (Private Pilot)
Commanders Age:	34 Years
Commanders Flying Experience:	200 hours, all types
Information Source	AAIU Field Investigation

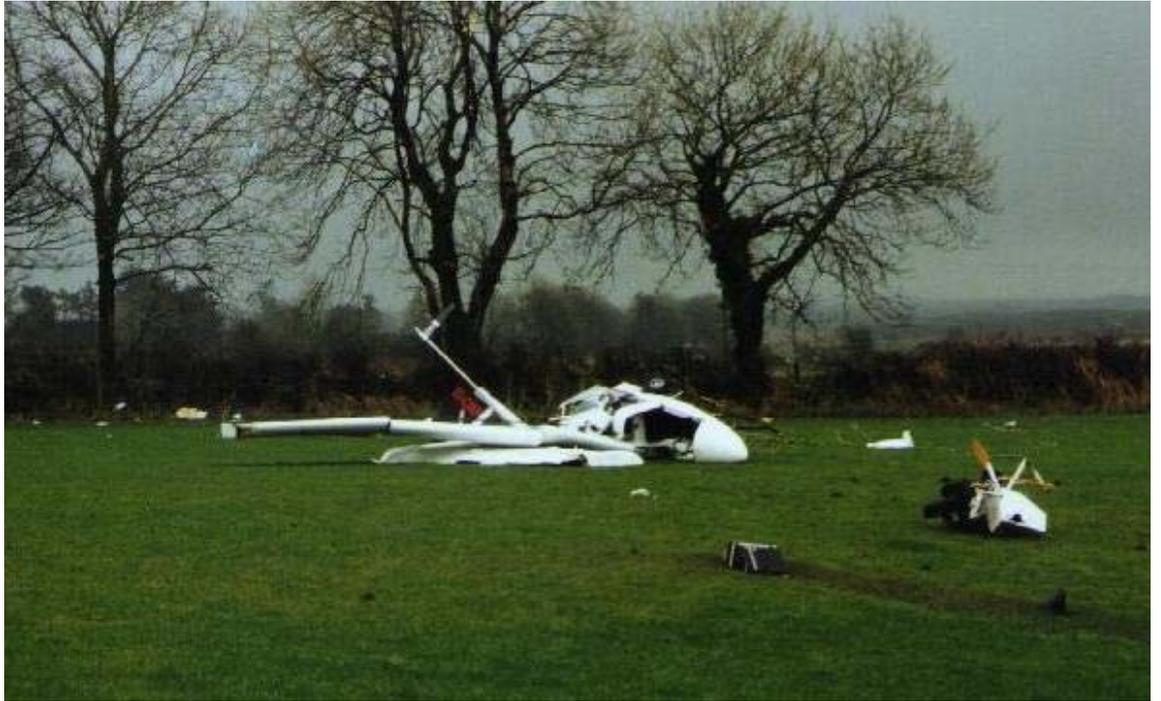
It was the pilot's intention to carry out one circuit from this field to flight test the aircraft for the purpose of the issue of the Permit. Take-off was just after 1800 hours into a light south-westerly wind. The orientation of the field is from east to west. Once airborne, the pilot commenced his circuit and lost sight of the airfield. He carried out a further two or three more circuits to regain sight of the airfield. Once sighted, he made one final low pass to confirm his position and commenced his final approach to land. With full flaps set, airspeed at 60 MPH and throttle closed, the pilot lined up with the field and flew into one of four large ash trees, about 35 feet high, on the airfield boundary. On impact the aircraft spun into the ground and disintegrated, with the exception of the cabin pod structure. In this instance, the intact cabin structure may have prevented serious injury or loss of life. The pilot quickly freed himself from the cockpit and walked away unaided. There was no fire. The accident was witnessed by the two co-owners. The flight lasted about 12 minutes.

In a full and forthright debrief the pilot described the circumstances of the accident. This was his first flight in the aircraft. He did not hold a Night Rating on any aircraft. He thought "that he had adequate light for the job to do one circuit". However, the more disorientated he got after takeoff the more the light faded, and the presence of two nearby cumulo-nimbus clouds added to the fading light. So much so, he recalled, that he did not see the tree tops on his landing approach, which he subsequently struck.

The scene of the accident photographed the following day showing the wreckage of the aircraft and the ash trees in the background.
