*AAIU Report No. 2000/002*  
*AAIU File No. 1999/0067*  
*Published: 31/03/2002*

<b>Aircraft Type and Registration:</b>	Steen Skybolt EI-CIZ
<b>No. and Type of Engines:</b>	1 Lycoming 10-360 AIB 6D with Hartzell HC-C2Y-4BF Variable Pitch Propeller.
<b>Aircraft Serial Number:</b>	001
<b>Year of Manufacture:</b>	1980
<b>Date and Time (UTC):</b>	8th Nov. 1999 13.20 hrs
<b>Location:</b>	Near Abbeyshrule, Co. Longford.
<b>Type of Flight:</b>	Private
<b>Persons on Board:</b>	Crew -- 1
<b>Injuries:</b>	Crew -- Minor
<b>Nature of Damage:</b>	Considerable Damage to Aircraft
<b>Commanders Licence:</b>	Private Pilots Licence -- Aeroplanes
<b>Commanders Age:</b>	49 years
<b>Commanders Flying Experience:</b>	1000 hours + Last 90 days - 12 hrs Last 28 days - 4 hrs
<b>Information Source:</b>	Owner of Aircraft AAIU Field Investigation

### **SYNOPSIS**

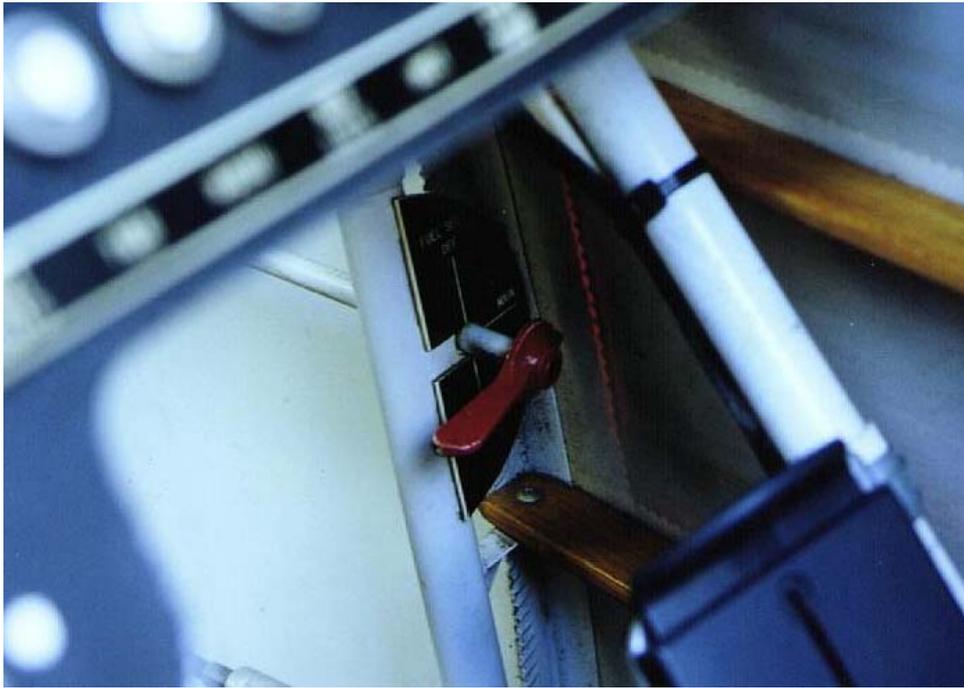
**FIG. 1** FUEL SELECTOR -- REAR COCKPIT

On inspection of the aircraft in the field on the day following the incident, no fuel was found in the engine metering valve, injector, engine driven fuel pump and booster pump. The fuel selector lever was found in the "Off" position. When the fuel valve was turned to "Main" and the booster pump (used for starting purposes only) switched on, there was an immediate flow of fuel to the engine cylinder entries.

Ground checks were carried out at the start of RWY 28 in preparation for take off and the verification of fuel quantity and position of the fuel valve were part of these checks. If the fuel selector lever were moved in order to verify its position at this time, it is possible, considering the construction of the valve and its leverage, that the internal valve ports were not aligned. This would produce a severe restriction or even cut-off in the fuel flow from the main tank to the engine.

4.1 It is recommended that the Society of Aircraft Constructors (SAC) inform their members that this type of fuel valve with "brass to brass" bearing surfaces should not be used in the construction of aircraft fuel systems. **(SR 1 of 2000)**

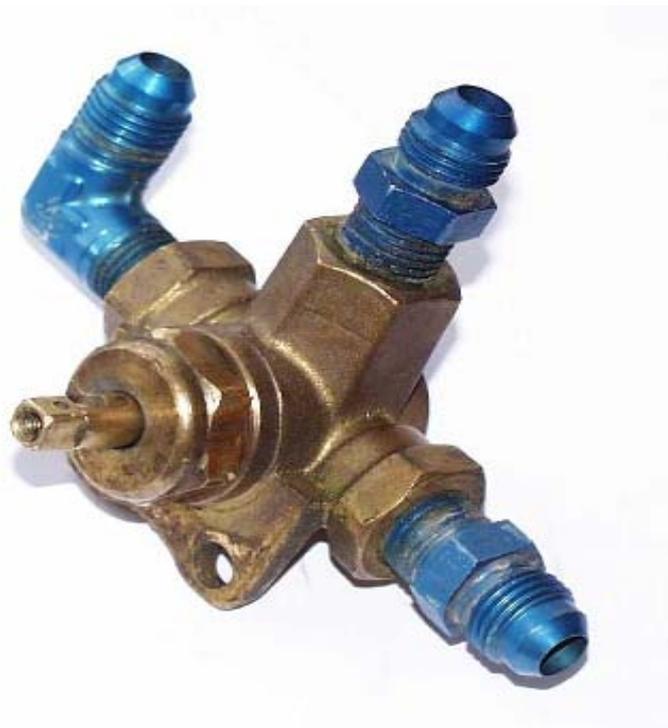
**FIG. 2** FUEL SELECTOR VALVE EI-CIZ

- (c) The fuel used was Avgas 100 LL
- (d) The fuselage main tank is situated immediately aft of the firewall and has a fuel capacity of 29US gallons. The wing tank is installed in the centre-section of the upper wing and has a fuel capacity of 10 US gallons. The refuelling point is on the upper surface forward of the windscreen and on the top surface of the upper wing. The main tank has an internal baffle and a flop tube which ensures that the tank sump is always full when performing aerobatics. The fuel lines from the wing tank and main tank meet at the fuel selector valve which is mounted on the starboard side just behind the firewall. The outlet from the fuel selector valve then goes through the firewall to the electrical booster pump and then to the fuel gascolator underneath the booster pump. The fuel line is then taken from the gascolator to the engine driven fuel pump. The selector valve is operated by a lever in the rear cockpit (Fig.1) through a long handle passing through the front cockpit, past the main fuel tank and connected to the fuel selector valve near the firewall.(Fig.2). The fuel selector lever positions are - Off - Main- Wing.

The 3 position fuel selector valve ( Off-Main- Wing) was removed from the aircraft. Its operation on a fuel test bench was checked and the operation found to be satisfactory. It was found very stiff to operate requiring a torque of 43 in lbs to rotate the spindle. This varied depending on the position of the spindle. A detent could be felt in each of the three positions indicating that the valve spindle was "home". Due to the stiffness of the spindle and the length of the operating handle from the rear cockpit to the forward engine bulkhead it is possible that the cockpit indicator might indicate "Main" whilst the valve spindle might not be exactly in a position to allow full fuel to flow from the main tank.

Contact was made with the manufacturer of this aircraft kit in the US. They indicated that the builder of this particular aircraft used an "Imperial" 3 way fuel valve which was, at the time, certified for aircraft use. The problem with this valve is that it has a "brass to brass" cone shaped seal which frequently binds when moved and can also bind in between ports. The original manufacturer of the kit never gave any recommendations for the fuel system components. The present manufacturer bought over the business in 1990 and has written a builders guide which includes a section on the fuel system.

There is a possibility that the fuel selector may have been cycled at some stage prior to the flight and when finally switched to "Main" that the valve ports did not line up fully. This could have supplied enough fuel flow for starting and taxiing. However, when full power was applied the engine fuel consumption rate exceeded the fuel flow rate through the partially open valve resulting in a lean cut shortly after take off.

It is concluded that the internal parts of the fuel valve were not aligned at take off, thus restricting the amount of fuel available for flight.

4.2 It is recommended that the FAA, as the authority in the state of manufacture, should take on board the problems associated with this type of valve and consider appropriate action. **(SR 2 of 2000)**
