**AAIU Report No.** 1998/ 015  
**AAIU File No.** 19960053  
**Published:** 26/11/1998

**Aircraft Type and Registration:** Robinson R22 B; G-CLYV

**Location:** Killary Harbour, Co. Galway

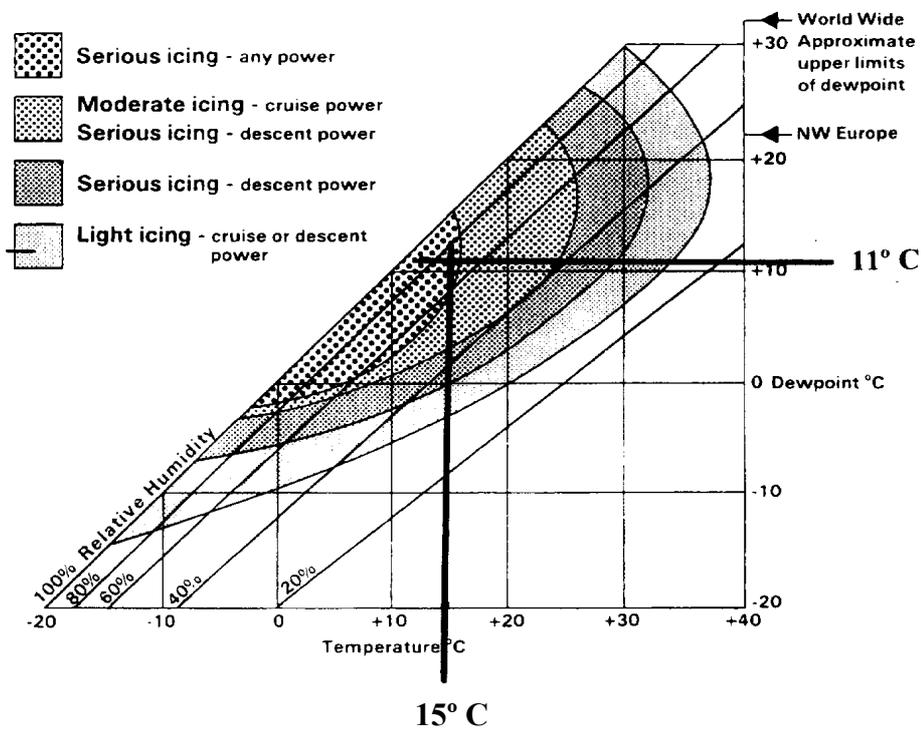
### CARBURETTOR ICING IN AIR FREE OF CLOUD, FOG, OR PRECIPITATION

Finally, the possibility of carburettor icing was explored. Information on the weather in the Killary Harbour area was provided by Met Eireann, the Irish Meteorological Service. The cloud base in the area was 2200 ft. The estimated temperature at 800 ft was 15°C and the dew point was 11°C. Plotting these values on the appropriate chart, as shown in Annex A, shows that the aircraft was operating in edge of the zone of probable serious carburettor icing, at any power setting.

The graph shown below is reproduced from the Irish Aviation Authority (IAA) Aeronautical Information Circular (AIC) NR 11/97, titled "Induction system icing on piston engines as fitted to aeroplanes, helicopters and airships". The conditions prevailing at 800 ft, when the accident occurred to G-CLYV, have been superimposed on this graph. The result shows that serious icing of the carburettor could be encountered, at any power setting, at the time of the accident.
