Air Accident Investigation Unit Ireland

**SYNOPTIC REPORT
SERIOUS INCIDENT
Boeing 737-8AS, EI-EBW
Airbus A320-214, EI-DER**

**Dublin Airport
19 May 2018**

AAIU Report No: 2019-001
 State File No: IRL00918032
 Report Format: Synoptic Report
 Published: 10 January 2019

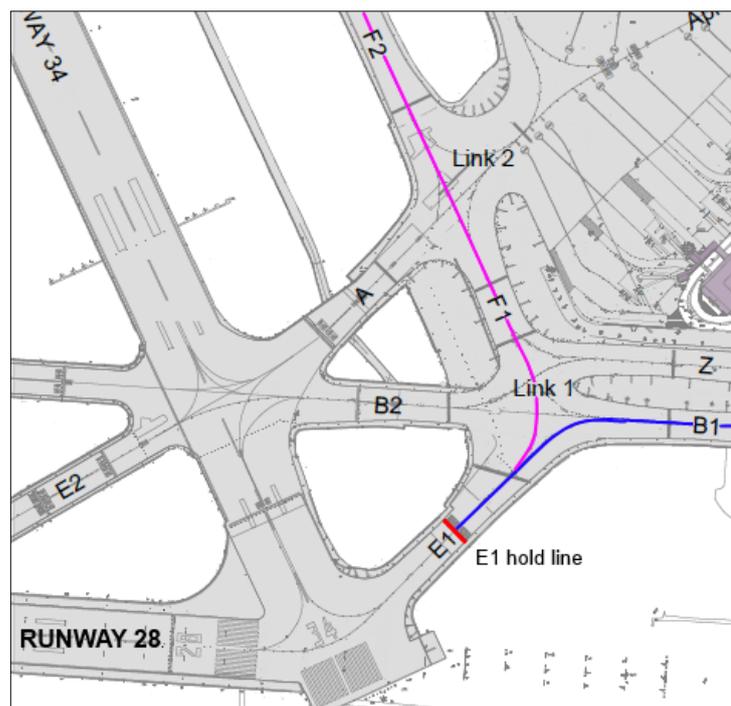
Graphic No. 1: Taxi route of EI-DER (blue line) and EI-EBW (magenta line)

The layout of Taxiways between the apron and RWY 28 is shown in **Graphic No. 1**. The taxi route of EI-DER from TWY B1 to TWY E1 is shown in blue; the taxi route of EI-EBW from TWY F2 to TWY E1 is shown in magenta. The TWY E1 hold line is shown in red.

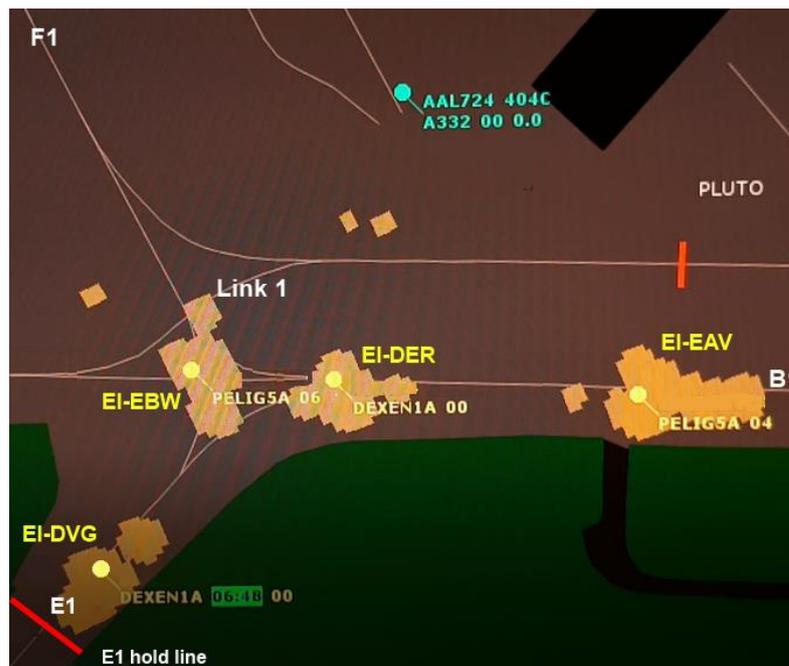
Image No. 1: Labelled A-SMGCS image of Link 1 showing the relative positions of each aircraft

A screen capture of the A-SMGCS⁶ ground radar (**Image No. 1**) shows the relative positions of the aircraft with EI-DVG stationary at the hold line on TWY E1, EI-DER stationary on Link 1 and Airbus A330 EI-EAV about to stop on TWY B1. EI-EBW is in a turn on Link 1 to position behind EI-DVG.
