# Air Accident Investigation Unit Ireland

**FACTUAL REPORT**

**Parajet 130 Thor, Unregistered  
Near Camp, Co. Kerry**

**27 May 2020**

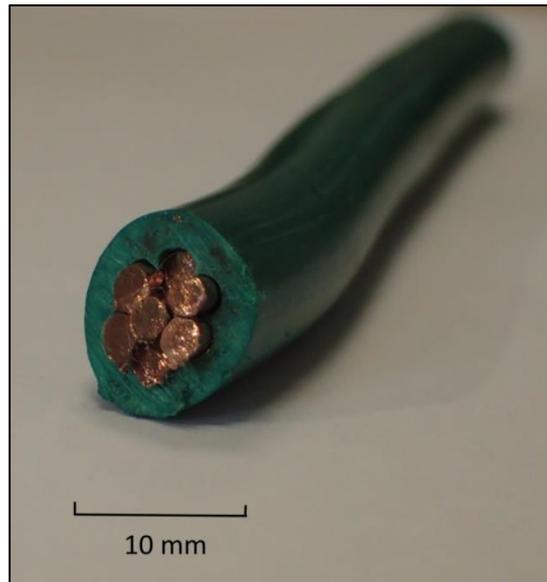
Two 20 kiloVolts (kV), 25 square mm insulated electricity transmission cables (a sample is shown in **Photo No. 1**) running through the caravan park at a height of 9.62 m broke as a result of the impact. The cable insulation was rated for 1,000 Volts. The grass below the transmission cables was scorched when the live ends of the transmission cables made contact with the ground.

**Photo No. 1:** Sample of Cable from Power Line
