Air Accident Investigation Unit Ireland

SYNOPTIC REPORT

**Cessna FR172K Hawk XP, EI-EZU
Near Killimordaly, Co. Galway**

11 July 2020

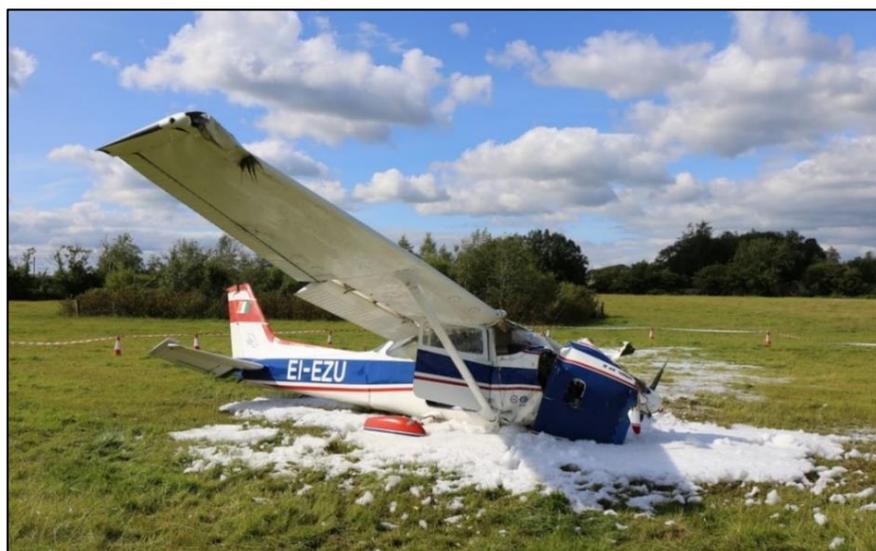
After the MAYDAY call, the aircraft descended in a north-north westerly direction for approximately 1.5 nautical miles (NM), before commencing a turn towards the west as it approached an agricultural field near Killimordaly, Co. Galway. The aircraft contacted the ground hard during the attempted forced landing. When the aircraft came to rest, it was on a magnetic heading of 114° (i.e. back towards the direction it had approached from). The impact occurred approximately two minutes after the MAYDAY call was made. The aircraft sustained substantial damage in the impact sequence (**Photo No. 1**). There was no fire.

Photo No. 1: Final resting position of aircraft

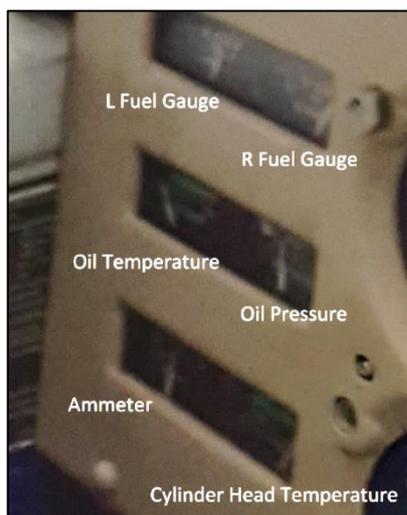
The passenger had taken some sight-seeing photographs during the flight, which were provided to the Investigation. One of these, with a time stamp of 11:43:41, shows a panel on the left side of the cockpit's main instrument panel, in addition to the view outside the aircraft. The panel contains several gauges, including the oil temperature, oil pressure and cylinder head temperature gauges. The Investigation provided an annotated version of the photograph to the Pilot for his opinion regarding the gauge needle positions (**Photo No. 2**). The Pilot stated that the oil temperature gauge appeared to be indicating a lower temperature than normal, whereas the oil pressure gauge appeared to be indicating close to normal. Regarding the cylinder head temperature gauge needle, the Pilot said it *'would [normally] be slightly to the right of vertical but not as far as it appears to be in the photo [...]*'.

Photo No. 2: Cockpit panel containing cylinder head temperature and oil gauges

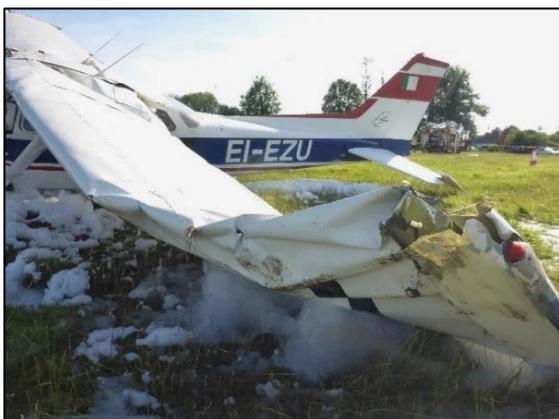
The aircraft was substantially damaged as a result of the impact sequence. The outer part of the left wing was bent upwards (**Photo No. 3**). This part of the wing had also sustained damage to its leading edge. In addition, there was significant creasing and bending on the left wing's upper surface at the wing root (**Photo No. 4**). It was subsequently identified that the top section of the fuel tank fitted inside the left wing was damaged, exposing the fuel to atmosphere (**Section 1.11**).

Photo No. 3: Damage to outer part of left wing

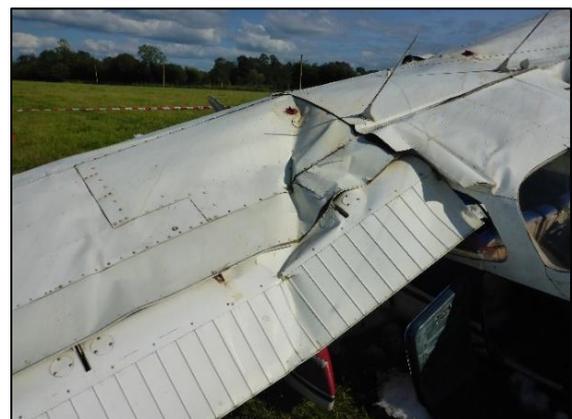
Photo No. 4: Creasing and bending on left wing's upper surface

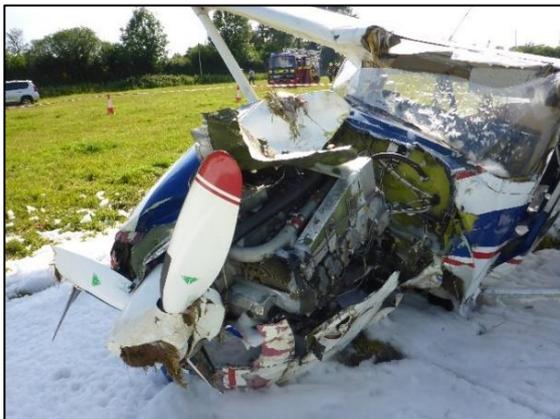
Photo No. 5: Damage to propeller blades and spinner

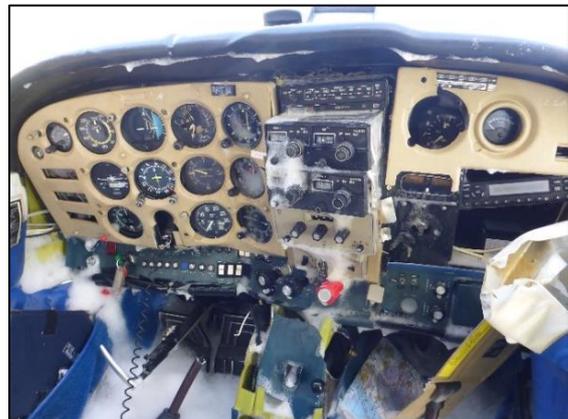
Photo No. 6: Damage to instrument panel and front foot wells

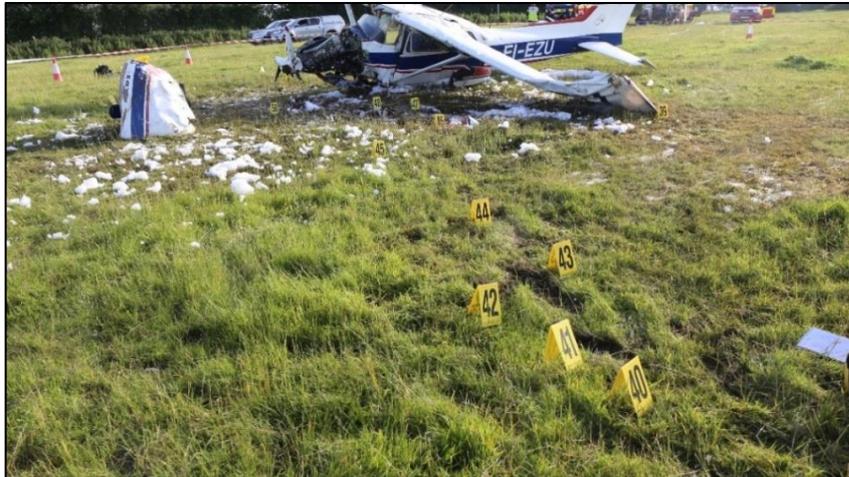
The impact site itself was compact and there was no evidence of any ground run behind the aircraft. Several areas of damage to the ground surface were evident along a line which ran from outboard and forward of the left wing tip, towards the wing root (**Photo No. 7**). A piece from a main wheel spat was present about halfway along the line of ground surface damage. Other debris from the aircraft was evident along the line of the ground surface damage.

Photo No. 7: Ground damage outboard and forward of left wing

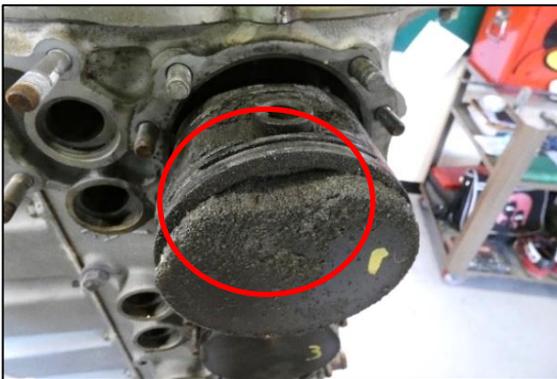
The No. 1, No. 3 and No. 4 pistons and cylinders were found to have 'detonation/pre-ignition damage' (Section 1.12.2). The damage to the No. 1 piston crown and skirt was substantial (Photo No. 10 and Photo No. 11), with material missing from the edges of the piston crown and damage to the piston ring lands¹⁰. The No. 1 cylinder was found to be scored, with metal transfer from the piston to the cylinder wall. The piston rings were also scored and were seized in the piston ring grooves. In addition, the inlet and exhaust ports were wet with oil. There was no visible damage to the inlet and exhaust valves. The cylinder's two spark plugs could not be tested due to debris between the electrodes.

Photo No. 10: Damage to the No. 1 piston crown (ringed)

Detonation occurs ahead of the normal flame front and usually initiates at the extremities of the combustion chamber. It can cause rapidly rising temperatures at the piston edges, which, in conjunction with the piston ring lands, can be damaged as a result. When the engine was disassembled it was found that several of the engine's pistons had sustained damage, which included damage to the edges of the piston crowns and large areas of material missing. The damage found is therefore consistent with detonation.

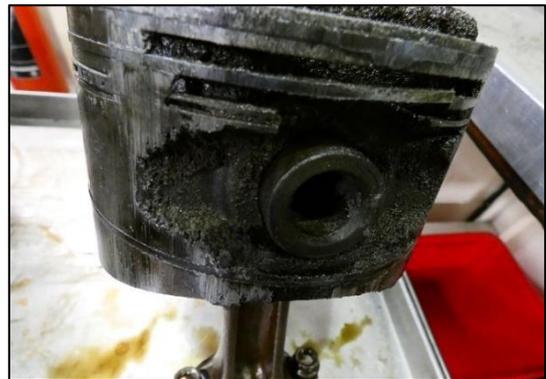
Photo No. 11: Damage to the No. 1 piston skirt and piston ring lands.

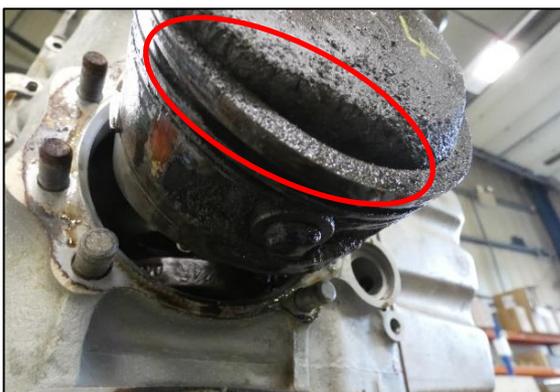
The findings were similar for the No. 4 piston (Photo No. 12) and the No. 4 cylinder. There was damage to the No. 3 piston crown (Photo No. 13) which was also attributed to 'detonation/pre-ignition', although the damage was less severe. There was scoring to the cylinder walls. The inlet port was wet with oil; the exhaust port was dry. The two spark plugs from the No. 3 cylinder were tested satisfactorily.

Photo No. 12: Damage to the No. 4 piston crown (ringed)

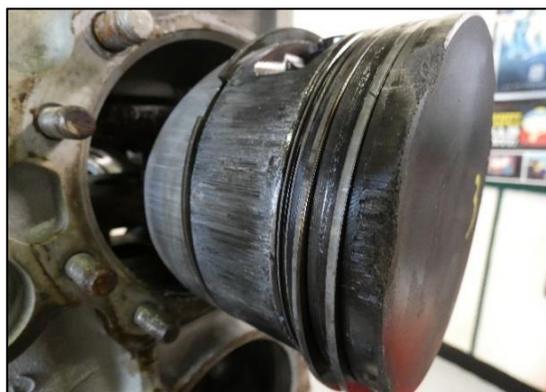
Photo No. 13: Damage to the No. 3 piston crown
