Air Accident Investigation Unit Ireland

FACTUAL REPORT

**Urban Air Samba UFM-10, EI-DXT
Fethard Airstrip, Co. Tipperary**

22 June 2021

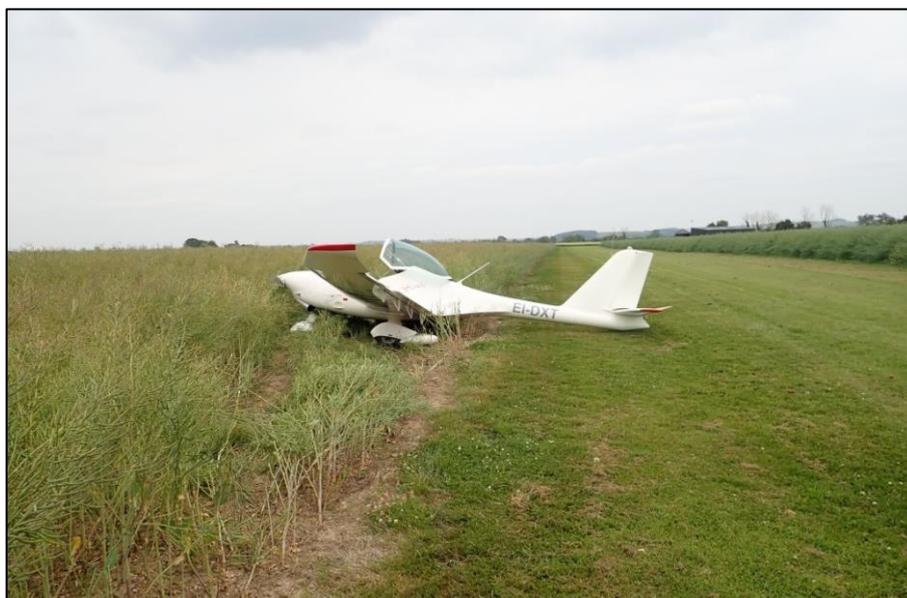
Photo No. 1: Final resting position of aircraft

The aircraft's nose landing gear partially collapsed, the right main landing gear detached from the aircraft, and the left main landing gear sustained damage. There was some scuffing evident to the underside of the left wing. In addition, the engine and propeller likely sustained shock loading.

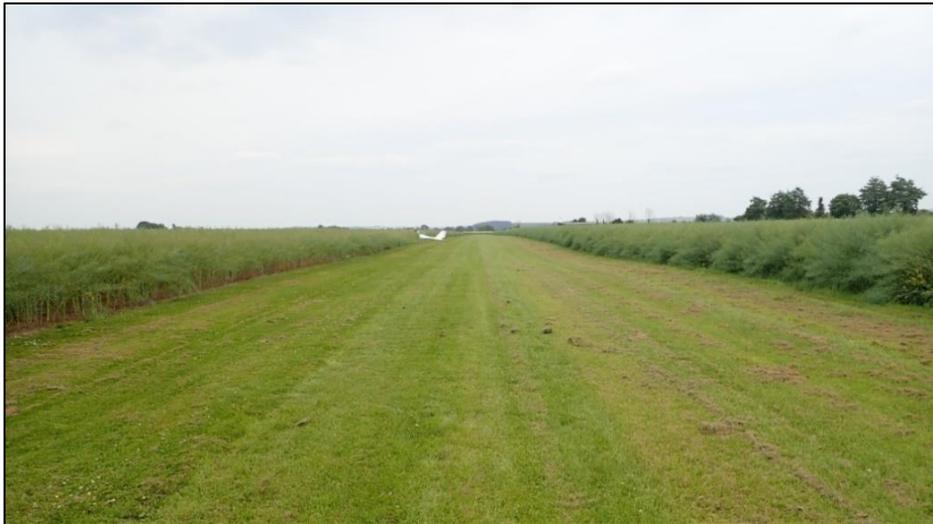
Fethard Airstrip is located in County Tipperary in the Irish midlands. It has one prepared grass runway – RWY 07/25. The AAIU measured the runway length as 420 m between the cones at each end. The runway width at the accident location was measured to be between 12.1 m and 12.3 m. A rapeseed crop, approximately 1.2 to 1.5 m in height, was growing in tilled ground adjacent to each side of the runway (**Photo No. 2**).

Photo No. 2: View along RWY 07 at Fethard Airstrip

The AAIU measured the runway width as approximately 12.1 to 12.3 m at the location of the accident. The aircraft's wingspan is 9.93 m. This resulted in a lateral separation of just over 1 m between each wingtip and the rapeseed crop growing adjacent to each side of the runway. The surface wind, as contained in the meteorological aftercast, was west to north-west at 5 to 8 kts, with gusts of 10 to 12 kts. Therefore, there would have been a crosswind when landing on RWY 07; this was noticed by the Pilot. Landing on the longitudinal centre of an unmarked grass runway and remaining within 1 m of the centre during the landing roll would be challenging, particularly with a crosswind. The height of the rapeseed crop was greater than the height of the aircraft's wingtips, and once lateral separation was lost, contact with the crop was inevitable. The contact with the crop caused the aircraft to turn suddenly to the left and depart the runway. The damage to the aircraft's landing gear was likely due to side loading and the surface conditions experienced once the aircraft departed the prepared runway.

This occurrence highlights the importance of establishing the exact conditions at a planned arrival airstrip before commencement of flight, including runway width, and whether or not crops or other obstacles are present. These details are essential in informing aeronautical decision-making regarding the suitability of an airstrip for the type of aircraft being flown, and whether or not the flight should be undertaken.
