# Air Accident Investigation Unit Ireland

**FACTUAL REPORT**

**Citabria, 7ECA, EI-ANT  
Trim Airfield, Co. Meath**

**13 June 2021**

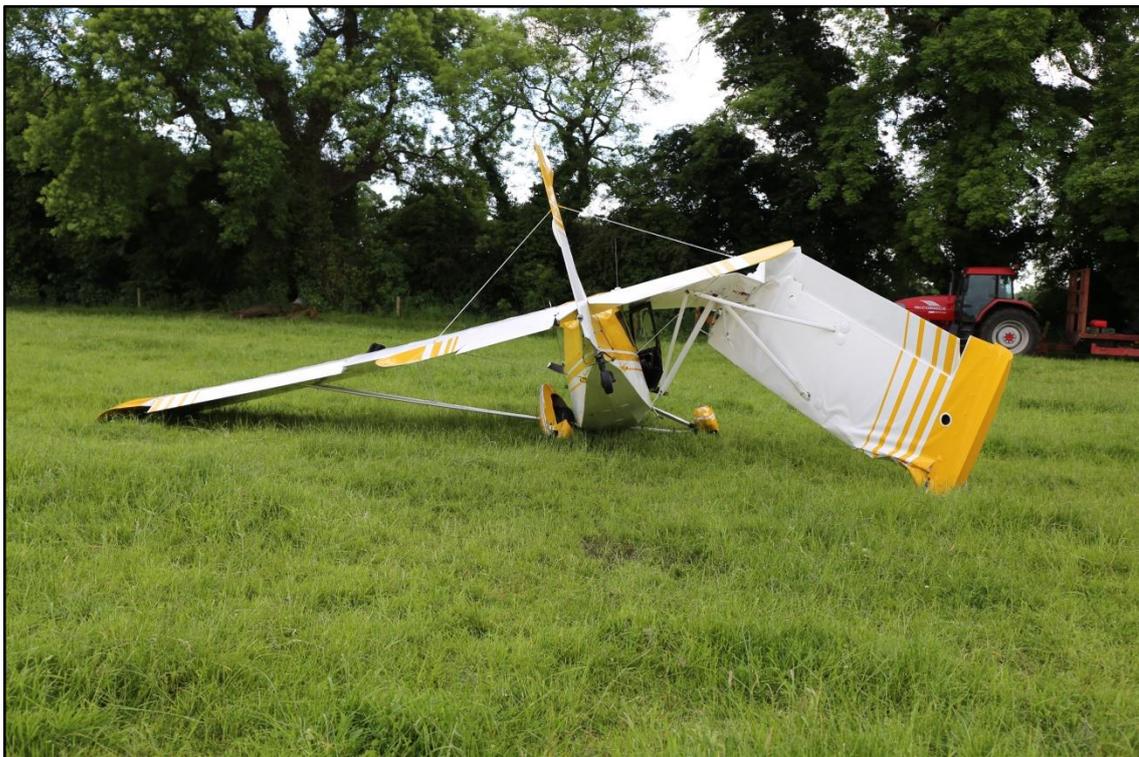
**Photo No. 1:** Final resting position of the aircraft

The aircraft came to rest on a magnetic heading of approximately 180 degrees (**Photo No. 1**).

The right wing was fractured and bent rearwards and downwards and the associated wing struts were bent and folded. The left undercarriage leg had separated from its attachment point to the fuselage. The propeller's two blades exhibited evidence of ground impact. The door through which both occupants exited the aircraft was restricted in its opening range because of interference with the distorted structure of the right wing.

A survey of the runway indicated that during the landing the aircraft touched down to the left of centreline, and that approximately 140 m from the runway threshold, the aircraft started to veer to the left. Over the subsequent 20 m (in the runway direction) the aircraft traversed the 24 m wide runway shoulder and impacted with the boundary fence. The aircraft continued into the adjacent field, coming to rest approximately 20 m from the boundary fence.

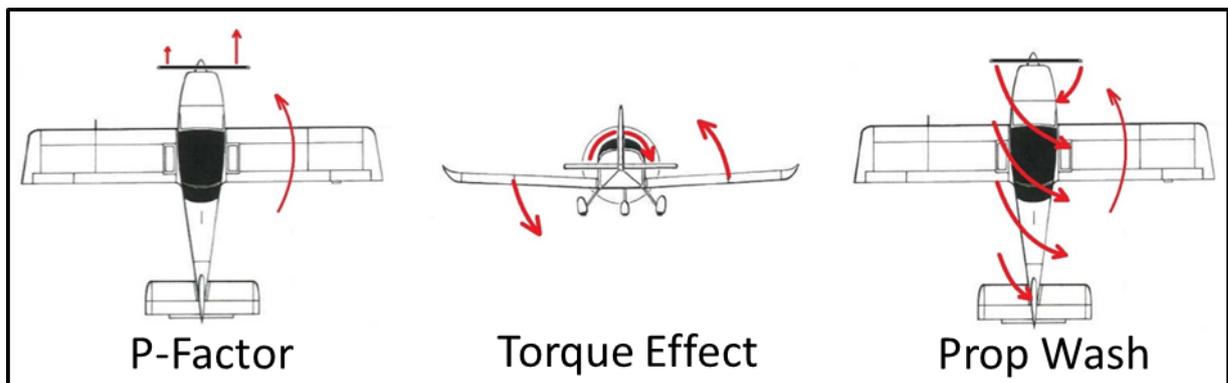
**Figure No. 1:** Generic schematic of propeller and handling factors

The following factors (**Figure No. 1**) are known to affect single engine propeller driven aircraft:

- P-Factor
- Roll due to propeller torque effect
- Prop-wash
- Gyroscopic precession
